## PRIMARY RECORD

\*Resource Name or # (Assigned by recorder) 1308 Bruce Ave

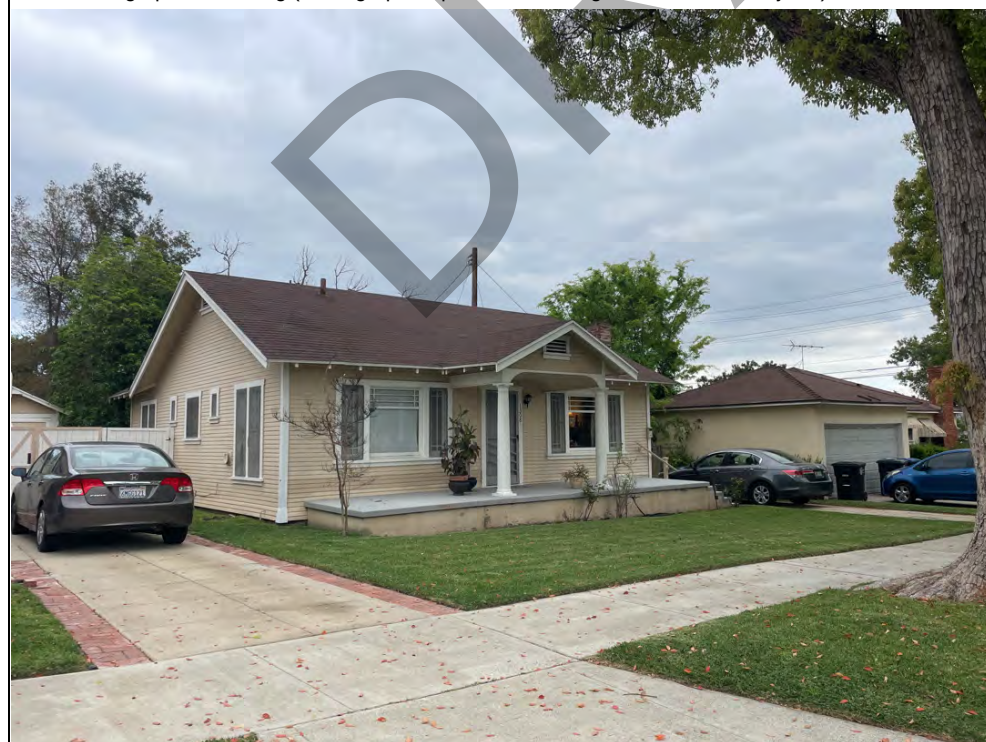
Setting: set back  
Height: 1-story  
Plan: rectangular  
Primary Façade Composition: symmetrical  
Type of Construction: wood frame  
Wall Cladding: wood, clapboard  
Architectural Details: decorative wood elements

Roof Form: gable, side; gable, front  
Roof Cladding: composition shingle  
Roof Details: eaves, open; exposed rafter tails; gable vent; exterior chimney, brick

Alterations: railings altered/replaced; driveway gate added/replaced; no major alterations

**Integrity:** high

P5b. Description of Photo: (view, date, accession #) View southeast, 3/27/2025

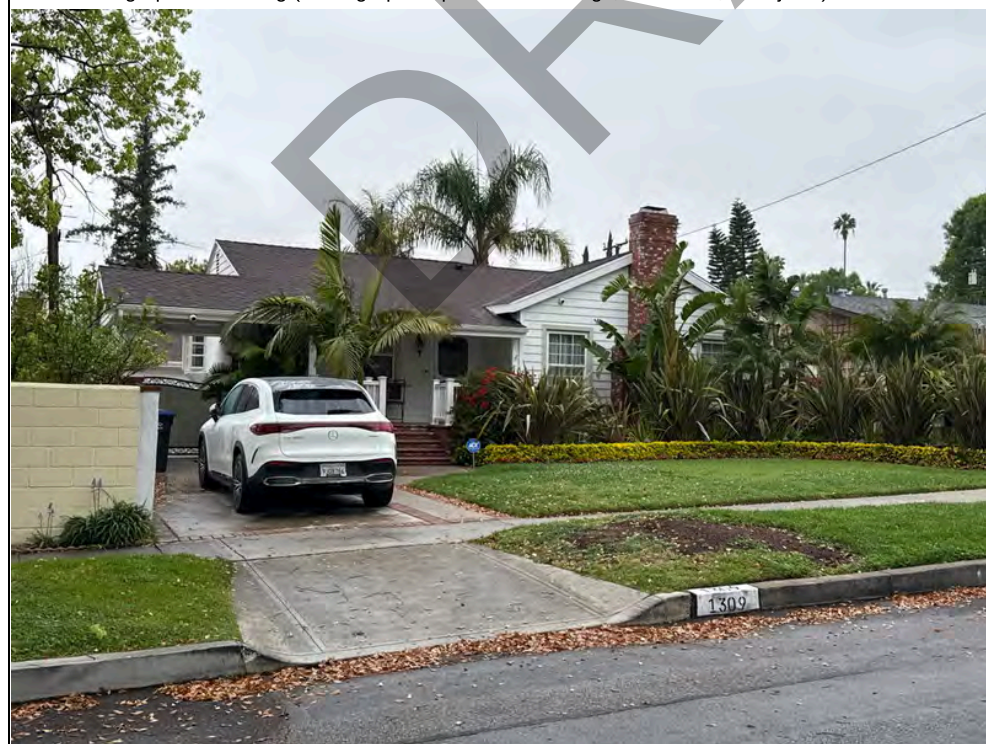
Alterations: door replaced, primary; windows replaced, all; wall cladding added/replaced; driveway gate added/replaced; porch flooring altered/replaced; railings altered/replaced; garage door replaced; window surrounds altered

P5b. Description of Photo: (view, date, accession #) View northwest, 3/26/2025

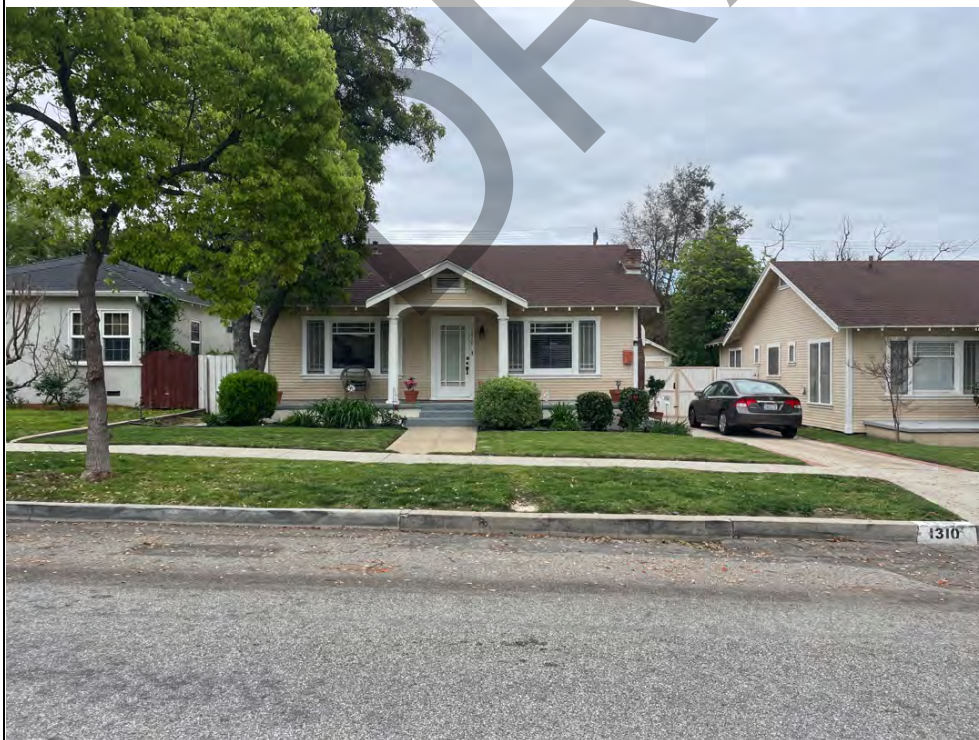
P5b. Description of Photo: (view, date, accession #) View east, 3/27/2025

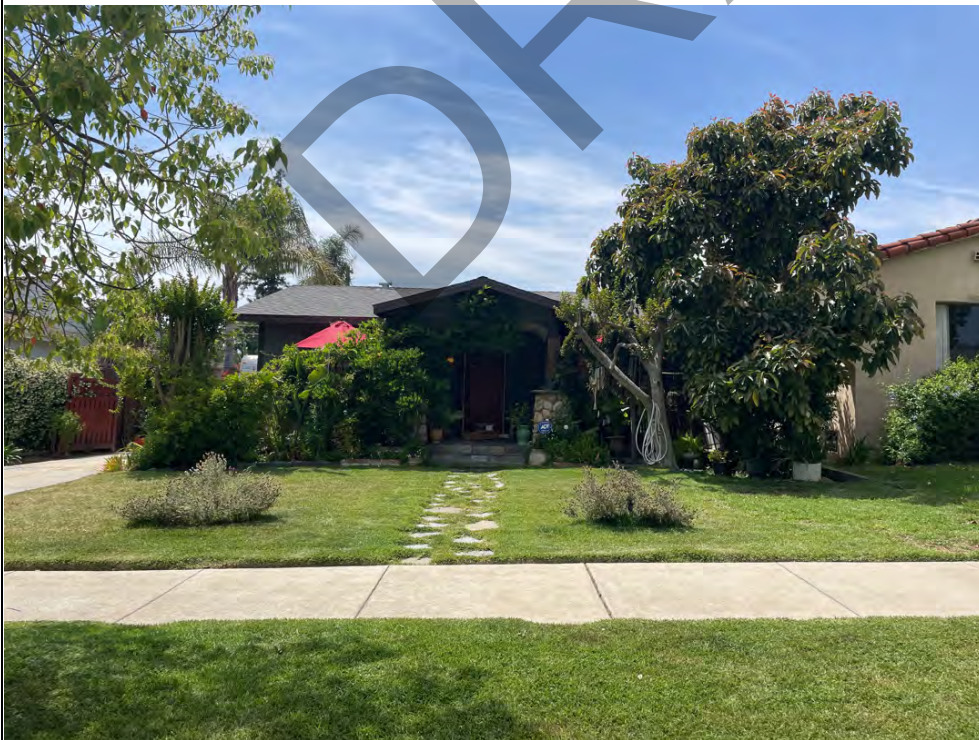
Alterations: porch flooring altered/replaced; door replaced, primary; windows replaced, some, primary; windows replaced, some, secondary; wall cladding added/replaced; driveway gate added/replaced; garage door replaced

P5b. Description of Photo: (view, date, accession #) View west, 3/26/2025

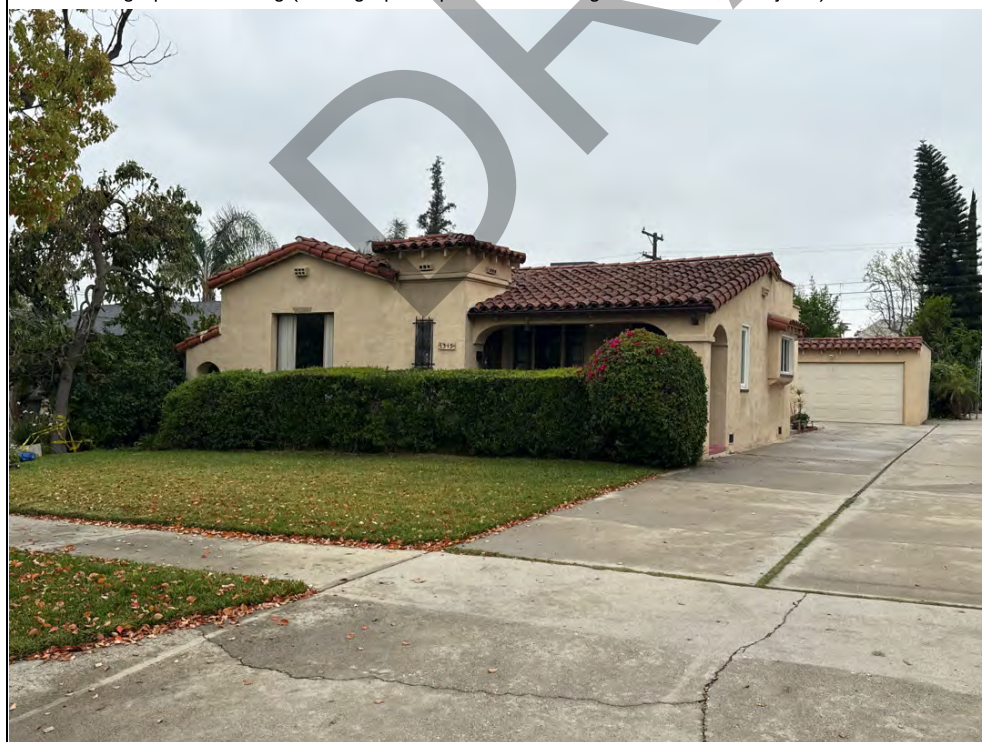
Alterations: door replaced, primary; windows replaced, some, primary; windows replaced, some, secondary; security window bars added; garage door replaced

P5b. Description of Photo: (view, date, accession #) View southwest, 3/26/2025

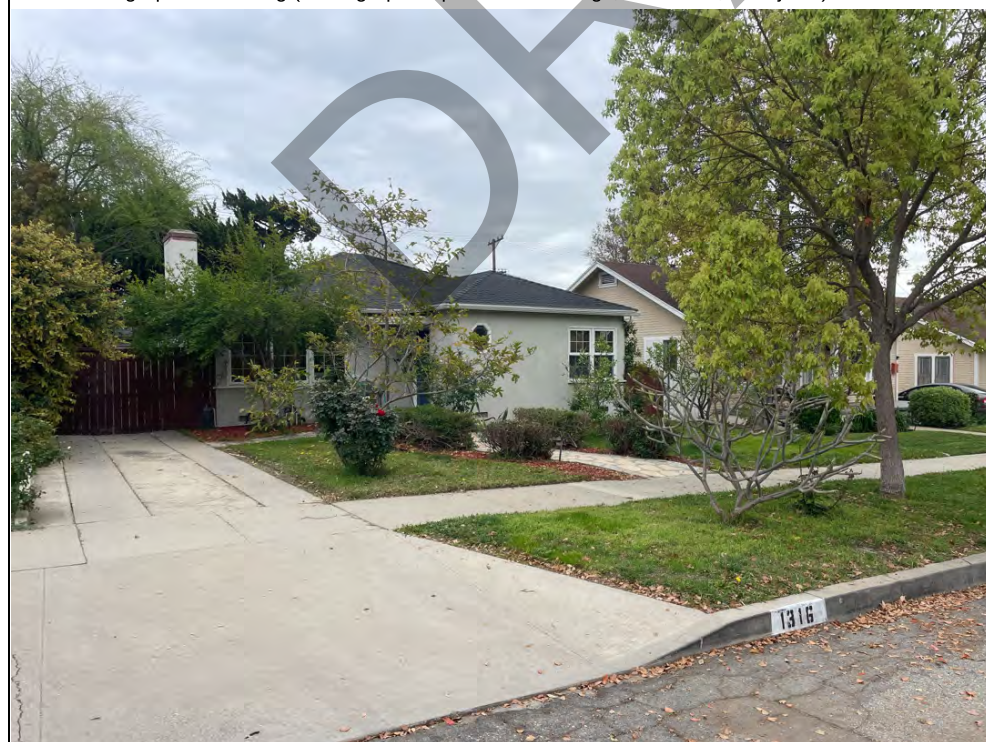
Alterations: windows replaced, all; porch flooring altered/replaced; light  
fixture added/replaced; addition, rear; driveway gate added/replaced;  
gate added/replaced; window openings altered, secondary

P5b. Description of Photo: (view, date, accession #) View southeast, 3/27/2025

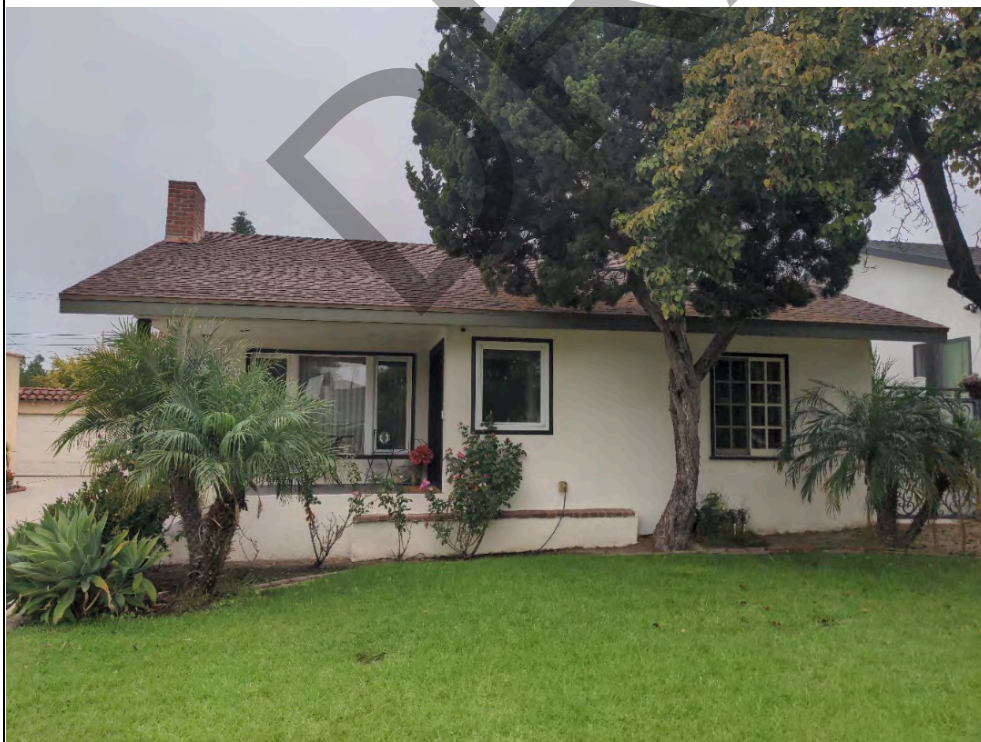
Alterations: wall cladding added/replaced; windows replaced, some,  
primary; windows replaced, some, secondary; door replaced, primary;  
window openings altered, primary; window openings altered, secondary;  
gate added/replaced; addition, rear

P5b. Description of Photo: (view, date, accession #) View west, 3/26/2025

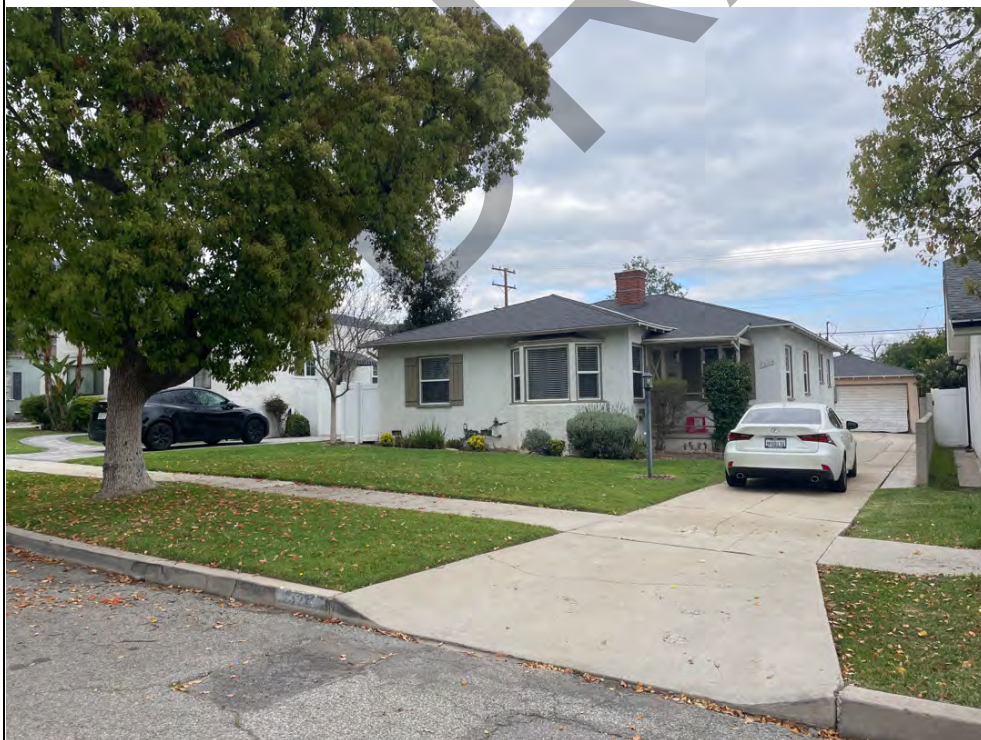
Alterations: wall cladding added/replaced; windows replaced, all; gate added/replaced; window openings altered, secondary; wall or fence added, side

P5b. Description of Photo: (view, date, accession #) View northeast, 3/27/2025

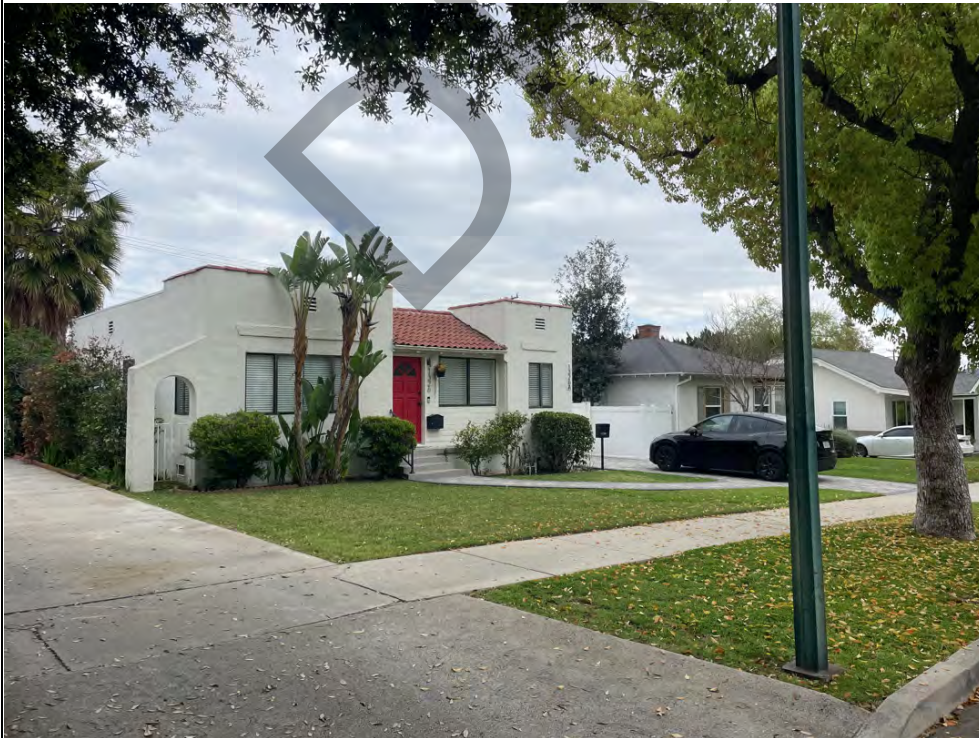
Alterations: restuccoed, compatible; door replaced, primary; entrance altered, primary; porch flooring altered/replaced; wall cladding added/replaced; windows replaced, all; driveway altered; driveway gate added/replaced; garage door replaced; light fixture added/replaced; railings altered/replaced

P5b. Description of Photo: (view, date, accession #) View southeast, 3/27/2025

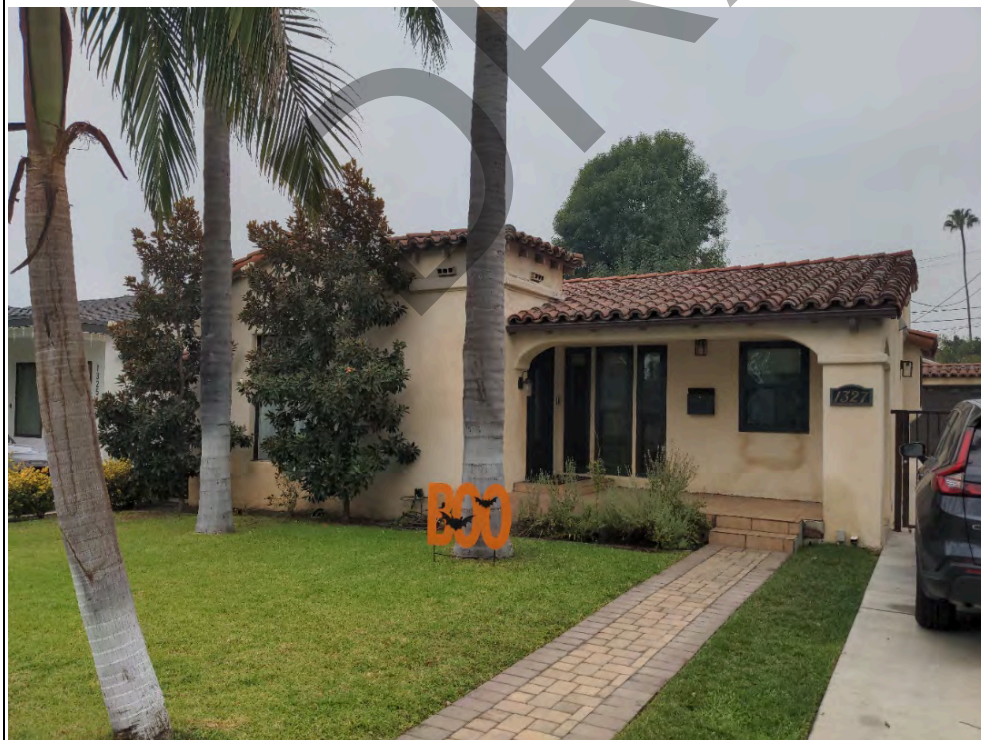
Alterations: windows replaced, some, primary; windows replaced, some, secondary; door replaced, primary; garage door replaced; gate added/replaced; light fixture added/replaced; porch flooring altered/replaced; walkway altered; window openings infilled, primary

P5b. Description of Photo: (view, date, accession #) View southwest, 3/26/2025

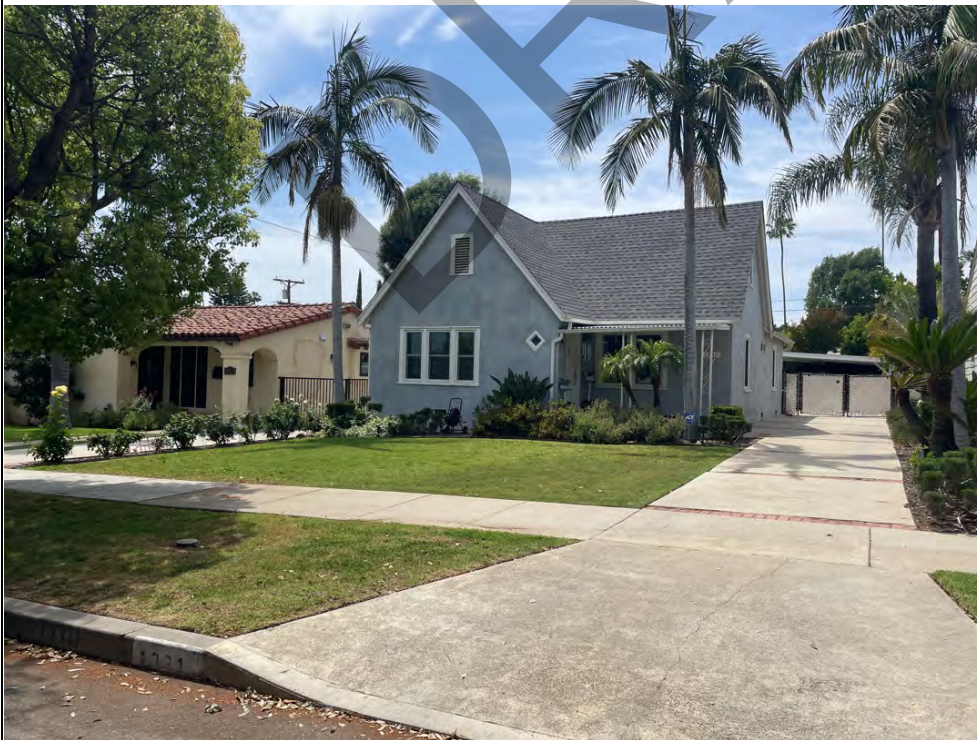
Alterations: restuccoed, compatible; windows replaced, some, primary; windows replaced, some, secondary; awning(s) added; porch supports altered; driveway gate added/replaced; carport added

P5b. Description of Photo: (view, date, accession #) View southwest, 3/26/2025

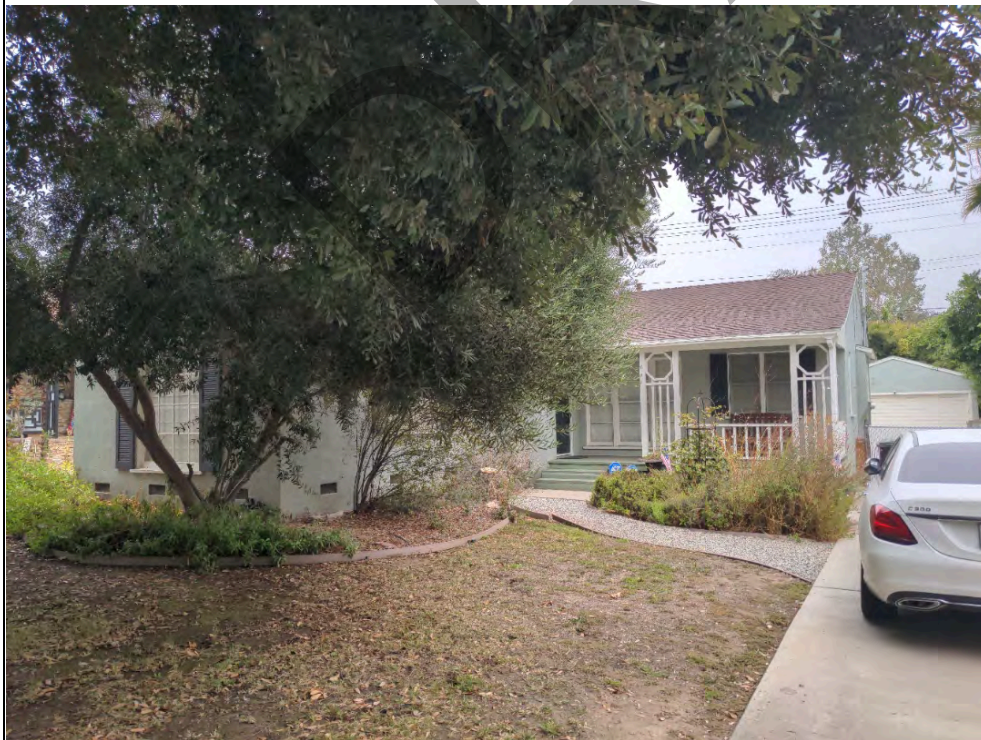
Alterations: light fixture added/replaced; no major alterations

P5b. Description of Photo: (view, date, accession #) View northeast, 3/27/2025

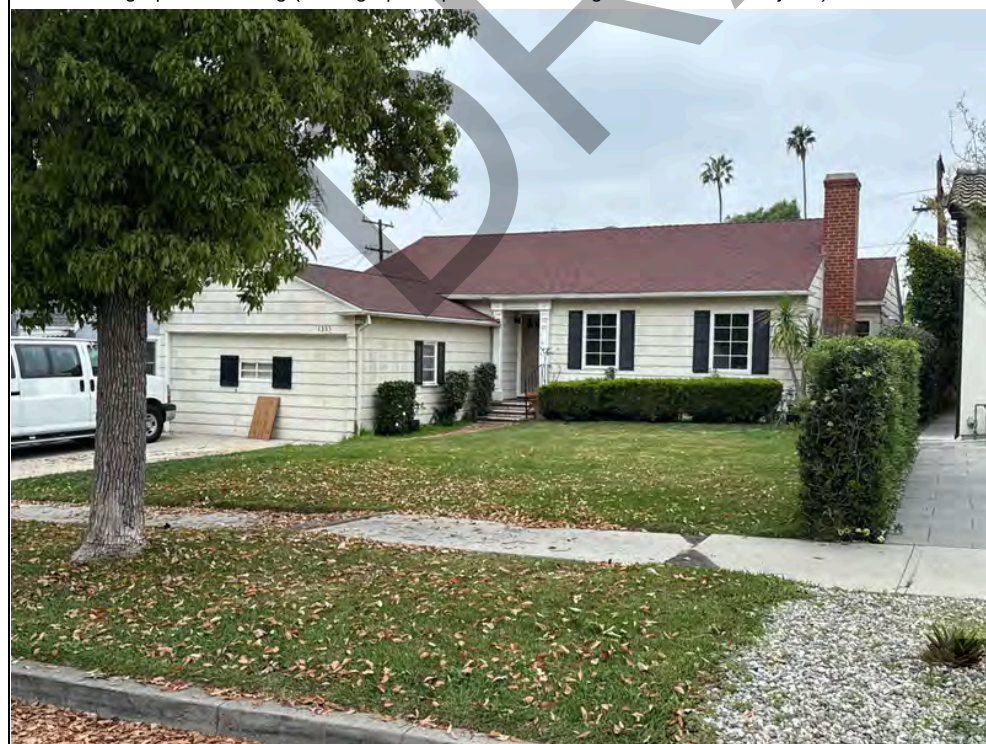
Alterations: windows replaced, some, primary; windows replaced, some,  
secondary; door replaced, primary

P5b. Description of Photo: (view, date, accession #) View southwest, 3/26/2025

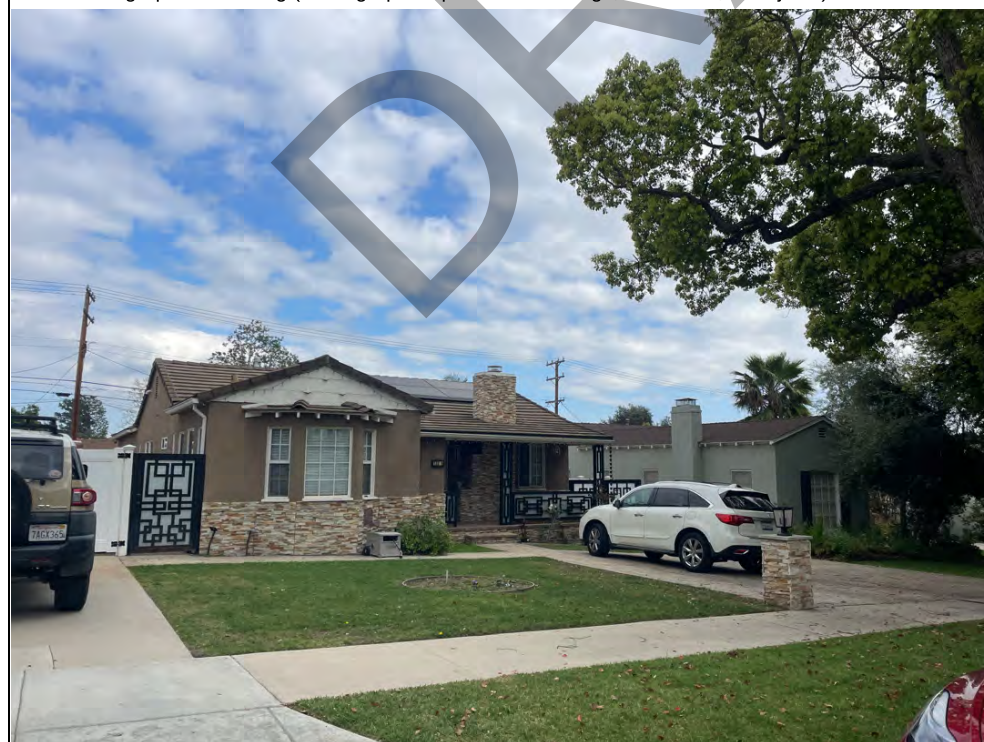
Alterations: windows replaced, all; wall cladding added/replaced; roof material replaced, incompatible; window openings altered, secondary; decorative elements added; decorative elements removed; porch flooring altered/replaced; driveway altered; walkway altered; driveway gate added/replaced; gate added/replaced; visible solar panels

P5b. Description of Photo: (view, date, accession #) View southeast, 3/27/2025

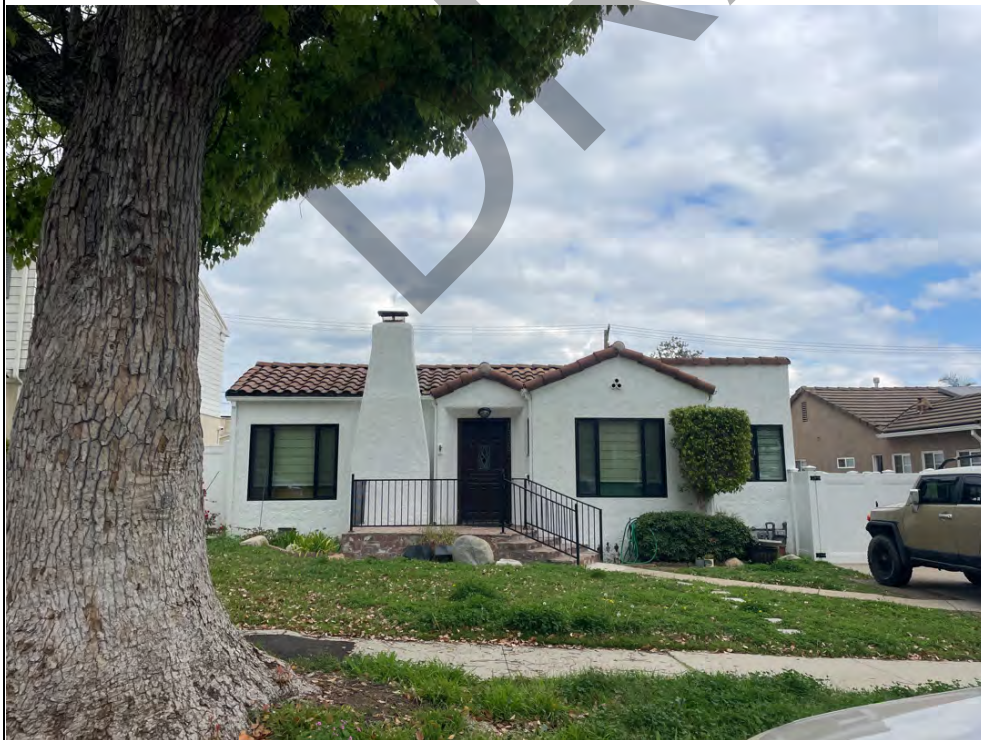
Alterations: windows replaced, some, primary; windows replaced, some, secondary; restuccoed, incompatible; porch replaced; porch flooring altered/replaced; door replaced, primary; railings altered/replaced; light fixture added/replaced; gate added/replaced; driveway gate added/replaced

P5b. Description of Photo: (view, date, accession #) View east, 3/27/2025

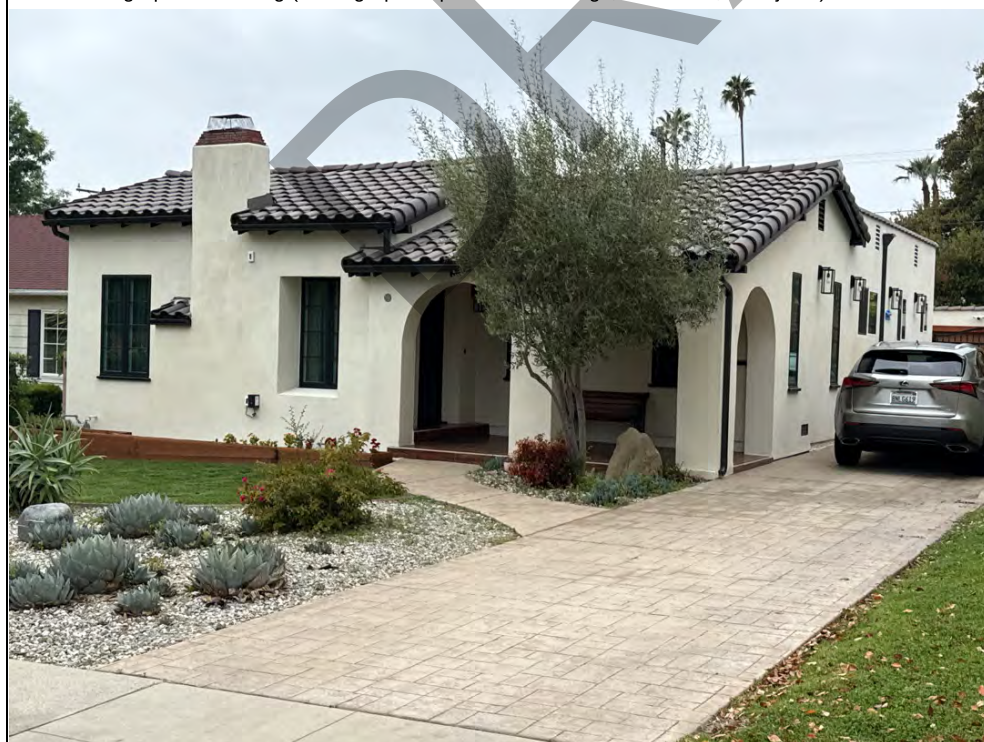
Alterations: windows replaced, all; restuccoed, incompatible; roof material replaced, compatible; decorative elements removed; door replaced, primary; porch flooring altered/replaced; driveway altered; driveway gate added/replaced; gate added/replaced; walkway altered; wing wall removed

P5b. Description of Photo: (view, date, accession #) View southwest, 3/26/2025

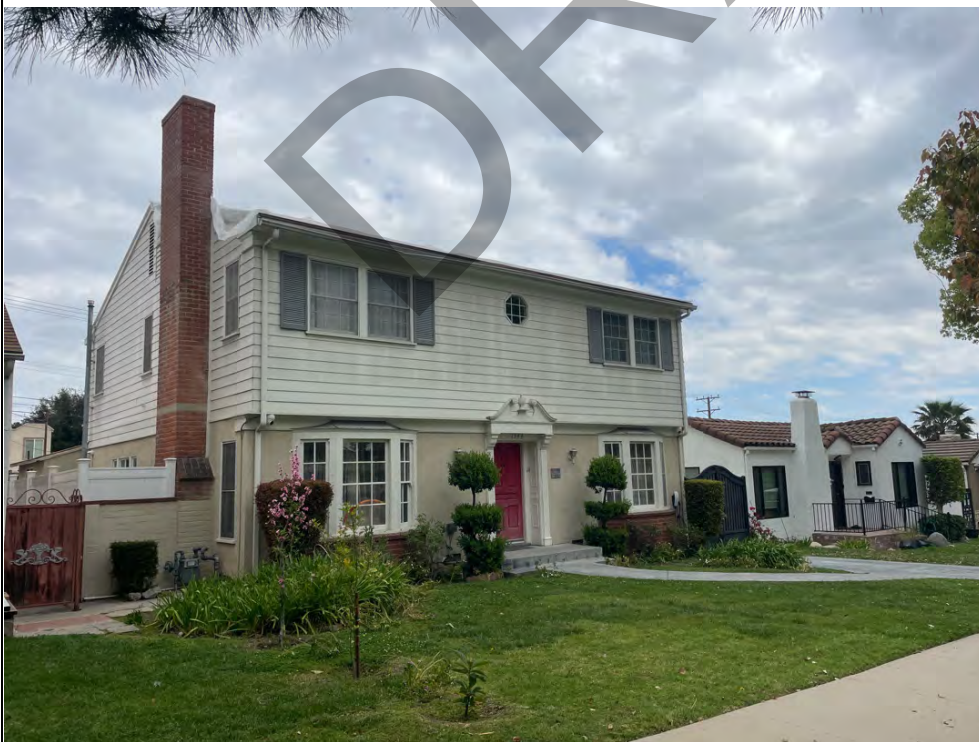
Alterations: restuccoed, compatible; porch flooring altered/replaced; windows replaced, some, primary; windows replaced, some, secondary; window openings altered, secondary; driveway gate added/replaced; wall or fence added, side

P5b. Description of Photo: (view, date, accession #) View southeast. 3/27/2025

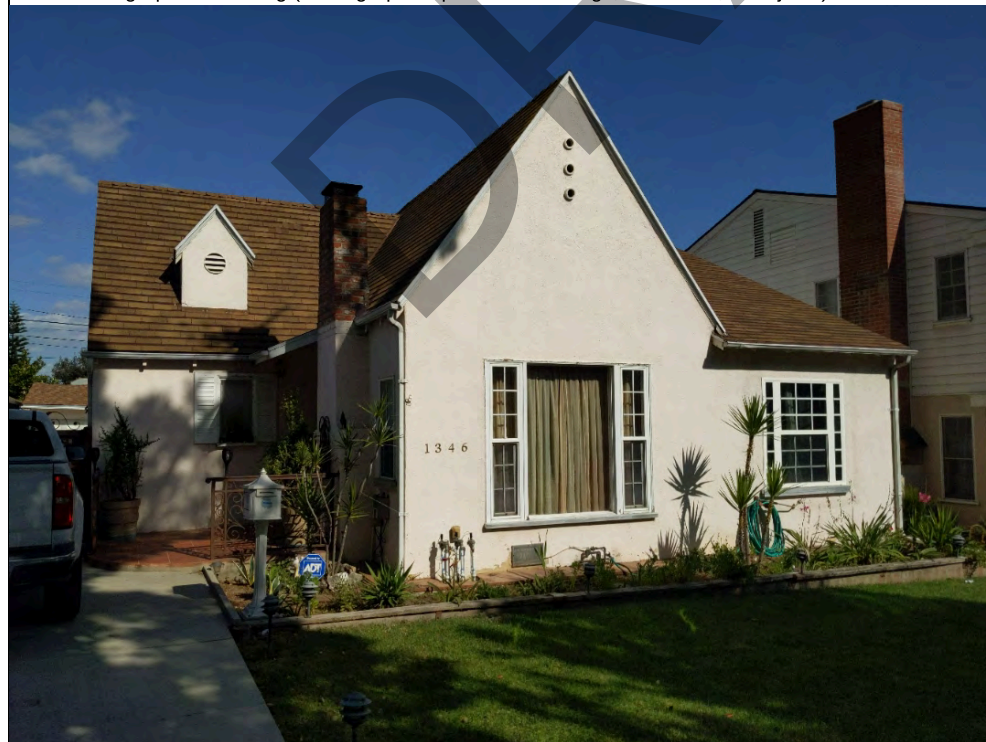
Alterations: windows replaced, some, primary; windows replaced, some, secondary; window opening altered, primary, secondary; porch flooring altered/replaced; railings altered/replaced; driveway gate added/replaced; window opening infilled, secondary; security door added

P5b. Description of Photo: (view, date, accession #) View southeast, 4/27/2026

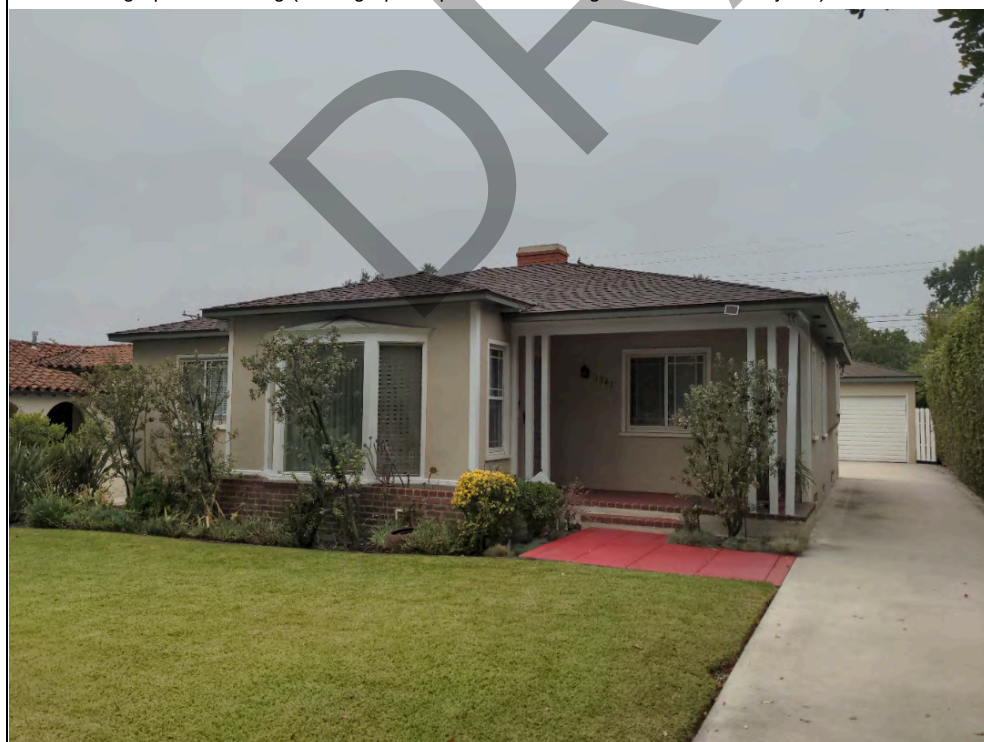
Alterations: windows replaced, some, primary; windows replaced, some, secondary; security door added; wall cladding added/replaced

P5b. Description of Photo: (view, date, accession #) View southwest, 3/26/2025

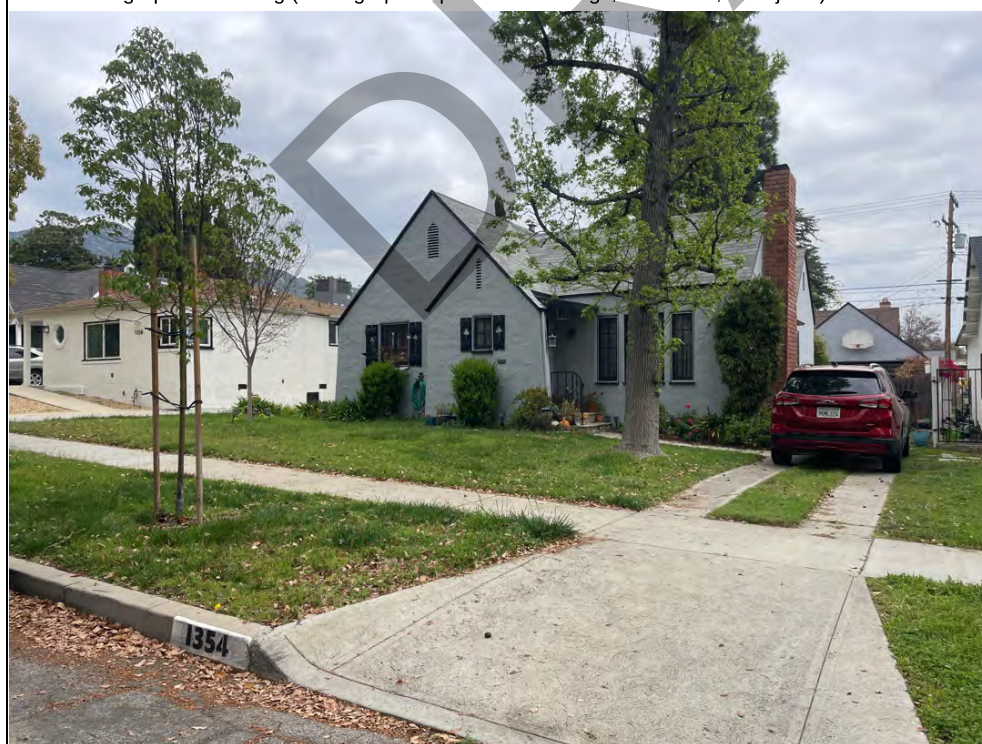
Alterations: roof material replaced, compatible; no major alterations; porch enclosed, side

P5b. Description of Photo: (view, date, accession #) View northeast, 3/27/2025

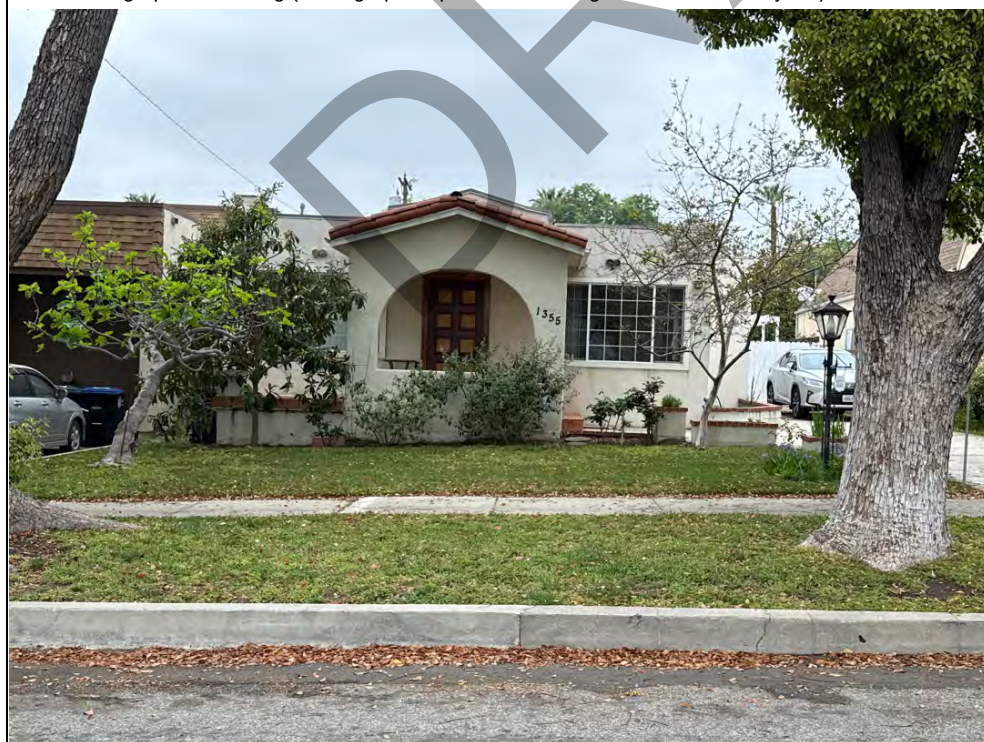
Alterations: windows replaced, all; door replaced, primary; restuccoed,  
compatible; porch flooring altered/replaced; addition, rear; driveway gate  
added/replaced; light fixture added/replaced; pergola added; planter(s)  
added; window surrounds altered

P5b. Description of Photo: (view, date, accession #) View west. 3/26/2025

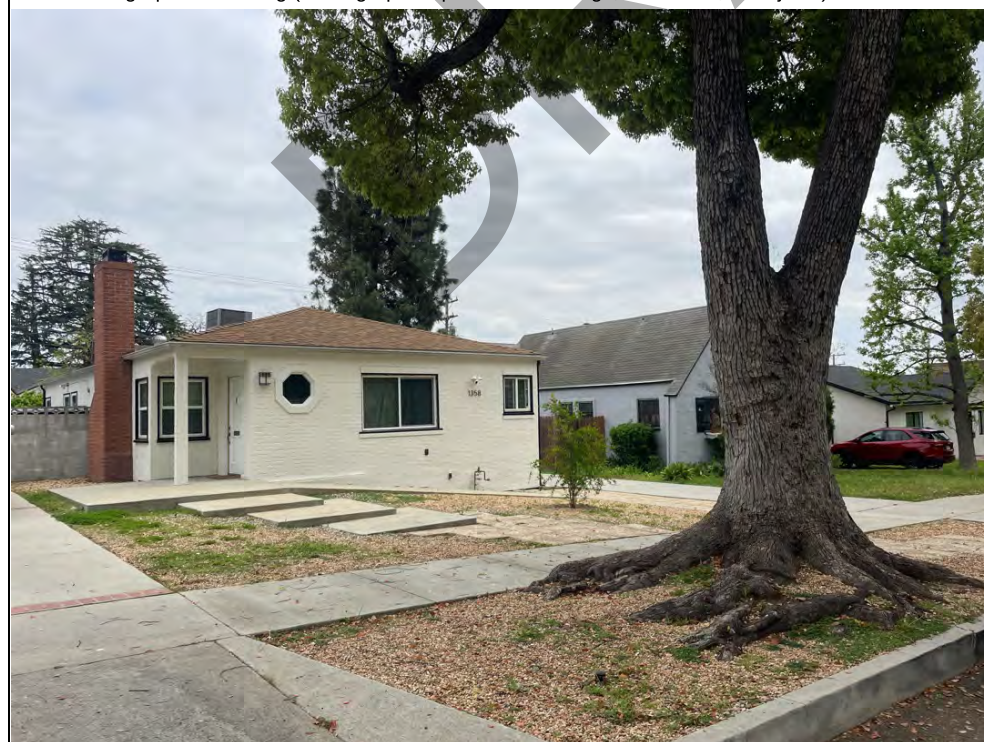
P5b. Description of Photo: (view, date, accession #) View southeast, 3/27/2025

Alterations: windows replaced, all; wall cladding added/replaced;  
entrance altered, secondary; window openings infilled, secondary; door  
replaced, primary; walkway altered; garage door replaced; light fixture  
added/replaced; decorative elements removed

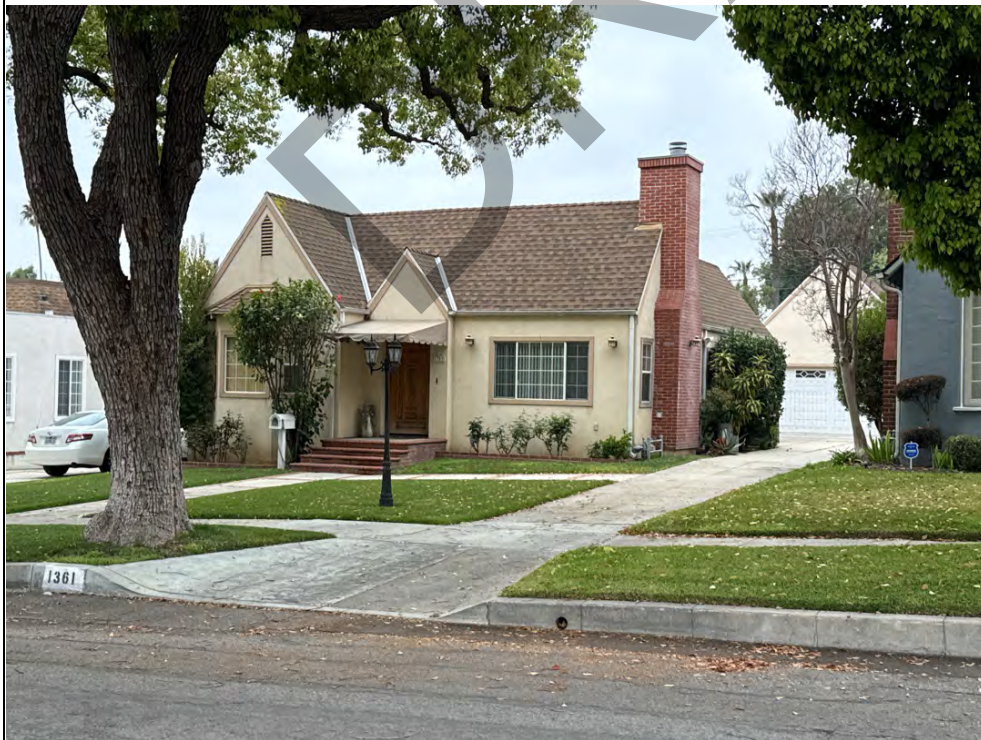
Alterations: restuccoed, compatible; windows replaced, all; porch flooring altered/replaced; walkway altered; window surrounds altered; driveway gate added/replaced; awning(s) added

P5b. Description of Photo: (view, date, accession #) View southwest, 3/26/2025

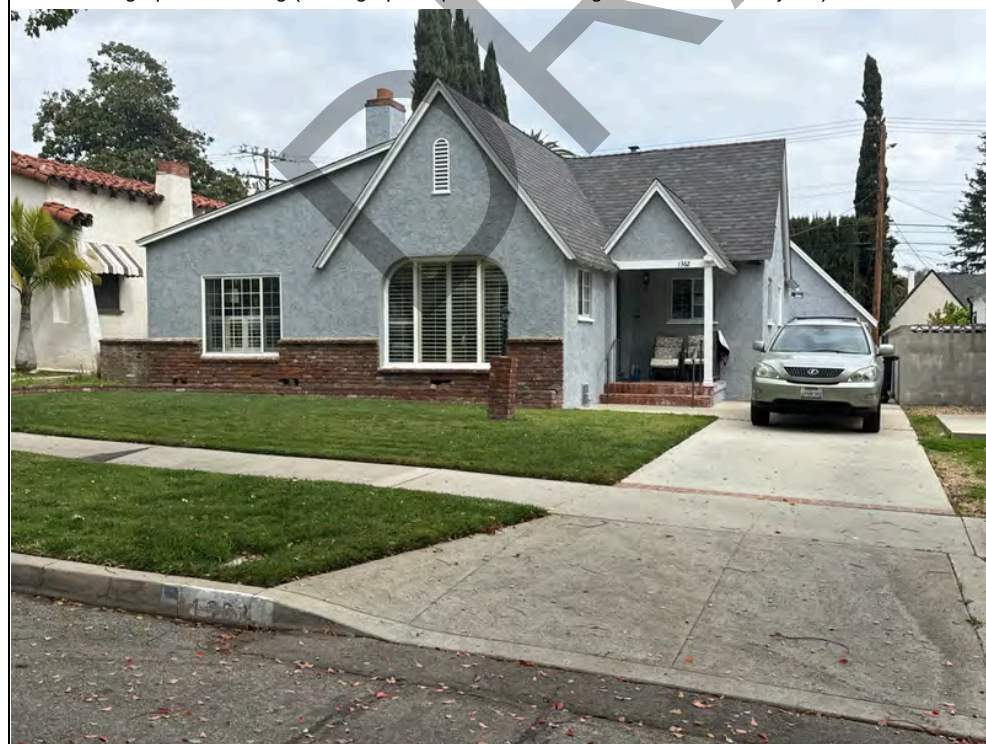
Alterations: restuccoed, incompatible; railings altered/replaced; windows replaced, some, primary; windows replaced, some, secondary; door replaced, primary; porch flooring altered/replaced; roofline altered; addition, side

P5b. Description of Photo: (view, date, accession #) View northeast, 3/27/2025

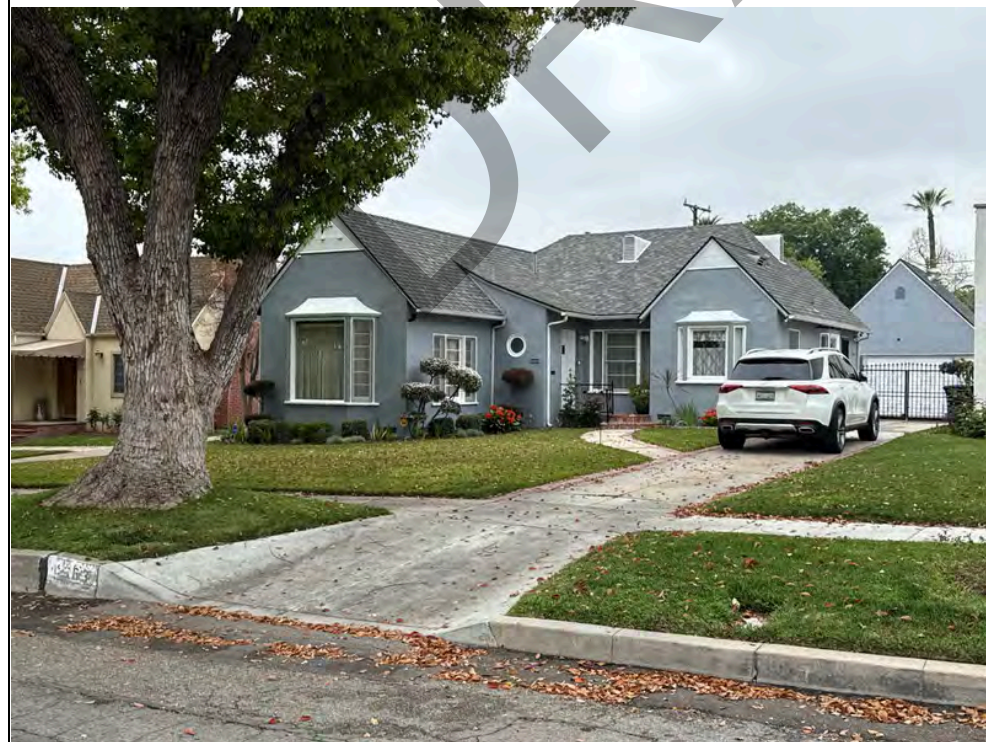
P5b. Description of Photo: (view, date, accession #) View southwest, 3/26/2025

Alterations: security door added; railings altered/replaced; no major alterations
