## PRIMARY RECORD

\*Resource Name or # (Assigned by recorder) 1009 Glenwood Rd

\*P11. Report Citation: (Cite survey report and other sources or enter "none".) ARG, Cleveland Knoll Historic District Report, (prepared for the City of Glendale Planning Division, 2025).

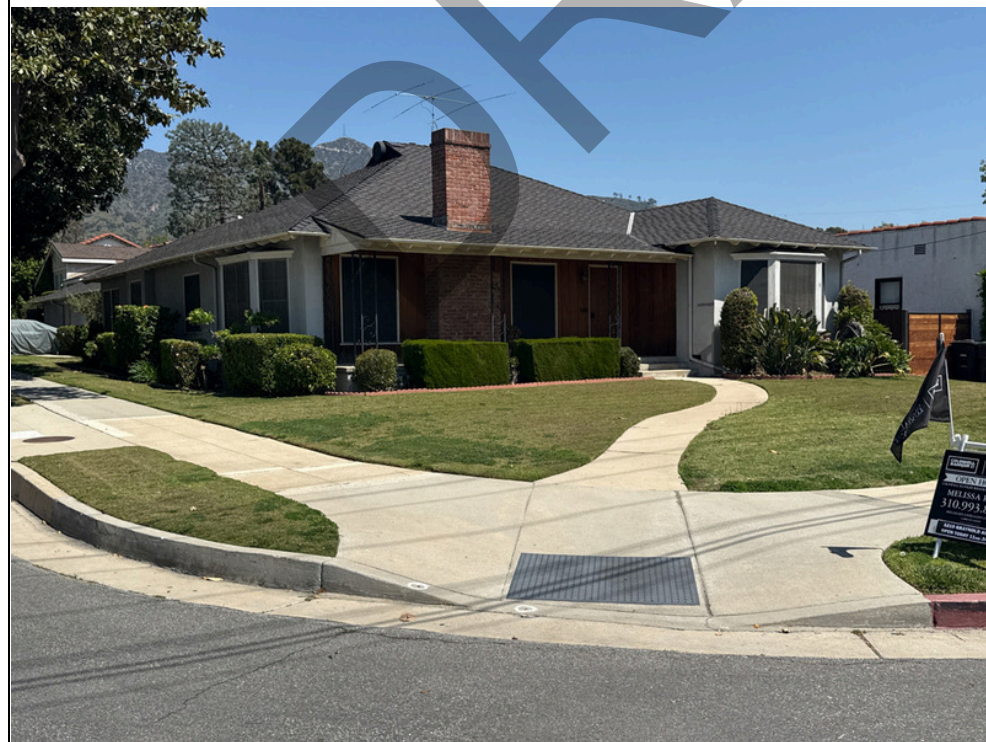
P5b. Description of Photo: (view, date, accession #) View northeast, 4/8/2025

**Primary Architectural Style:** Ranch, Minimal

Wall Cladding: stucco, smooth; wood, channel

Roof Form: hipped; shed

Roof Details: eaves, open; exposed rafter tails; dormer(s), vent roof; exterior chimney, brick

Alterations: appears to be unaltered

**Character-defining Features:** one story height, asymmetrical massing, stucco wall cladding, channel wood siding, hipped and shed roof with open eaves, exposed rafter rails, and vent roof dormers, corbels, jetties, partial-width projecting porch with decorative supports, slab wood door with speakeasy, multi-light wood canted bay window, multi-light wood double-hung windows, detached garage

**Integrity:** high

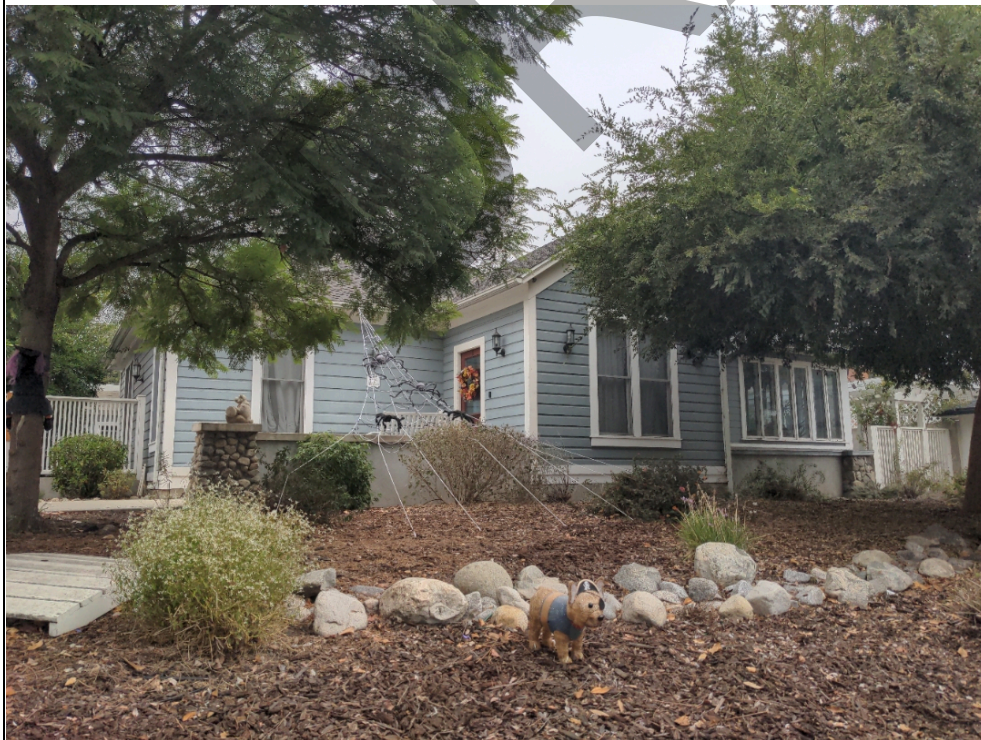
P5b. Description of Photo: (view, date, accession #) View northeast, 4/9/2025

**Primary Architectural Style:** Vernacular Victorian

Wall Cladding: wood, channel; engineered wood siding; stucco,

Roof Form: gable, cross; hipped

Alterations: addition, side; addition, rear; door replaced, primary; windows replaced, some, secondary; porch flooring altered/replaced; walkway altered; wall cladding added/replaced; wall or fence added, side; light fixture added/replaced; garage door replaced

**Character-defining Features:** one story height, asymmetrical massing, stucco wall cladding, cross gabled and hipped roof with boxed eaves and open eaves, full-width projecting porch with stucco wall and stone piers, double-hung wood windows, wood casement windows

**Integrity:** moderate

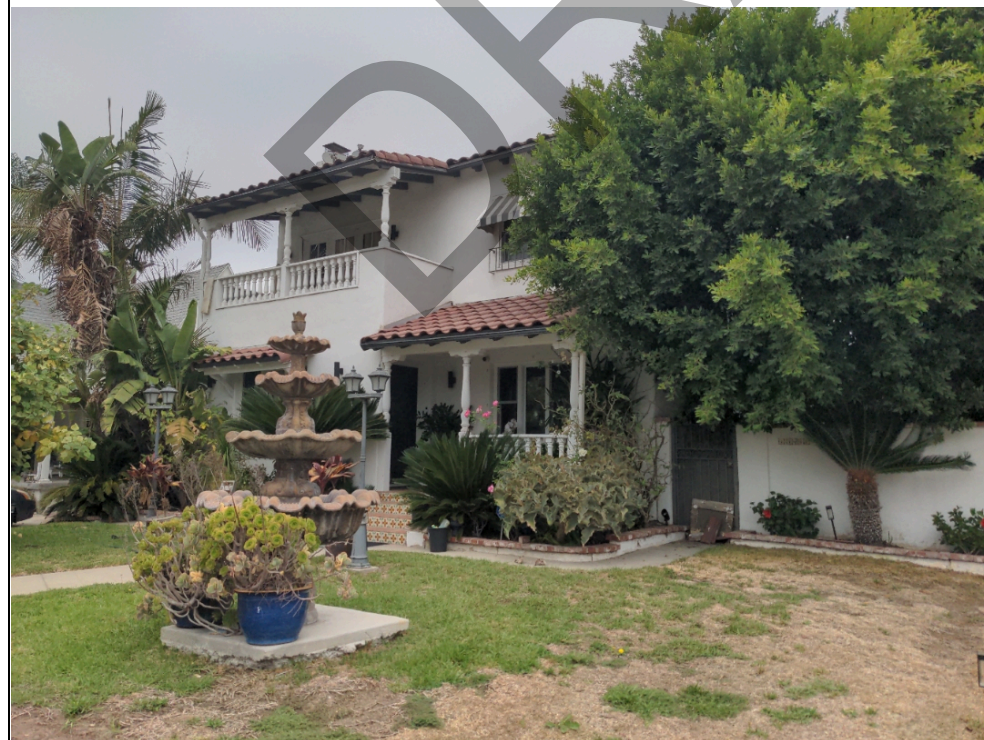
P5b. Description of Photo: (view, date, accession #) View northwest, 4/9/2025

Primary Architectural Style: Spanish Colonial Revival

Wall Cladding: stucco, smooth

Roof Form: gable, side; shed

Roof Cladding: clay barrel tile

Alterations: door replaced, primary; windows replaced, all; decorative elements added; decorative tile added; driveway gate added/replaced; gate added/replaced; garage door replaced; light fixture added/replaced; awning(s) added; porch/balcony enclosed, rear

**Character-defining Features:** two story height, asymmetrical massing, stucco wall cladding, side gabled and shed roof with clay barrel tile cladding, clay tile coping, open eaves, exposed rafter tails, and gable vents, stucco chimney, partial-width projecting porch with wood turned posts, balcony

**Integrity:** moderate

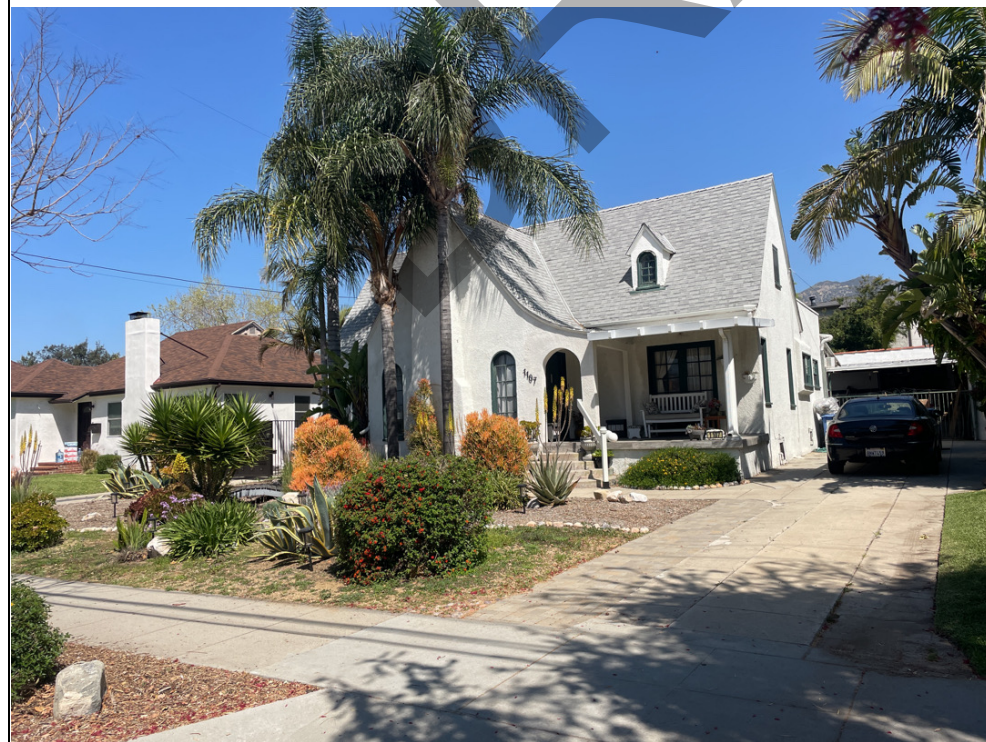
P5b. Description of Photo: (view, date, accession #) View northwest, 4/9/2025

Primary Architectural Style: Tudor Revival

Wall Cladding: stucco, smooth

Roof Form: gable, cross; cat slide; shed; flat

Alterations: restuccoed, compatible; addition, rear; porch flooring altered/replaced; railings altered/replaced; pergola added

**Character-defining Features:** one story height, asymmetrical massing, stucco wall cladding, jetties, cross gabled, cat slide, shed, and flat roof with window roof dormers, closed eaves, and flat parapet, stucco chimney, partial-width projecting porch with arched openings, wood door with speakeasy, multi-light wood casement windows with round arched openings, multi-light wood tripartite window, multi-light wood double-hung windows, detached garage

**Integrity:** moderate

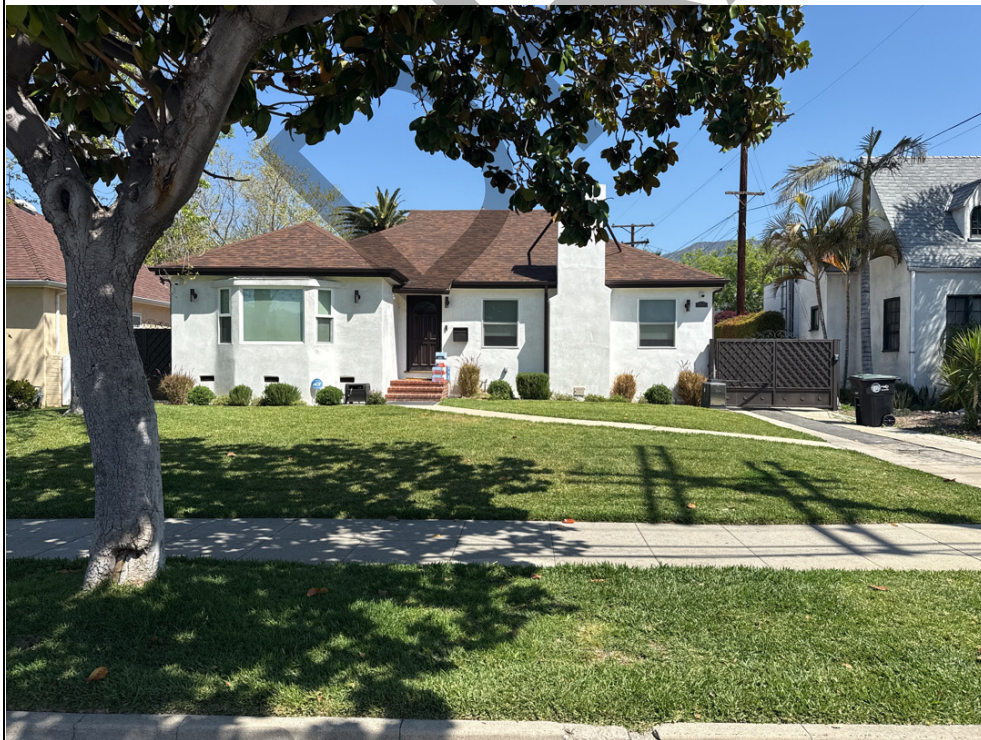
P5b. Description of Photo: (view, date, accession #) View north, 4/9/2025

Alterations: wall cladding added/replaced; door replaced, primary; windows replaced, all; decorative elements removed; driveway gate added/replaced; garage door replaced; gate added/replaced; light fixture added/replaced; window surrounds altered; chimney altered

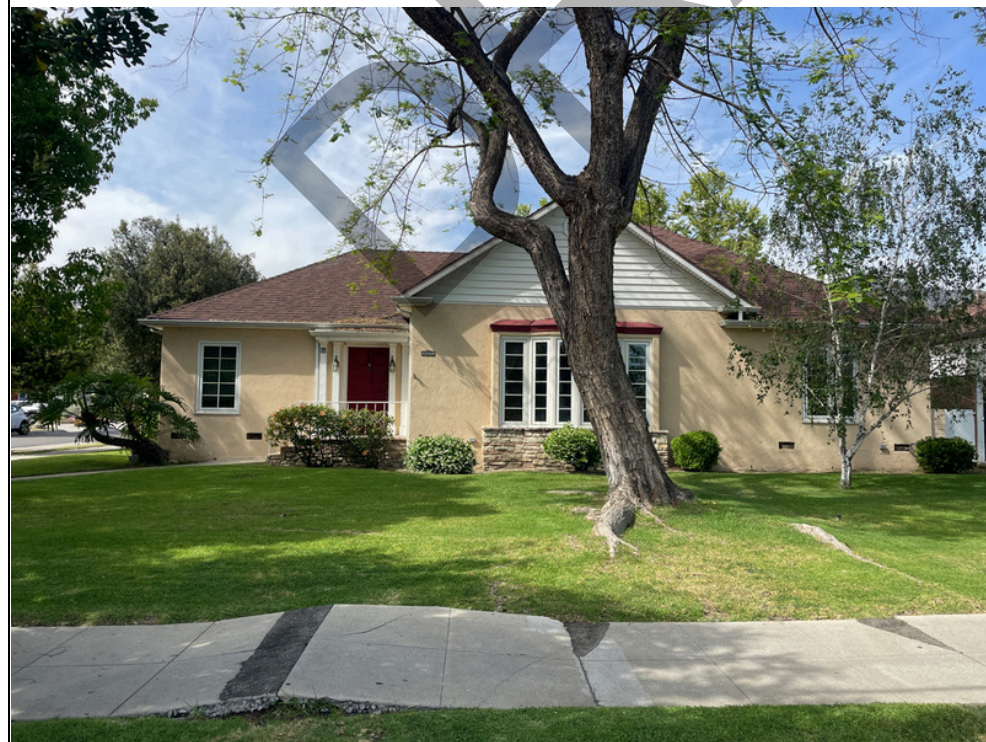
P5b. Description of Photo: (view, date, accession #) View north, 4/9/2025

Alterations: windows replaced, all; wall cladding added/replaced; addition, rear

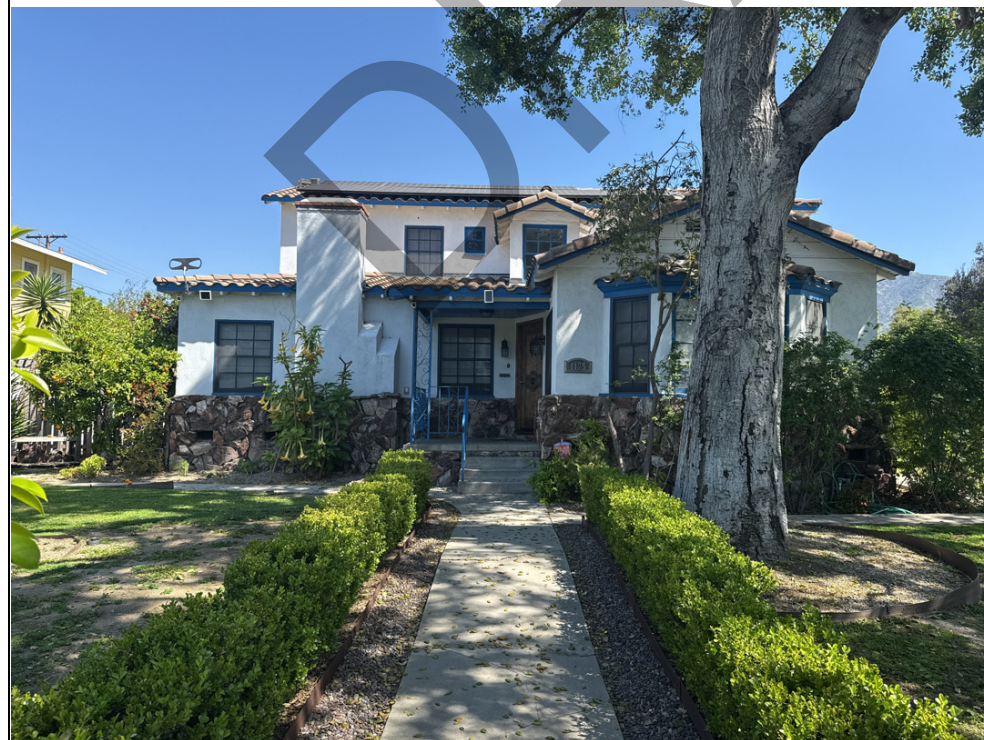
P5b. Description of Photo: (view, date, accession #) View north, 3/27/2025

Alterations: wall cladding added/replaced; door replaced, primary; visible solar panels; gate added/replaced; garage altered/replaced; garage door replaced; door replaced, secondary; porch enclosed; roof material replaced, incompatible; perimeter hedges added

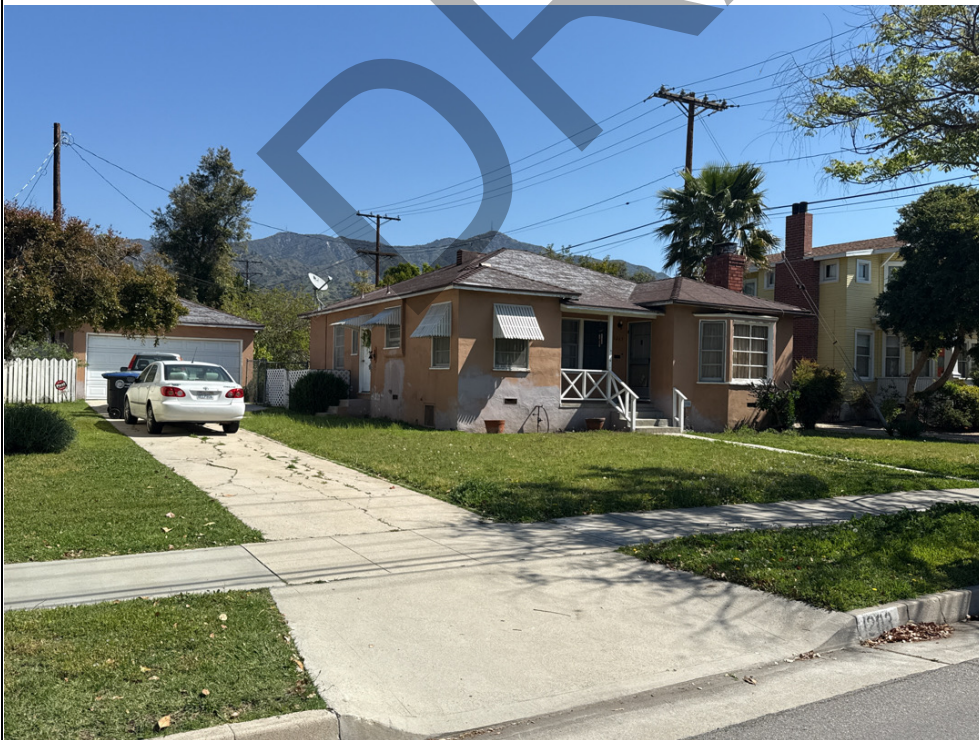
P5b. Description of Photo: (view, date, accession #) View southwest, 4/9/2025

Alterations: garage door replaced; no major alterations

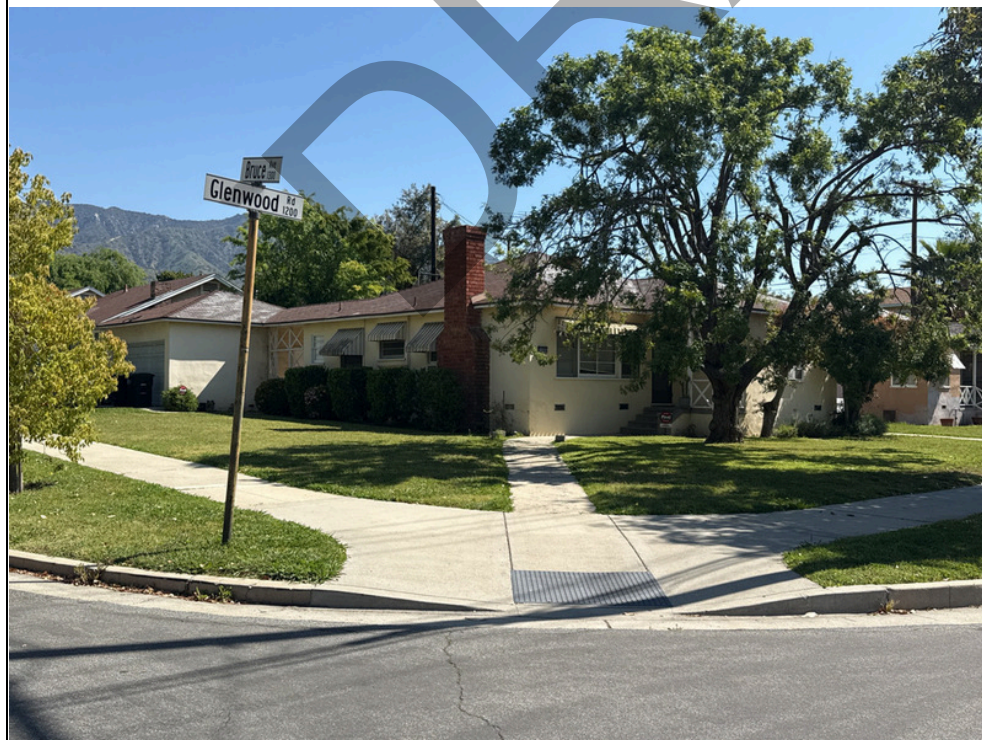
P5b. Description of Photo: (view, date, accession #) View northeast, 4/9/2025

Alterations: garage door replaced; no major alterations

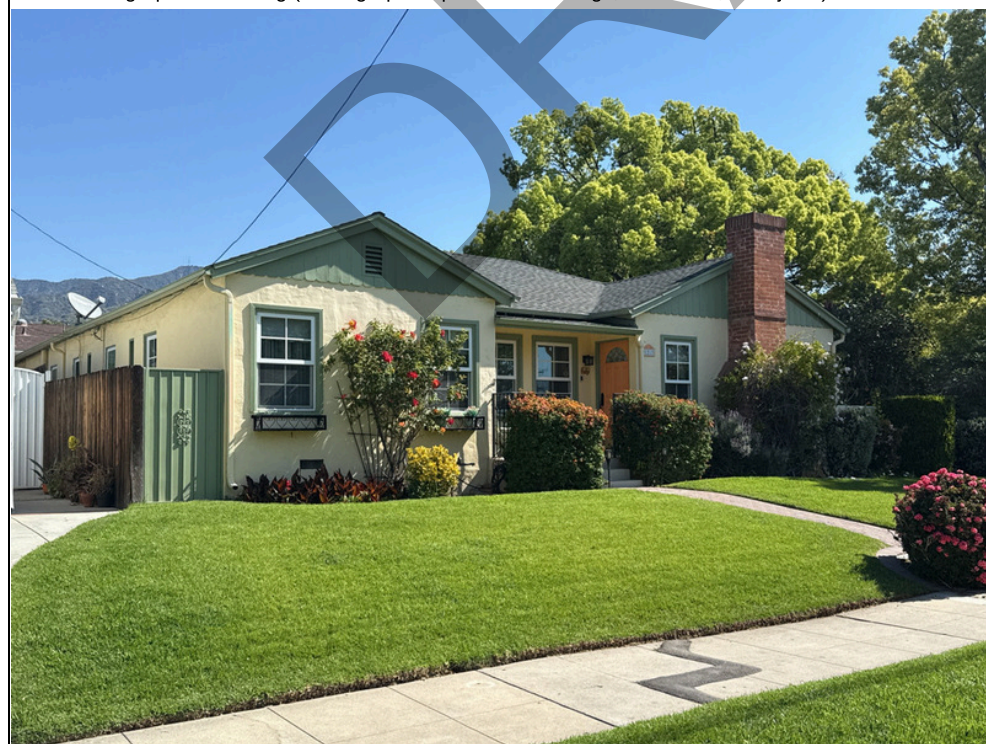
P5b. Description of Photo: (view, date, accession #) View northeast, 4/9/2025

Alterations: windows replaced, some, primary; windows replaced, some, secondary; door replaced, primary; door replaced, secondary; garage door replaced; gate added/replaced; walkway altered; wall or fence added, side

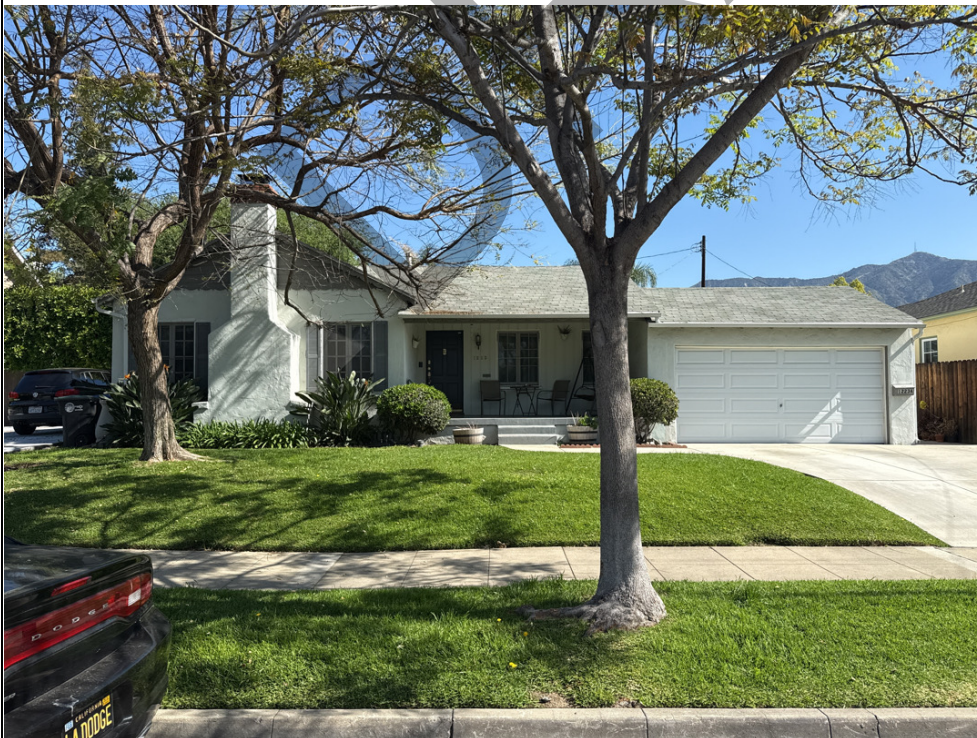
P5b. Description of Photo: (view, date, accession #) View east, 4/9/2025

Alterations: addition, rear; garage door replaced; gate added/replaced

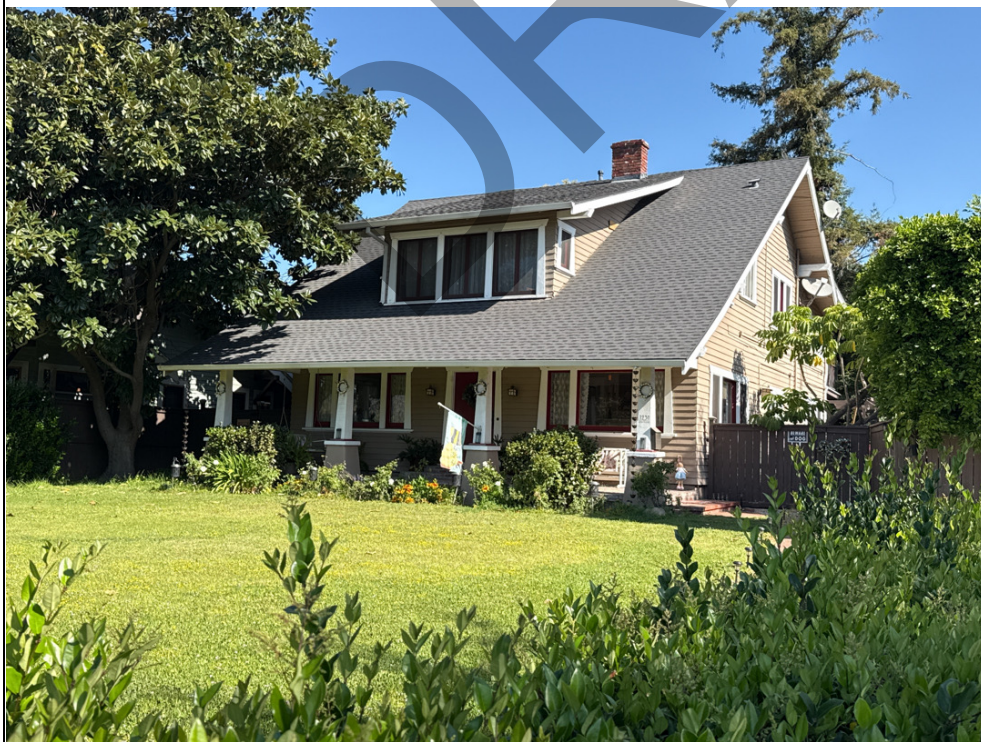
P5b. Description of Photo: (view, date, accession #) View northwest, 4/9/2025

Alterations: windows replaced, some, secondary; wall or fence added, perimeter; driveway altered; perimeter hedge(s) added

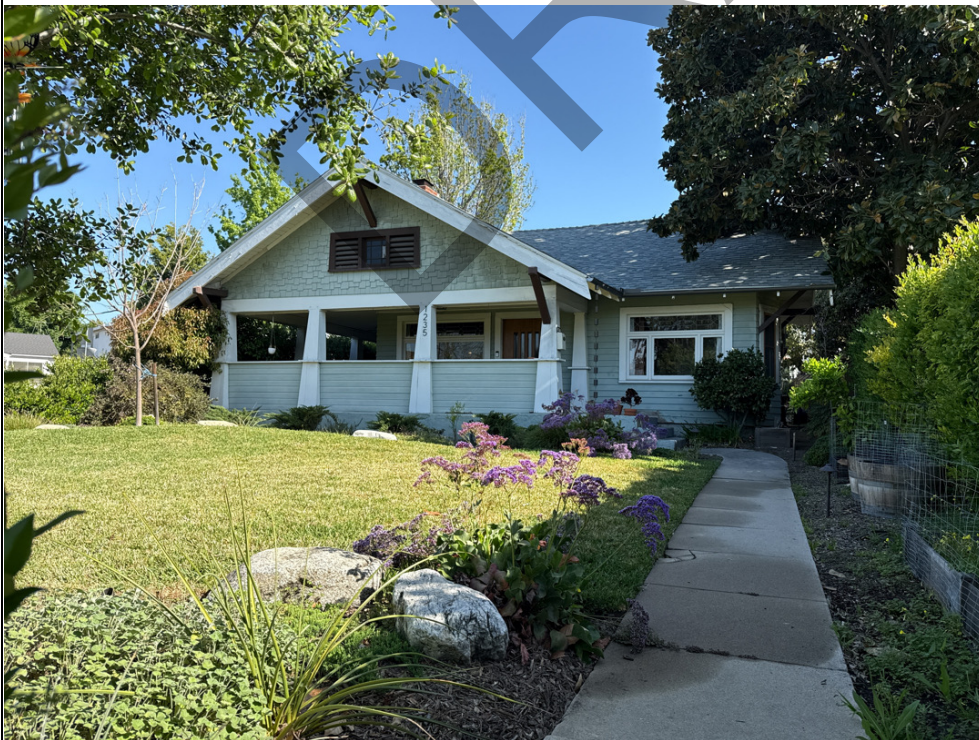
P5b. Description of Photo: (view, date, accession #) View northwest, 4/9/2025

Alterations: wall cladding added/replaced; garage door replaced; wall or fence added, perimeter; garage altered/replaced; perimeter hedge(s) added
