## PRIMARY RECORD

\*P11. Report Citation: (Cite survey report and other sources or enter "none".) ARG, Cleveland Knoll Historic District Report, (prepared for the City of Glendale Planning Division, 2025).

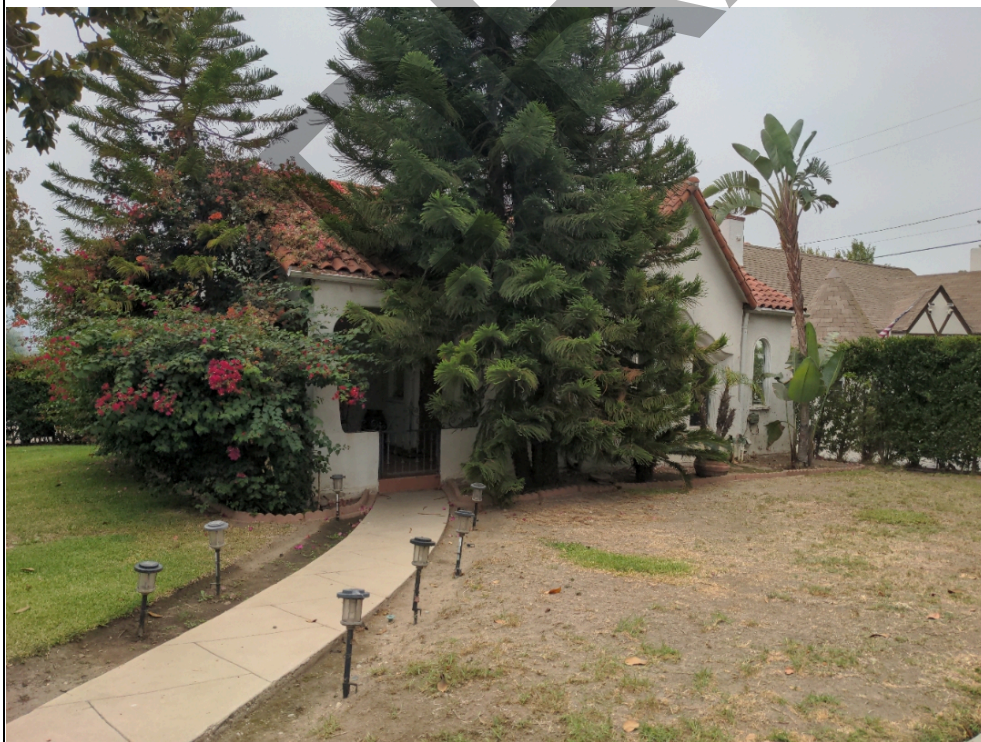
\*Resource Name or # (Assigned by recorder) 1016 Olmsted Dr

Primary Architectural Style: Spanish Colonial Revival

Alterations: windows replaced, some, primary; windows replaced, some, secondary; driveway altered; garage door replaced

**Character-defining Features:** one story height, asymmetrical massing, stucco wall cladding, cross gabled and flat roof with clay barrel tile cladding, clay tile coping, gable vents, flat parapet, and open eaves, brick and stucco chimney, partial-width projecting porch with arches, stucco wall, and stucco piers, partially glazed and arched wood door, wood tripartite window with scalloped arched openings, wood casement window with round arched opening

**Integrity:** moderate

P5b. Description of Photo: (view, date, accession #) View southwest, 4/8/2025

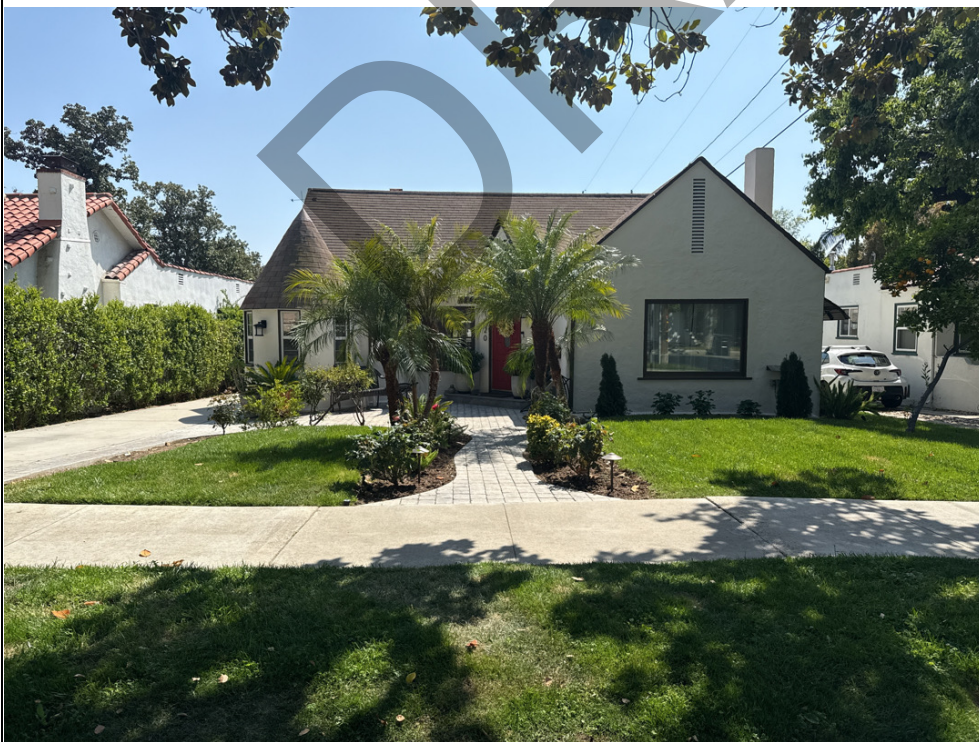
\*Resource Name or # (Assigned by recorder) 1020 Olmsted Dr

Primary Architectural Style: Tudor Revival

Alterations: windows replaced, some, primary; windows replaced, some, secondary; door replaced, primary; door replaced, secondary; awning(s) added; porch replaced; porch steps altered/replaced; walkway altered

**Character-defining Features:** one story height, asymmetrical massing, stucco wall cladding, half-timbering, cross gabled, front gabled, and flat roof with clay tile coping, flat parapet, closed eaves, shallow eaves, and gable vents, tower volume with conical roof, stucco chimney, stoop, wood fixed window, wood double-hung windows

**Integrity:** moderate

P5b. Description of Photo: (view, date, accession #) View south, 4/8/2025

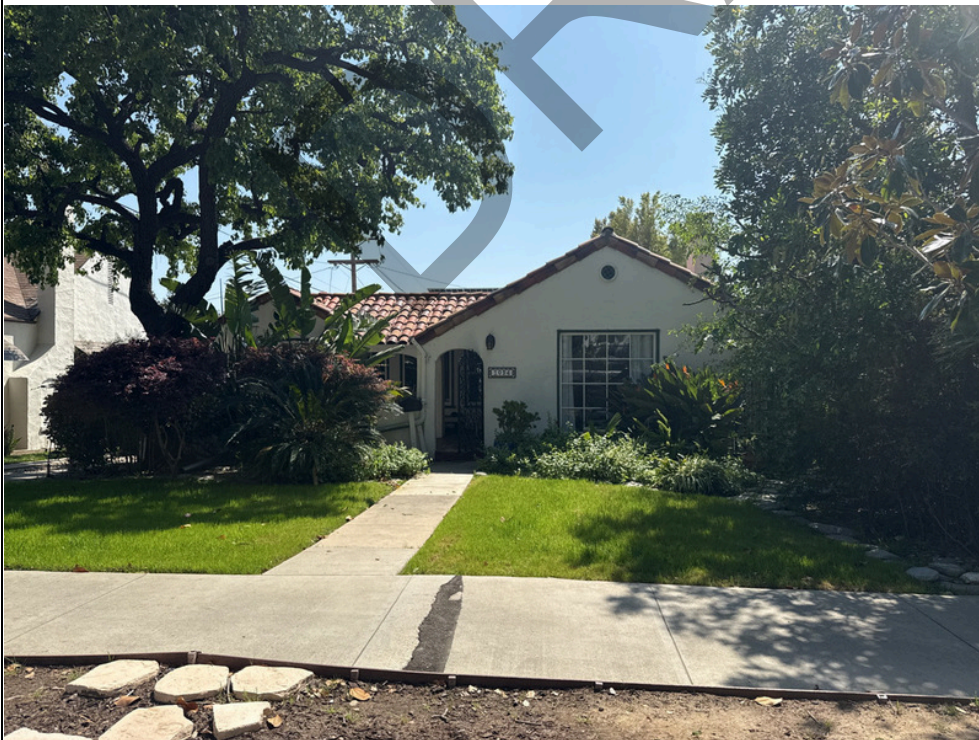
\*Resource Name or # (Assigned by recorder) 1024 Olmsted Dr

Primary Architectural Style: Spanish Colonial Revival

Alterations: windows replaced, some, primary; windows replaced, some,  
secondary; restuccoed, compatible; gate added/replaced; driveway gate  
added/replaced; garage door replaced

**Character-defining Features:** one story height, asymmetrical massing,  
stucco wall cladding, pierced screens, cross gabled, front gabled, and  
flat roof with clay barrel tile cladding, clay tile coping, flat parapet, closed  
eaves, shallow eaves, and gable vents, stucco chimney, brick chimney,  
wing wall, partial-width projecting porch with arch, entrance courtyard  
with stucco wall, plank wood door with speakeasy and grille, multi-light  
wood fixed window

**Integrity:** moderate

P5b. Description of Photo: (view, date, accession #) View south, 4/8/2025

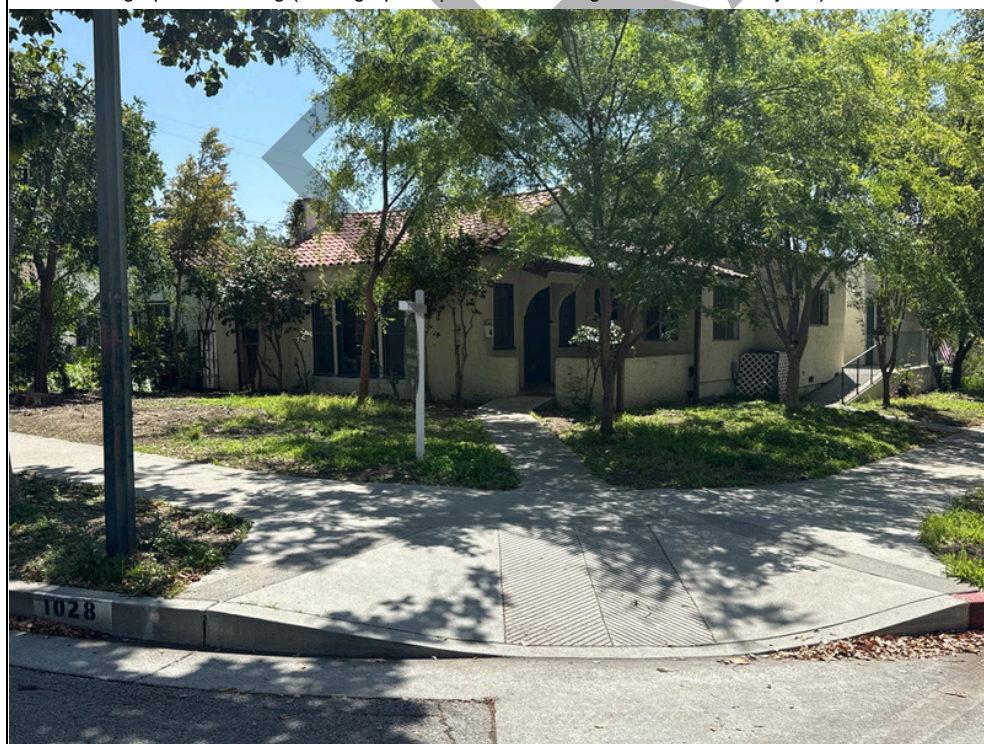
\*Resource Name or # (Assigned by recorder) 1028 Olmsted Dr

Primary Architectural Style: Spanish Colonial Revival

Alterations: addition, rear; addition, side; restuccoed, incompatible; windows replaced, some, primary; windows replaced, some, secondary; awning(s) added; railings altered/replaced; entrance added; entrance altered, primary; entrance altered, secondary; shed entry roof added

Character-defining Features: none identified

Integrity: low

P5b. Description of Photo: (view, date, accession #) View southeast, 4/4/2025

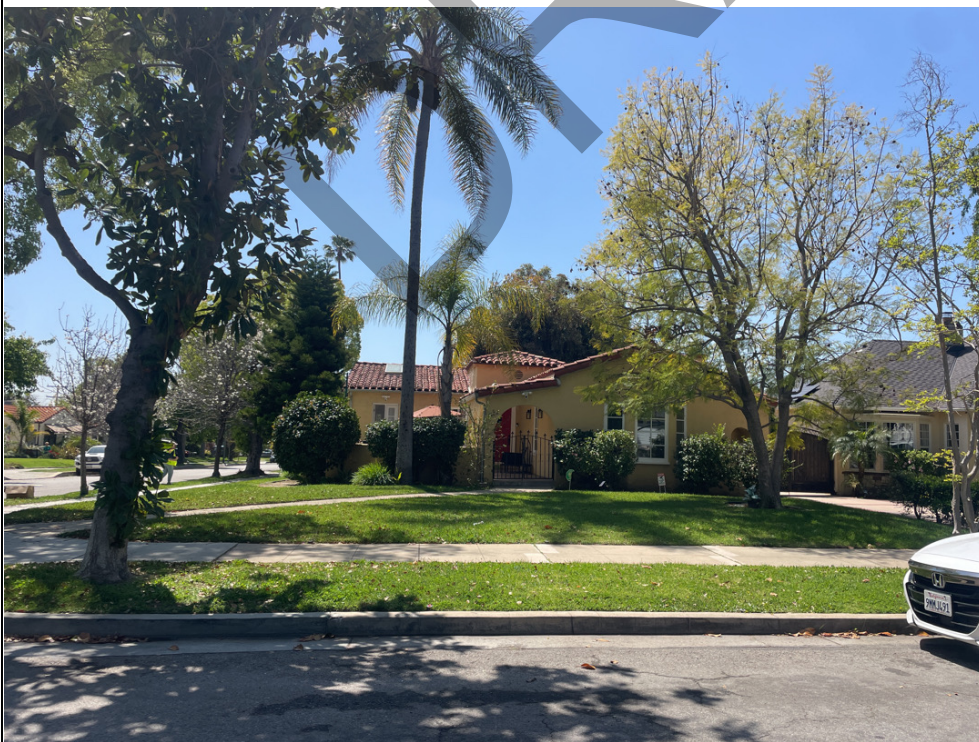
\*Resource Name or # (Assigned by recorder) 1102 Olmsted Dr

**Primary Architectural Style:** Spanish Colonial Revival

Alterations: windows replaced, all; garage altered/replaced; light fixture added/replaced; visible skylights

**Character-defining Features:** one story height, asymmetrical massing, stucco wall cladding, cross gabled roof with clay barrel tile cladding, clay tile coping, open eaves, gable vents, exposed rafter tails, skylights, and tower with pyramidal roof, brick and stucco chimney, partial-width projecting porch with arcade and arches, entrance courtyard with stucco piers, paneled wood door with speakeasy

**Integrity:** moderate

P5b. Description of Photo: (view, date, accession #) View south, 4/4/2025

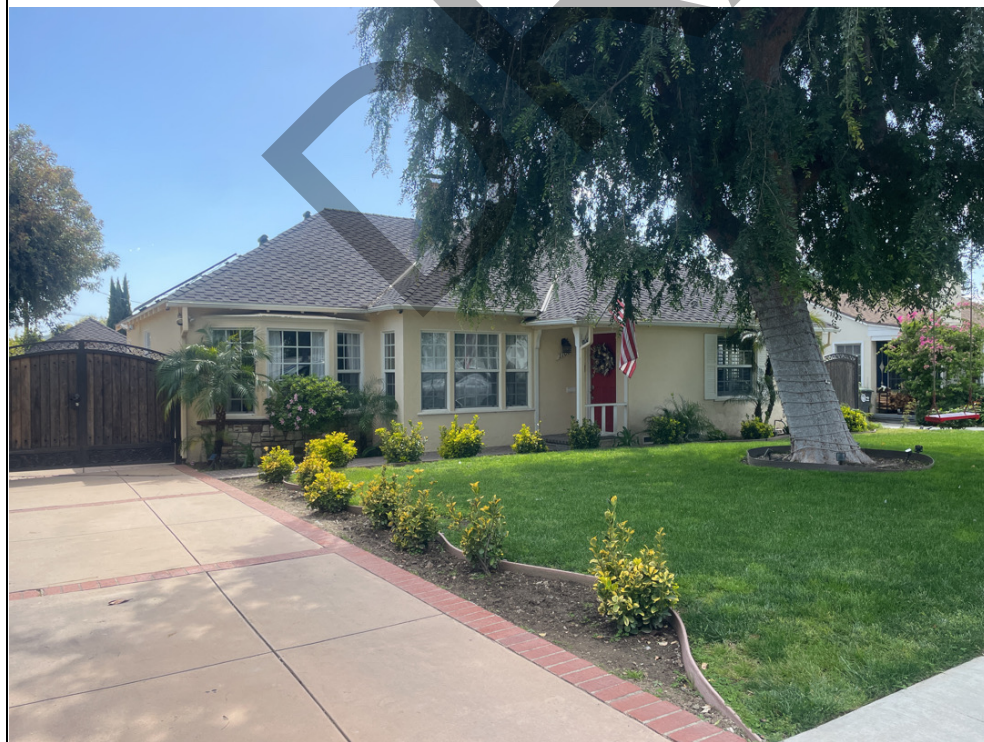
\*Resource Name or # (Assigned by recorder) 1108 Olmsted Dr

Primary Architectural Style: Ranch, Minimal

Alterations: windows replaced, all; door replaced, primary; driveway gate added/replaced; visible solar panels; gate added/replaced; driveway altered

P5b. Description of Photo: (view, date, accession #) View southwest, 4/4/2025

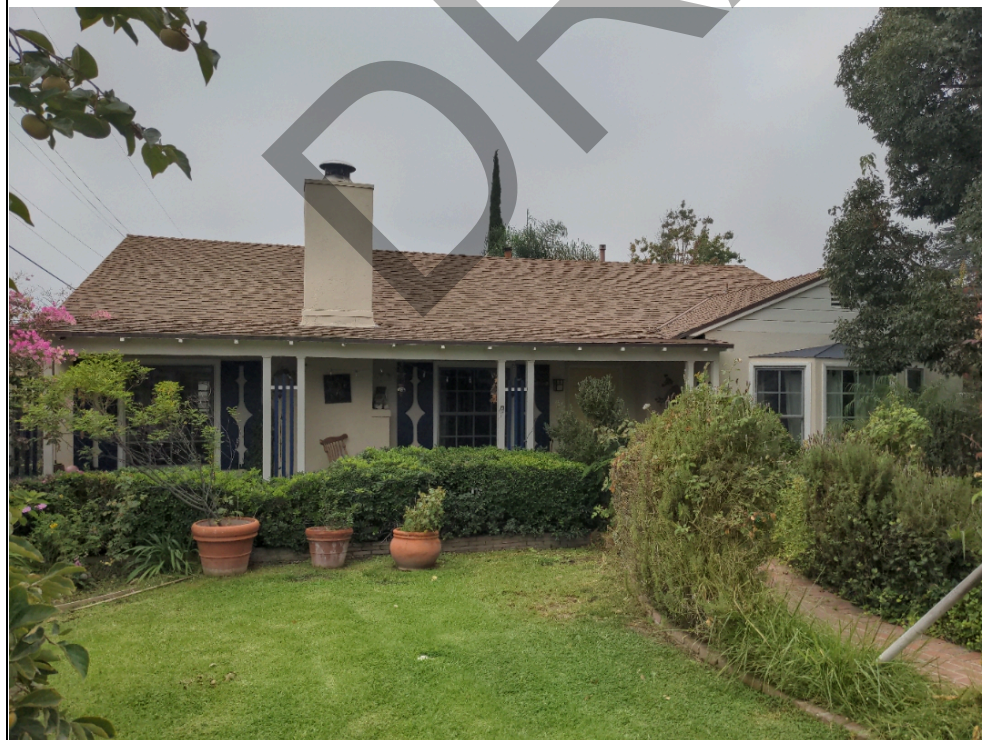
Alterations: windows replaced, all; decorative elements added; garage altered/replaced; driveway gate added/replaced; shutters added

P5b. Description of Photo: (view, date, accession #) View west, 4/4/2025
