## PRIMARY RECORD

Page 1 of 1 \*Resource Name or # (Assigned by recorder) 1301 Graynold Ave

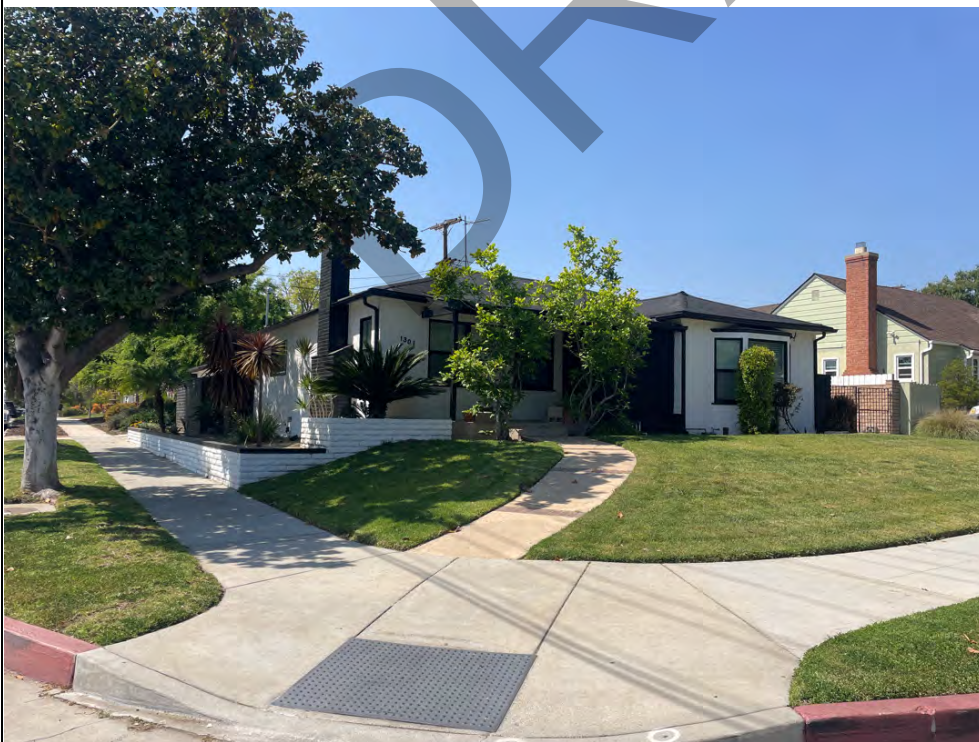
**\*P5a. Photograph or Drawing** (Photograph required for buildings, structures, or objects)

Setting: corner; set back  
Height: 1-story  
Plan: irregular  
Primary Façade Composition: asymmetrical  
Type of Construction: wood frame  
Wall Cladding: brick masonry; stucco, textured

Alterations: windows replaced, all; wall cladding added/replaced; decorative elements removed; security door added; light fixture added/replaced; pergola added; gate added/replaced; garage altered/replaced; garage door replaced; driveway gate added/replaced

**Integrity:** low

P5b. Description of Photo: (view, date, accession #) View northwest, 4/8/2025

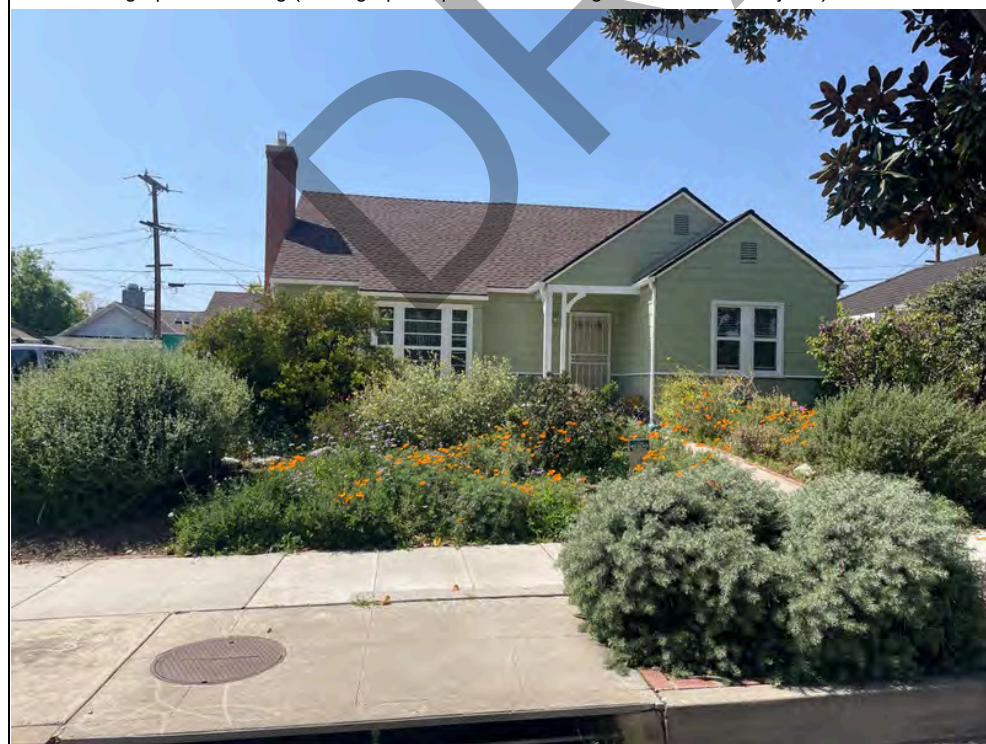
\*P5a. Photograph or Drawing (Photograph required for buildings, structures, or objects)

Alterations: windows replaced, all; garage door replaced; light fixture added/replaced; driveway gate added/replaced

P5b. Description of Photo: (view, date, accession #) View west, 4/8/2025

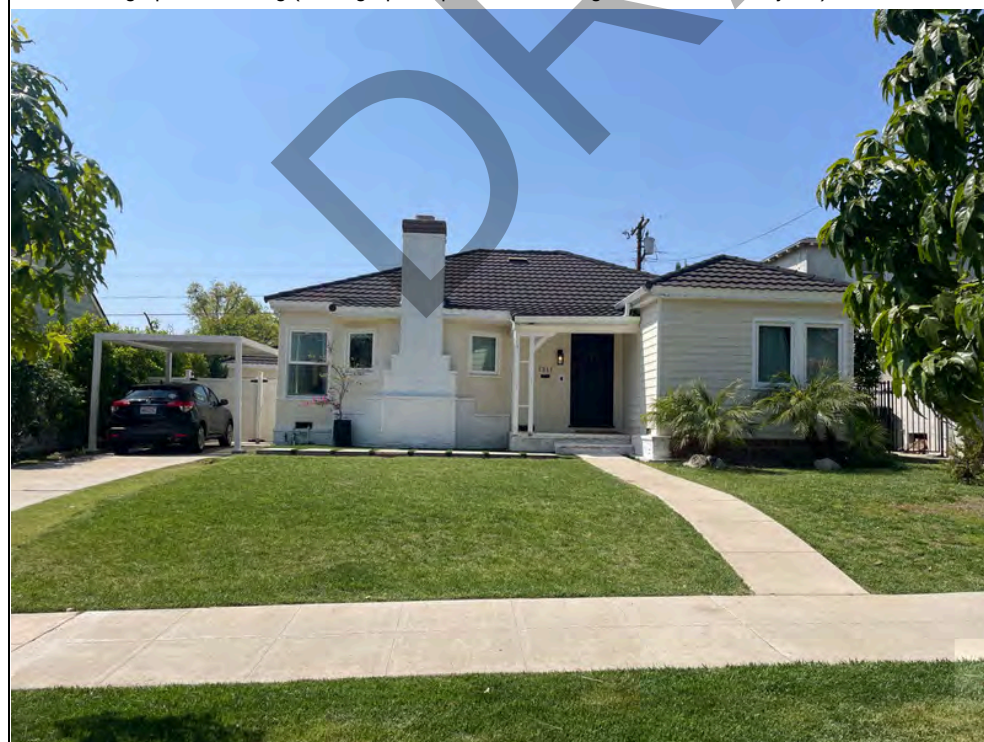
\*P5a. Photograph or Drawing (Photograph required for buildings, structures, or objects)

Alterations: windows replaced, all; roof material replaced, incompatible; wall cladding added/replaced; driveway gate added/replaced; gate added/replaced; carport added

P5b. Description of Photo: (view, date, accession #) View west, 4/8/2025

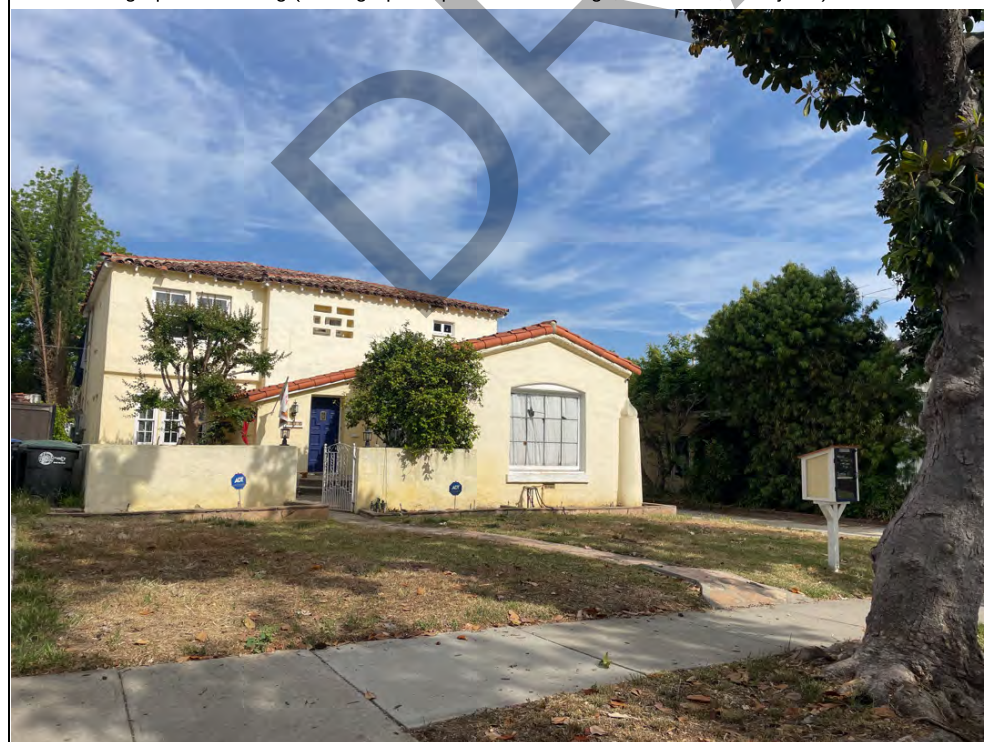
\*P5a. Photograph or Drawing (Photograph required for buildings, structures, or objects)

Alterations: windows replaced, some, primary; windows replaced, some,  
secondary; door replaced, primary; light fixture added/replaced; garage  
door replaced; gate added/replaced; driveway gate added/replaced

P5b. Description of Photo: (view, date,  
accession #) View southeast, 4/8/2025

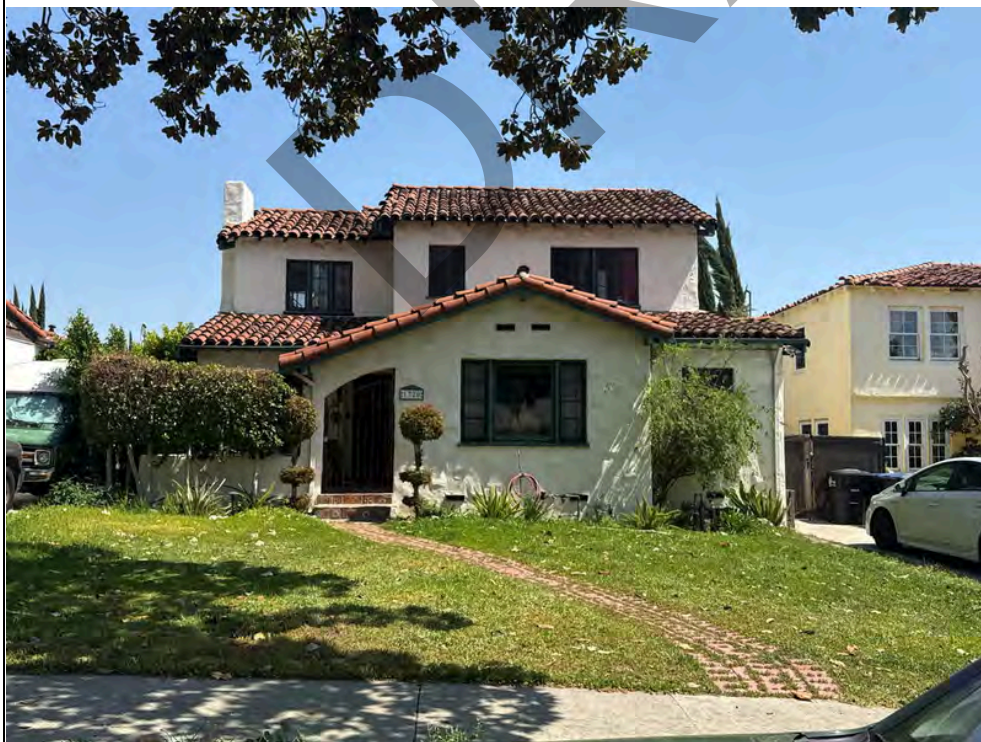
\*P5a. Photograph or Drawing (Photograph required for buildings, structures, or objects)

Alterations: walkway altered; driveway gate added/replaced; no major  
alterations

P5b. Description of Photo: (view, date,  
accession #) View east, 4/8/2025

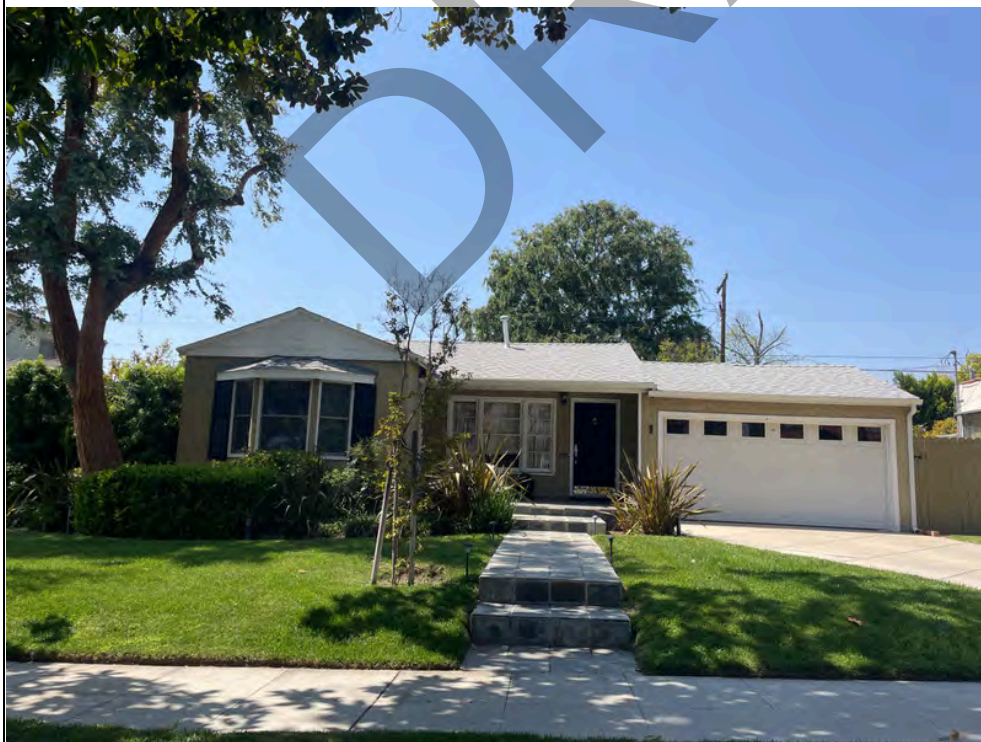
\*P5a. Photograph or Drawing (Photograph required for buildings, structures, or objects)

Alterations: windows replaced, some, primary; windows replaced, some, secondary; door replaced, primary; porch flooring altered/replaced; walkway altered; garage door replaced

P5b. Description of Photo: (view, date, accession #) View west, 4/8/2025

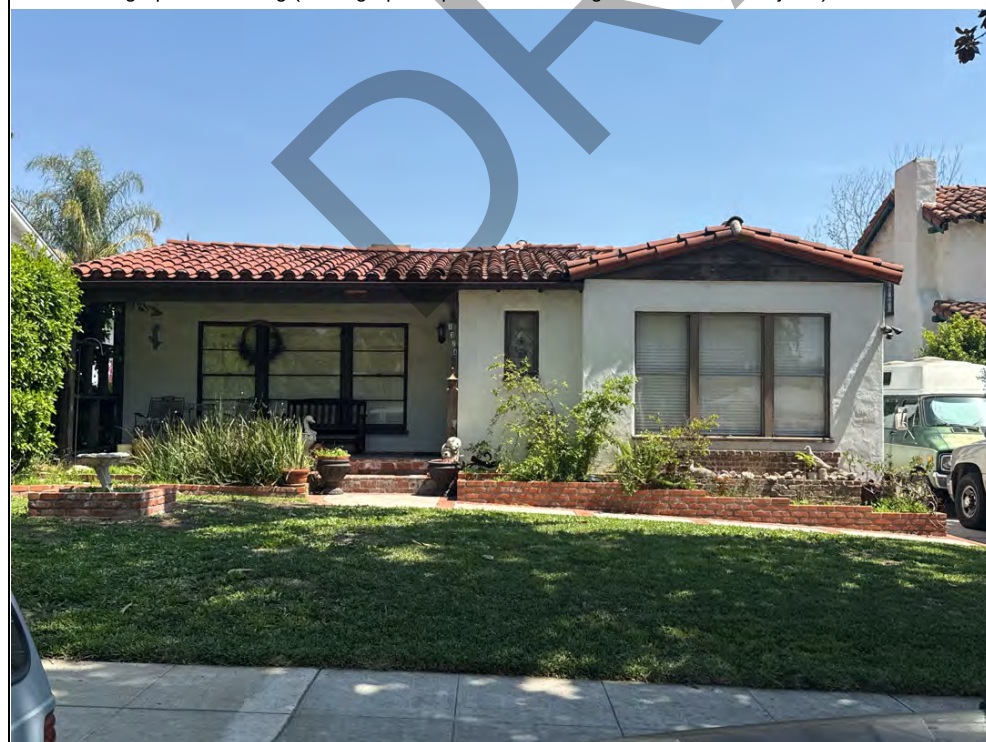
\*P5a. Photograph or Drawing (Photograph required for buildings, structures, or objects)

Alterations: windows replaced, some, primary; windows replaced, some,  
secondary; porch flooring altered/replaced; planter(s) added

P5b. Description of Photo: (view, date,  
accession #) View east, 4/8/2025

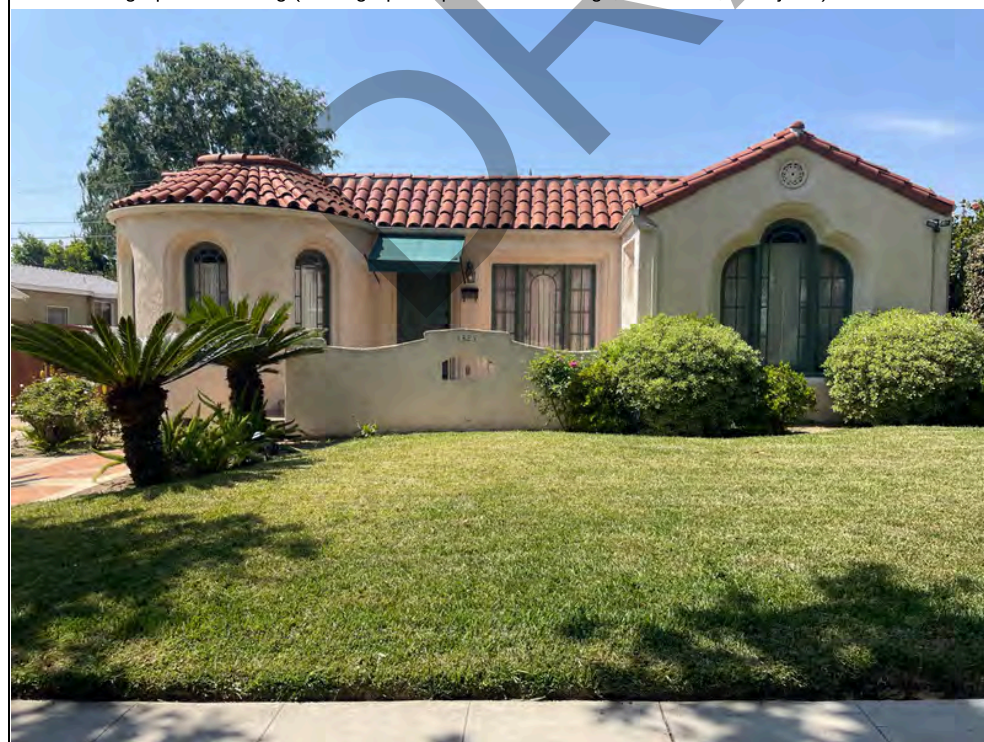
\*P5a. Photograph or Drawing (Photograph required for buildings, structures, or objects)

Alterations: restuccoed, incompatible; awning(s) added; driveway gate added/replaced; garage door replaced; walkway altered

P5b. Description of Photo: (view, date, accession #) View west, 4/8/2025

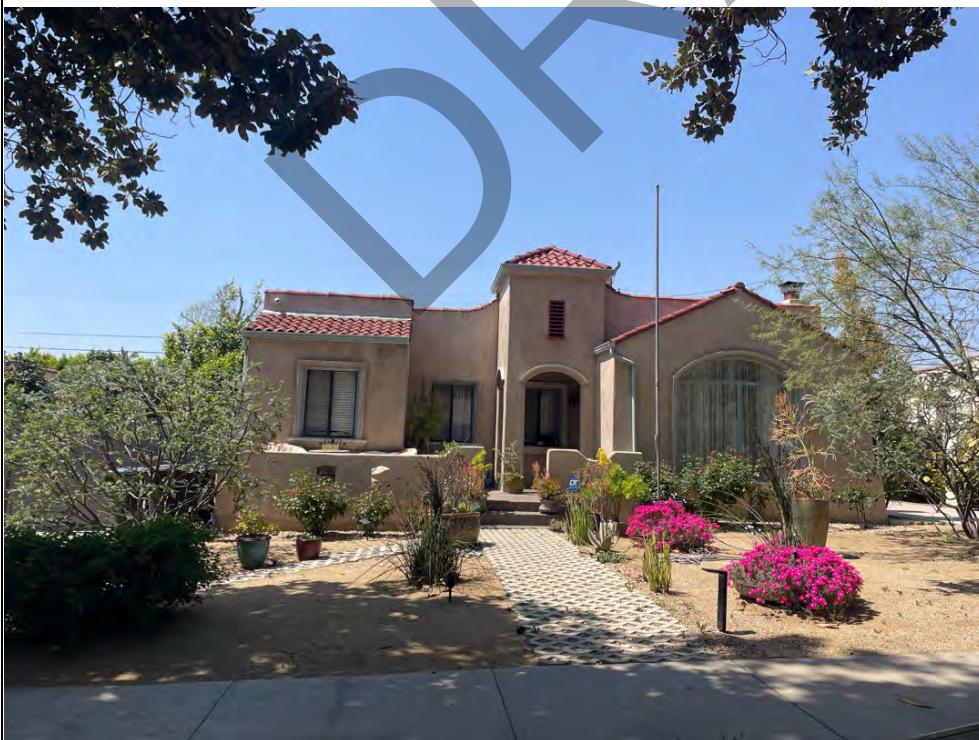
\*P5a. Photograph or Drawing (Photograph required for buildings, structures, or objects)

Alterations: windows replaced, some, primary; windows replaced, some,  
secondary; restuccoed, incompatible; window surrounds altered; s-tile  
roof cladding added; decorative elements added; light fixture added/  
replaced; security door added; walkway altered; driveway altered

P5b. Description of Photo: (view, date,  
accession #) View west, 4/8/2025

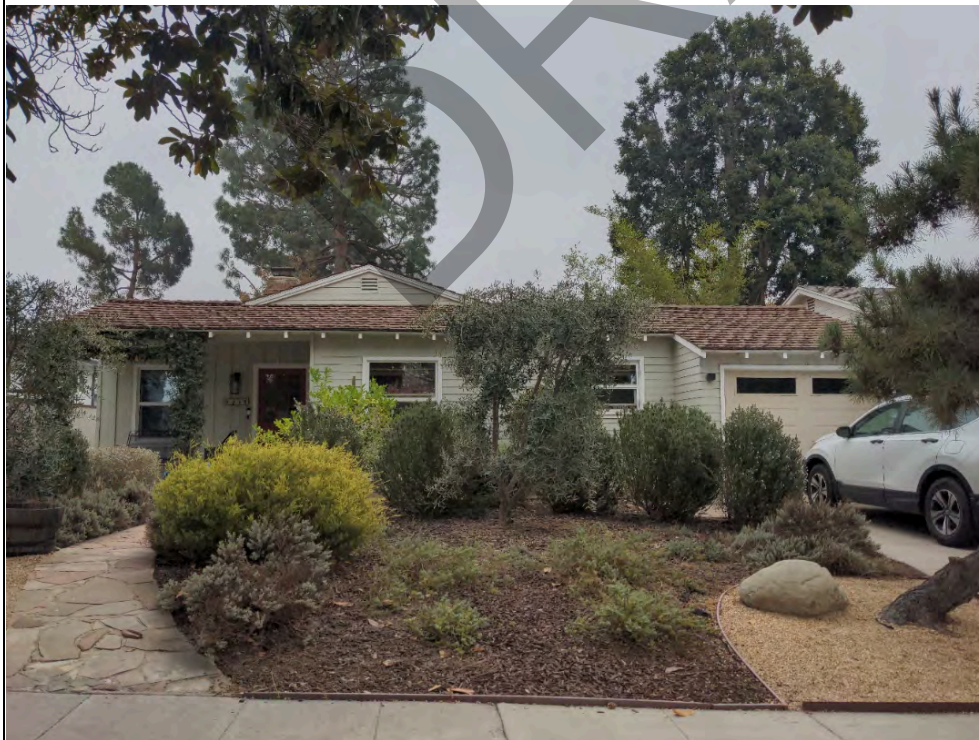
\*P5a. Photograph or Drawing (Photograph required for buildings, structures, or objects)

Alterations: windows replaced, all; garage door replaced

P5b. Description of Photo: (view, date, accession #) View east, 4/8/2025

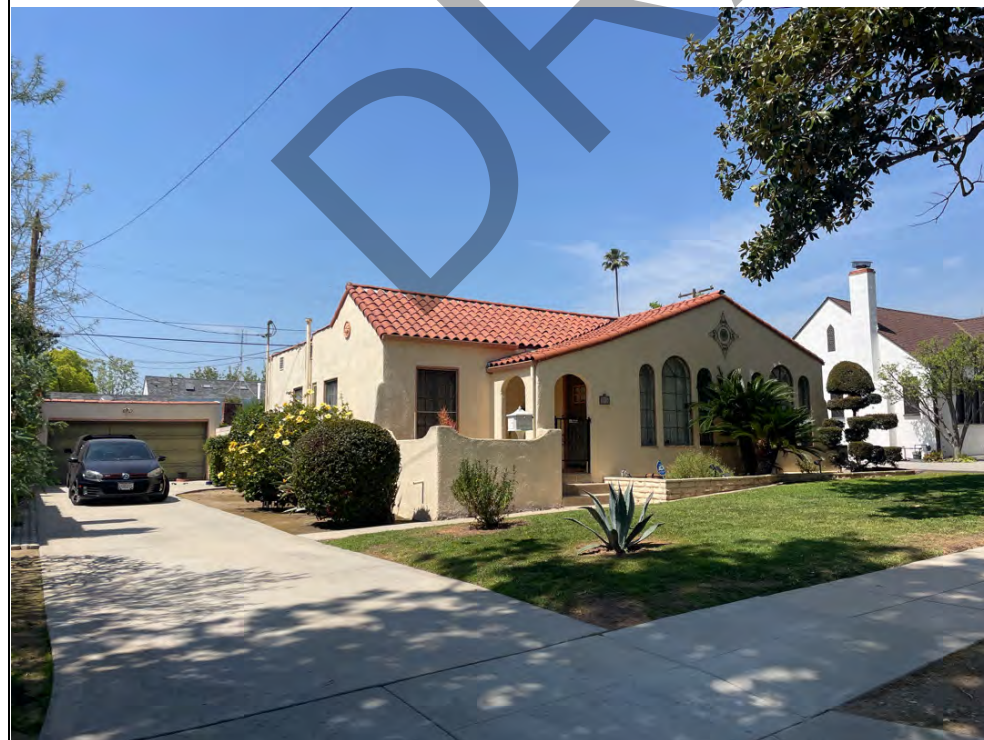
\*P5a. Photograph or Drawing (Photograph required for buildings, structures, or objects)

Alterations: windows replaced, some, primary; windows replaced, some, secondary; restuccoed, compatible; garage door replaced; gate added/replaced

P5b. Description of Photo: (view, date, accession #) View northwest, 4/8/2025

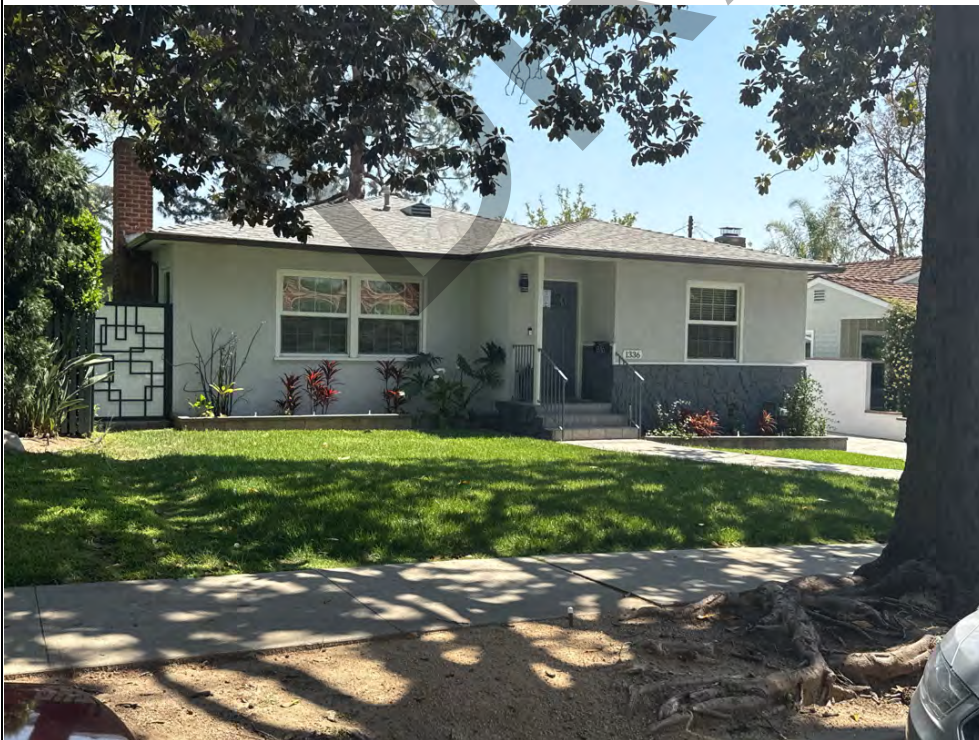
**\*P5a. Photograph or Drawing** (Photograph required for buildings, structures, or objects)

Alterations: windows replaced, all; wall cladding added/replaced; door replaced, primary; decorative elements removed; driveway altered; driveway gate added/replaced; gate added/replaced; porch flooring altered/replaced; walkway altered; railings altered/replaced

P5b. Description of Photo: (view, date, accession #) View southeast, 4/8/2025

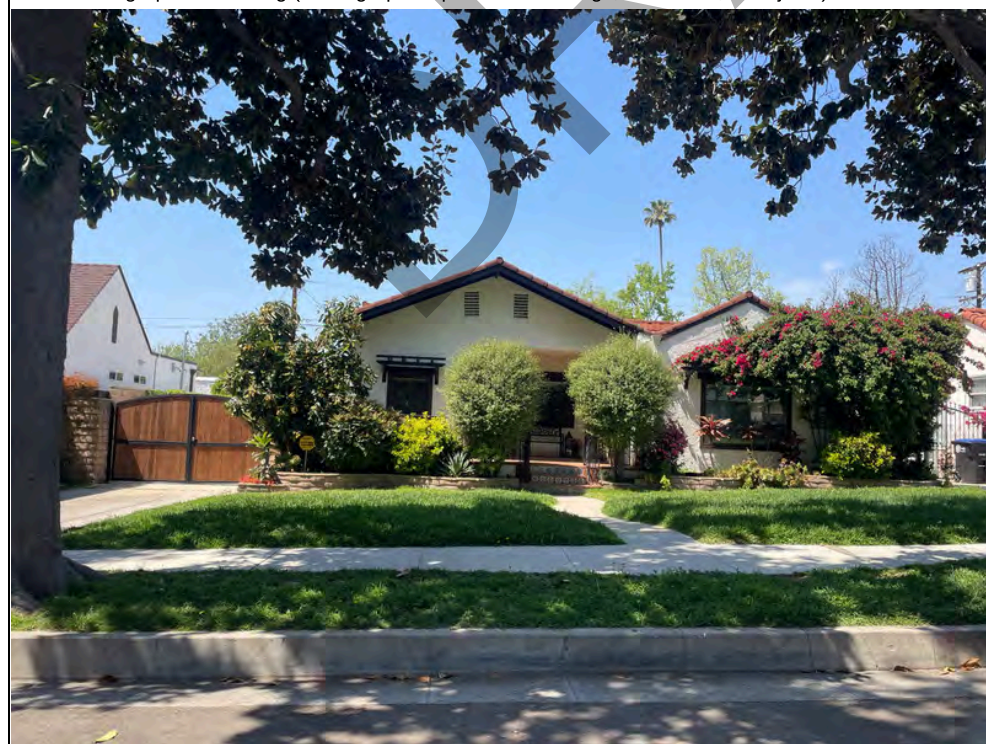
\*P5a. Photograph or Drawing (Photograph required for buildings, structures, or objects)

Alterations: addition at front; garage door replaced; light fixture added/replaced; windows replaced, all; restuccoed, incompatible; door replaced, primary; porch flooring altered/replaced; railings altered/replaced; decorative elements added; driveway gate added/replaced; roof material replaced, incompatible; roofline altered

P5b. Description of Photo: (view, date, accession #) View west, 4/8/2025

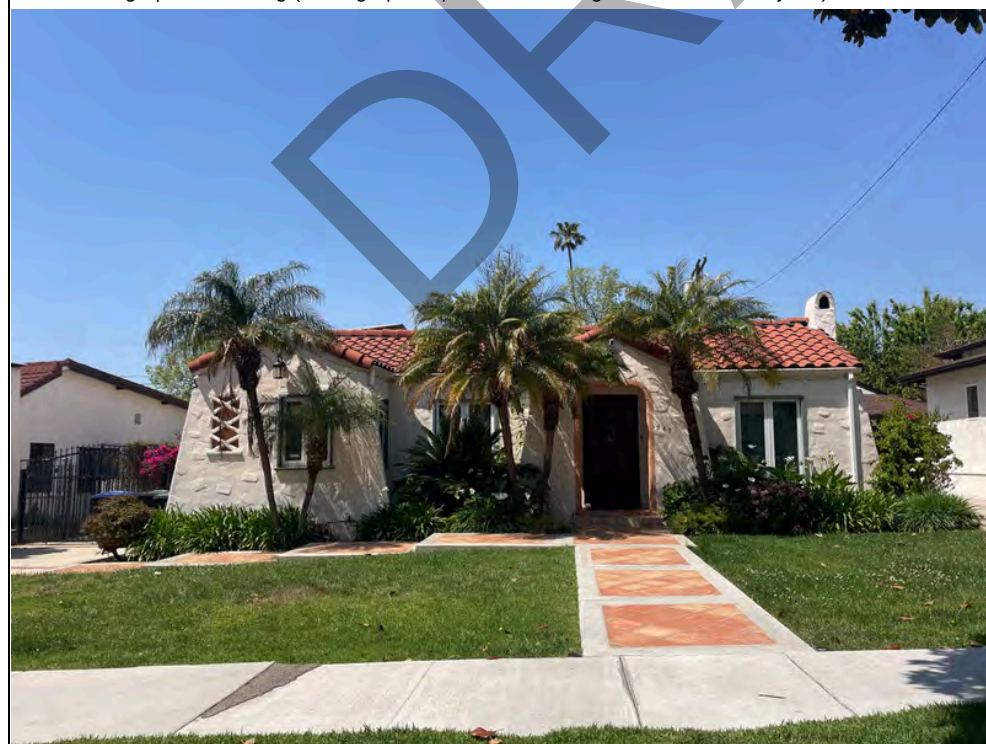
\*P5a. Photograph or Drawing (Photograph required for buildings, structures, or objects)

Alterations: windows replaced, all; door replaced, primary; porch flooring altered/replaced; driveway gate added/replaced; garage door replaced; walkway altered; visible solar panels

P5b. Description of Photo: (view, date, accession #) View west, 4/8/2025

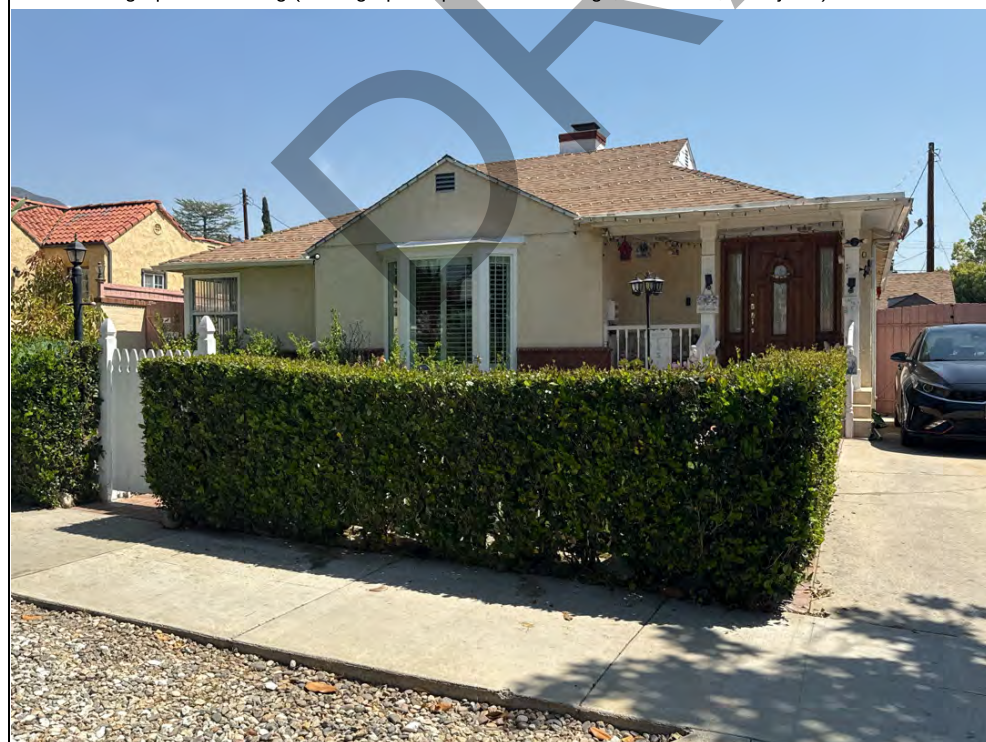
\*P5a. Photograph or Drawing (Photograph required for buildings, structures, or objects)

Alterations: wall cladding added/replaced; porch flooring altered/replaced; railings altered/replaced; windows replaced, all; door replaced, primary; garage door replaced; gate added/replaced; driveway gate added/replaced; walkway altered; perimeter hedge(s) added

P5b. Description of Photo: (view, date, accession #) View northeast, 4/8/2025

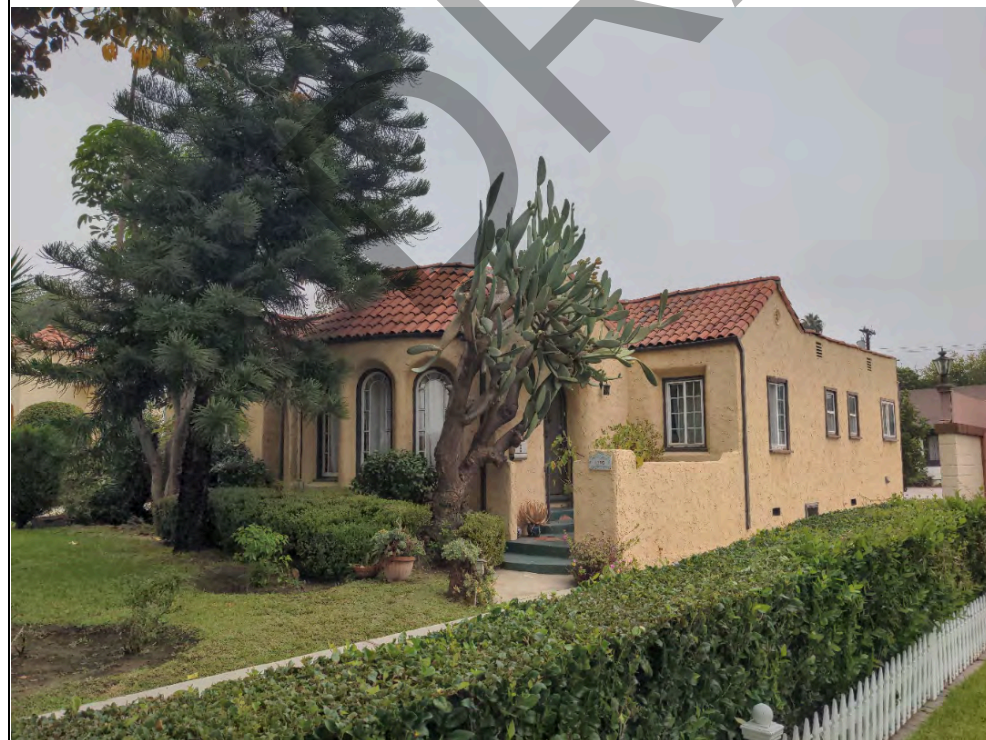
\*P5a. Photograph or Drawing (Photograph required for buildings, structures, or objects)

Alterations: restuccoed, incompatible; windows replaced, some, primary; windows replaced, some, secondary; railings altered/replaced; garage altered/replaced

P5b. Description of Photo: (view, date, accession #) View northeast, 4/8/2025

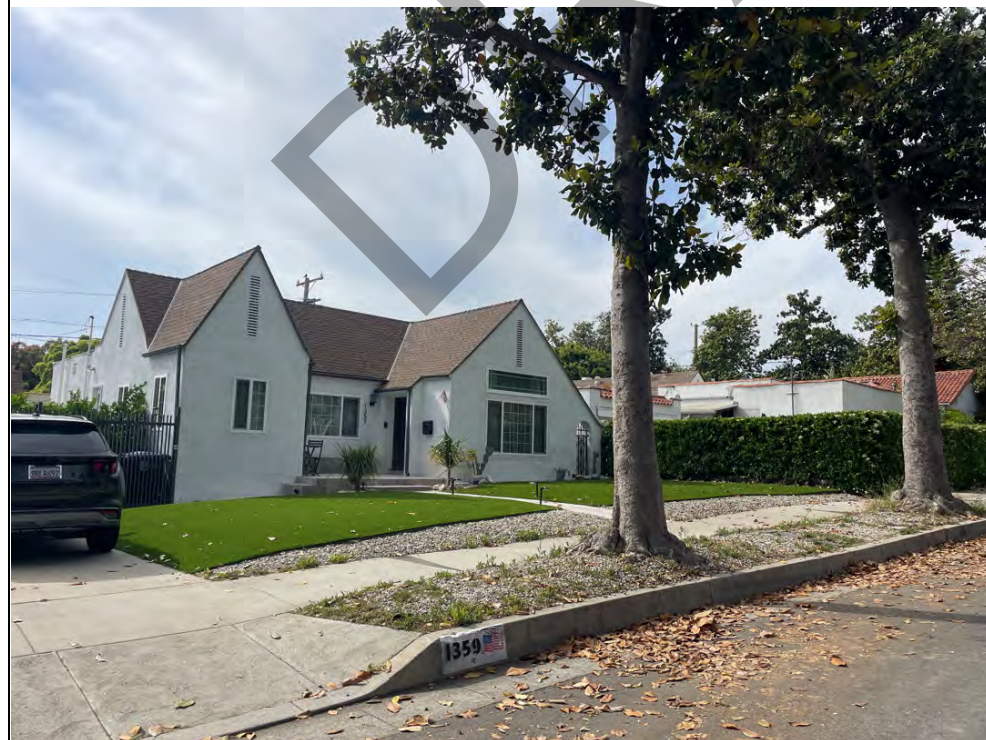
\*P5a. Photograph or Drawing (Photograph required for buildings, structures, or objects)

Alterations: door replaced, primary; driveway gate added/replaced; windows replaced, all; window openings altered, primary; window openings infilled, secondary; wall cladding added/replaced; entrance altered, primary; porch flooring altered/replaced; decorative elements removed; garage door replaced; gate added/replaced; light fixture added/replaced

P5b. Description of Photo: (view, date, accession #) View northwest, 4/8/2025

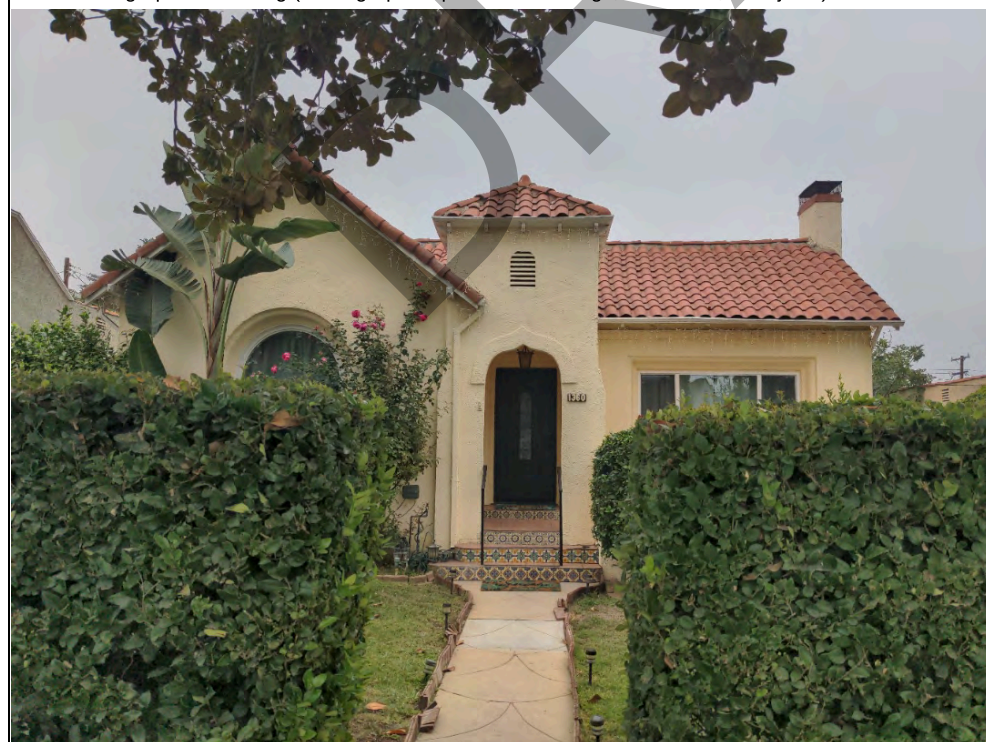
\*P5a. Photograph or Drawing (Photograph required for buildings, structures, or objects)

Alterations: windows replaced, all; restuccoed, compatible; door replaced, primary; decorative tile added; railings altered/replaced; driveway gate added/replaced; perimeter hedge(s) added

P5b. Description of Photo: (view, date, accession #) View east, 4/8/2025

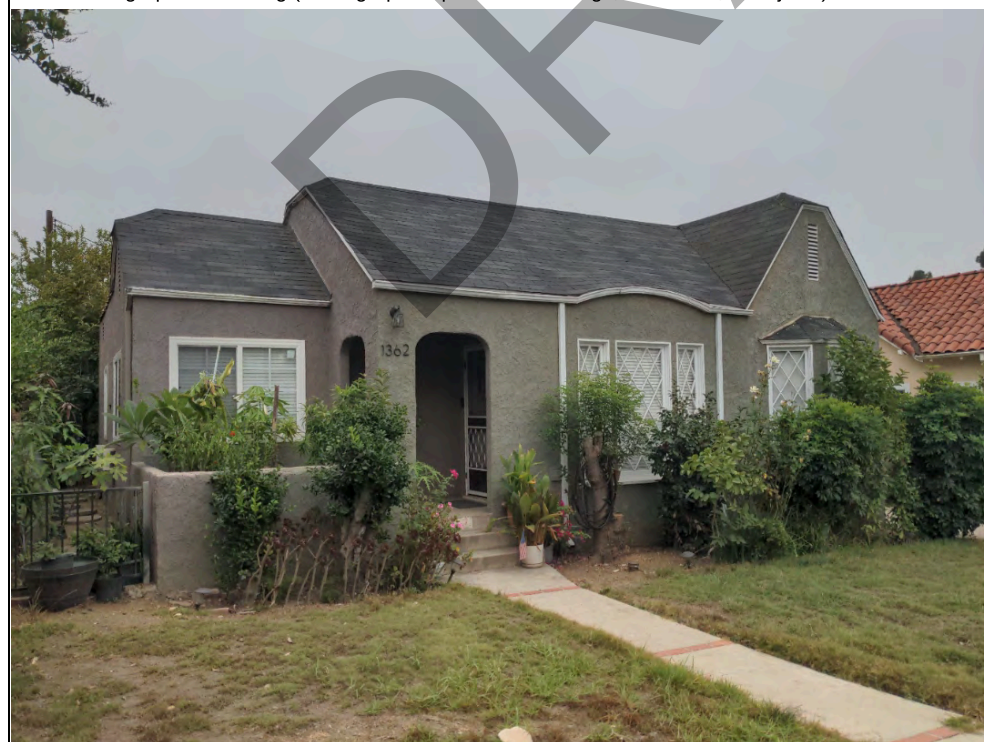
\*P5a. Photograph or Drawing (Photograph required for buildings, structures, or objects)

Alterations: wall cladding added/replaced; windows replaced, some, primary; windows replaced, some, secondary; garage door replaced; gate added/replaced

P5b. Description of Photo: (view, date, accession #) View southeast, 4/8/2025

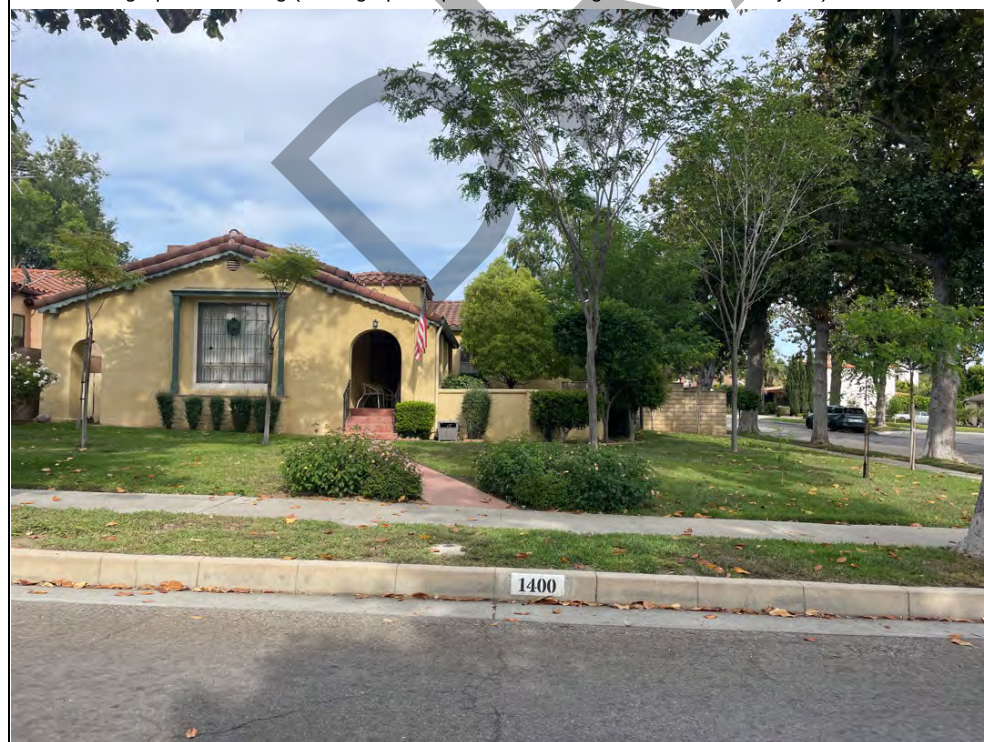
\*P5a. Photograph or Drawing (Photograph required for buildings, structures, or objects)

Alterations: restuccoed, incompatible; wall or fence added, side; windows replaced, some, secondary; gate added/replaced

P5b. Description of Photo: (view, date, accession #) View east, 4/8/2025

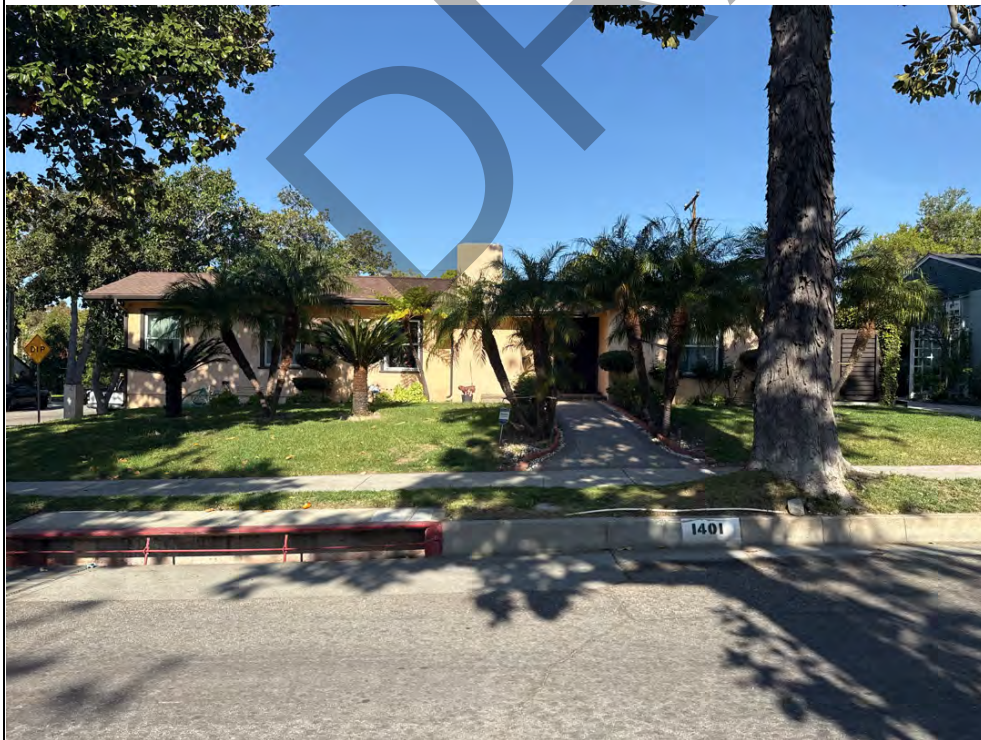
\*P5a. Photograph or Drawing (Photograph required for buildings, structures, or objects)

Alterations: windows replaced, all; door replaced, primary; porch flooring  
altered/replaced; wall cladding added/replaced; driveway gate  
added/replaced; gate added/replaced; light fixture added/replaced

P5b. Description of Photo: (view, date, accession #) View southwest, 4/8/2025

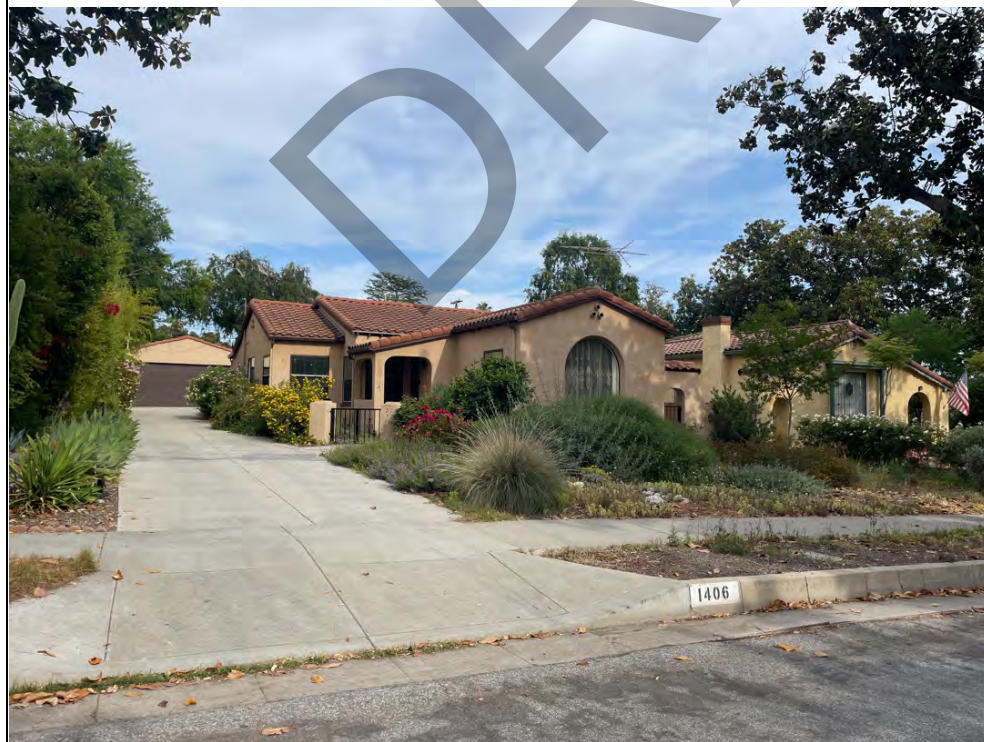
**\*P5a. Photograph or Drawing** (Photograph required for buildings, structures, or objects)

Alterations: windows replaced, some, primary; windows replaced, some, secondary; door replaced, primary; light fixture added/replaced; gate added/replaced

P5b. Description of Photo: (view, date, accession #) View southeast, 4/8/2025
