## PRIMARY RECORD

\*Resource Name or # (Assigned by recorder) 1804 Tamerlane Dr

Historic Property Type: Multi-family residential  
Current Property Type: Multi-family residential  
Property Sub-Type: Multi-Family Residential: Garden apartment  
Primary Architectural Style: Mid-Century Modern

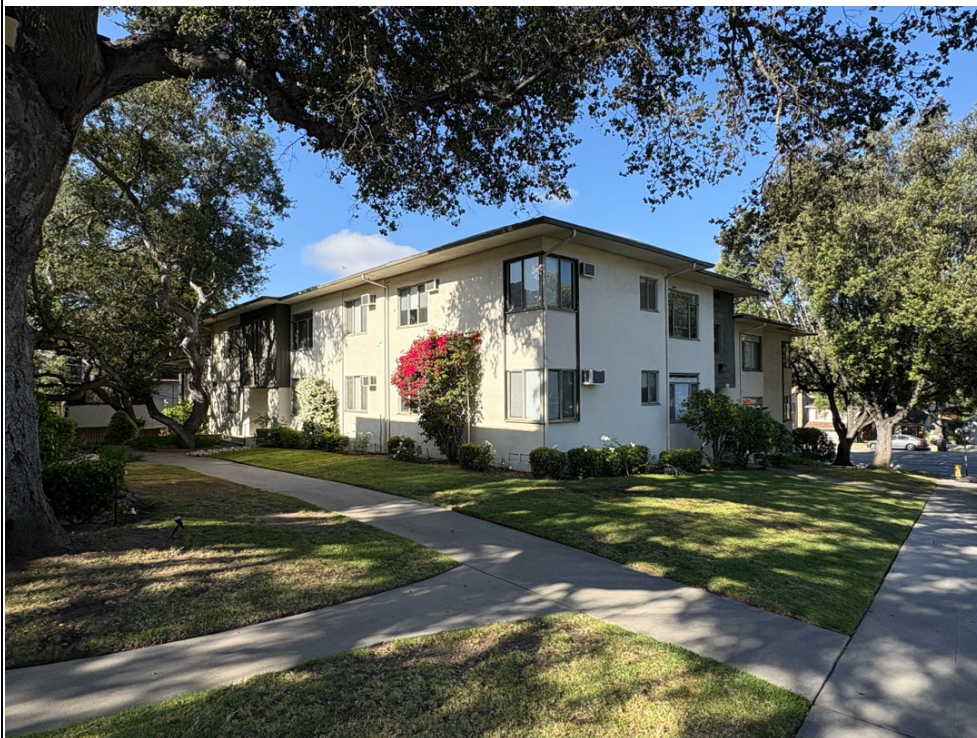
P5a. Photograph or Drawing (Photograph required for buildings, structures, or objects)

Roof Form: hipped; low-pitched  
Roof Cladding: composition shingle  
Roof Details: eaves, wide; eaves, closed

Primary Entry Type: multiple; stoop  
Primary Entry Materials & Details: cheek walls; hood; posts, wood;  
railing, metal  
Primary Door Type & Material: single door; slab door; wood  
Primary Door Details: screen, metal

Setting: corner; hillside; set back  
Height: 2-story  
Plan: irregular  
Primary Façade Composition: asymmetrical  
Type of Construction: wood frame  
Wall Cladding: stucco, smooth; wood, channel  
Architectural Details: decorative wood elements; jetties

P5b. Description of Photo: (view, date, accession #) View southwest, 4/24/2026

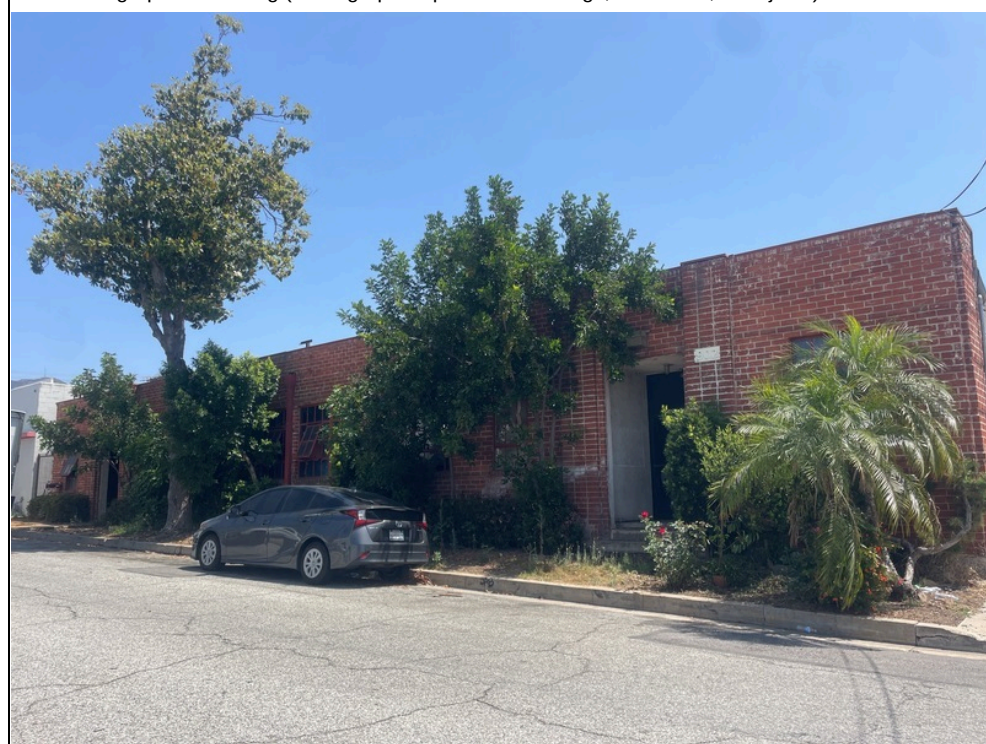
P5a. Photograph or Drawing (Photograph required for buildings, structures, or objects)

P5b. Description of Photo: (view, date, accession #) View east, 4/17/2026

\*B6. Construction History: (Construction date, alteration, and date of alterations) This property was constructed in 1940 for original occupant Dorothy C. Thorpe Glassware. Thorpe was a local glassware designer with a nationwide market. Alterations observed in the field are listed in P3a. Description.

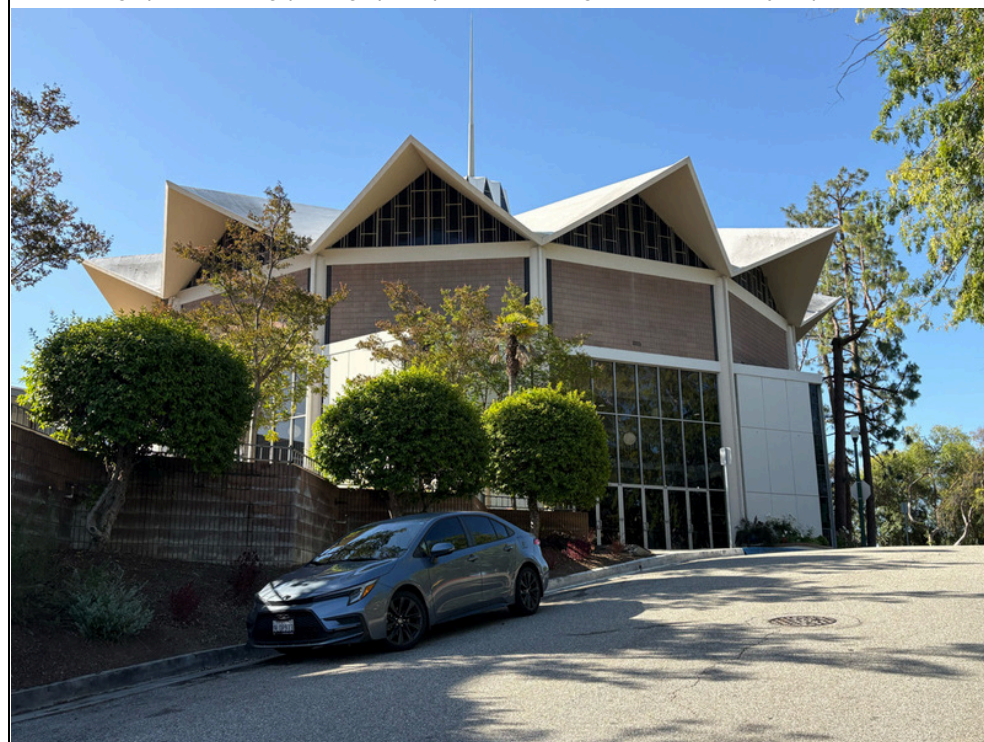
P5a. Photograph or Drawing (Photograph required for buildings, structures, or objects)

P5b. Description of Photo: (view, date, accession #) View southwest, 4/29/2026

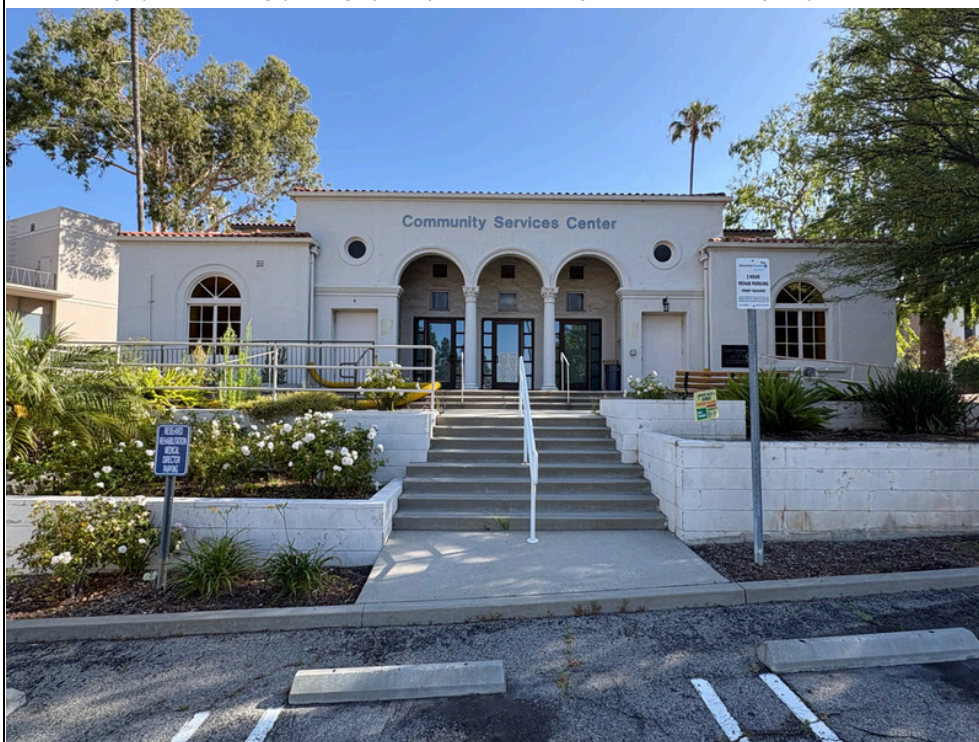
**P5a. Photograph or Drawing** (Photograph required for buildings, structures, or objects)

Window Grouping & Type 1: fixed; floor-to-ceiling; grouped  
Window Materials 1: metal  
Window Details 1: multi-light  
Window Grouping & Type 2: fixed; grouped  
Window Materials 2: metal  
Window Details 2: leaded glass; multi-light; stained glass  
Window Grouping & Type 3: fixed; single  
Window Materials 3: metal  
Window Details 3: multi-light; obscure glass

**P5b. Description of Photo:** (view, date, accession #) View northeast, 4/29/2026

\*B6. Construction History: (Construction date, alteration, and date of alterations) This property was constructed as the Glendale Sanitarium Chapel in 1928. It was associated with the Seventh-day Adventist Church. By 1969, the property became Glendale Adventist Hospital and later, the building was reused as a Community Services Building. Alterations observed in the field are listed in P3a. Description.

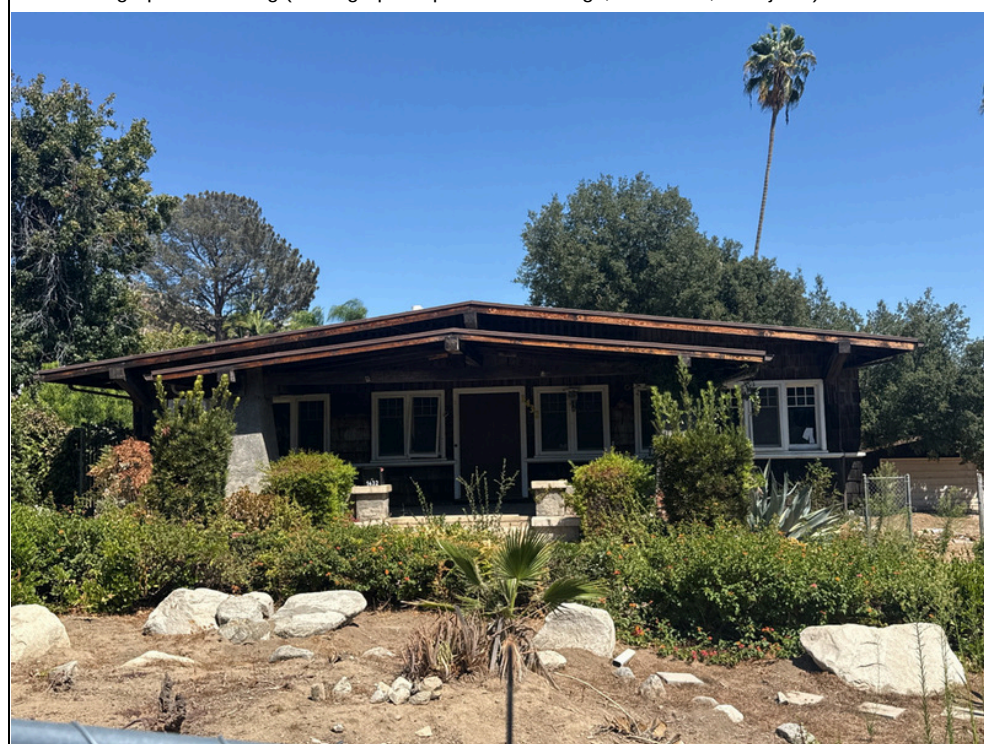
P5a. Photograph or Drawing (Photograph required for buildings, structures, or objects)

Alterations: door replaced, primary; windows replaced, some, secondary

P5b. Description of Photo: (view, date, accession #) View east, 8/27/2026

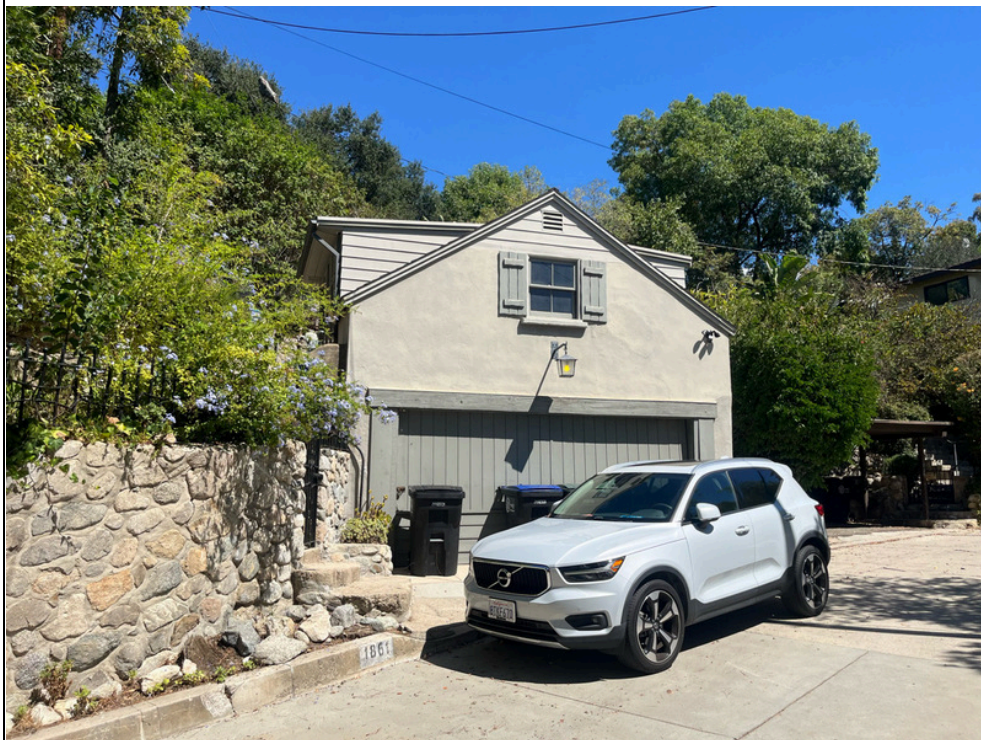
P5a. Photograph or Drawing (Photograph required for buildings, structures, or objects)

P5b. Description of Photo: (view, date, accession #) View northwest, 8/31/2026

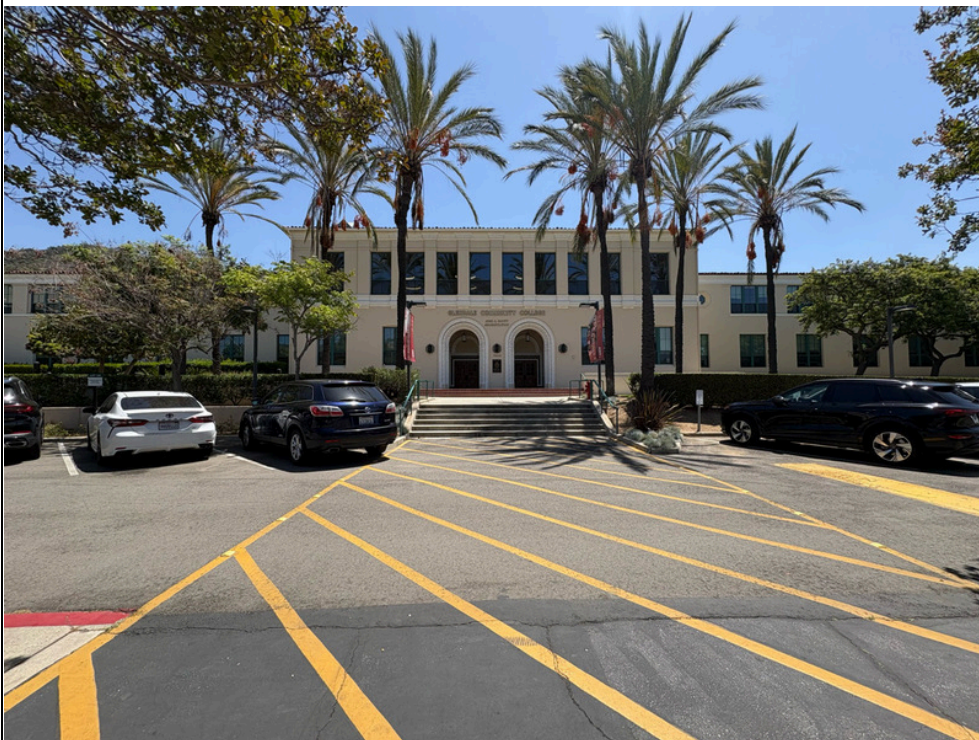
**P5a. Photograph or Drawing** (Photograph required for buildings, structures, or objects)

**P5b. Description of Photo:** (view, date, accession #) View east, 4/29/2026

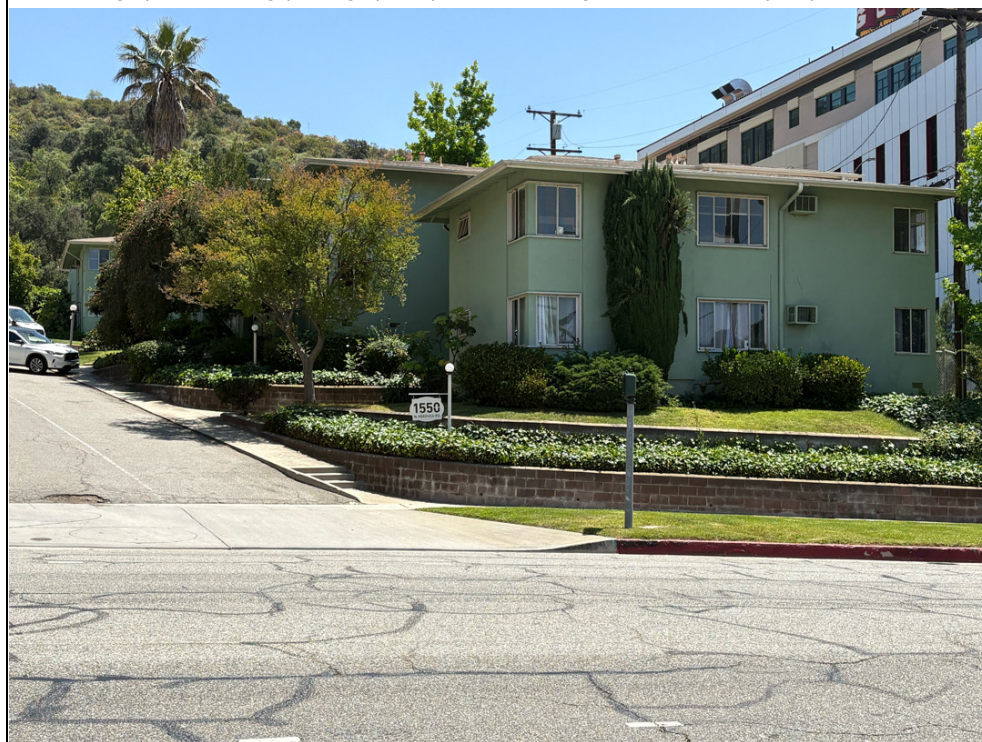
P5a. Photograph or Drawing (Photograph required for buildings, structures, or objects)

P5b. Description of Photo: (view, date, accession #) View east, 4/29/2026

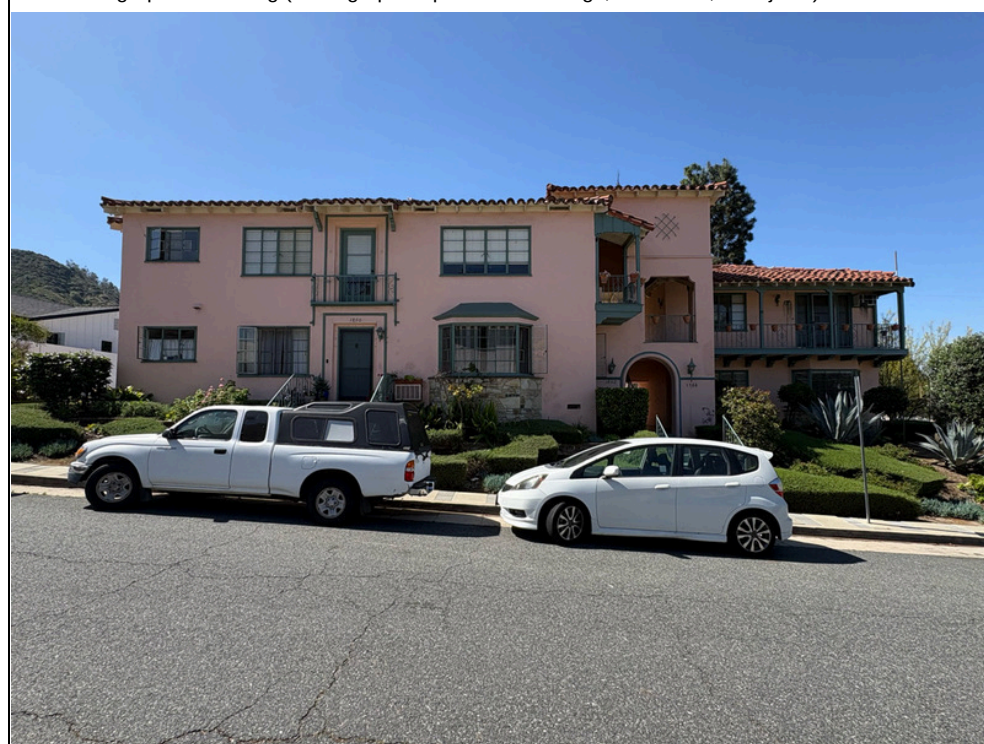
P5a. Photograph or Drawing (Photograph required for buildings, structures, or objects)

P5b. Description of Photo: (view, date, accession #) View southeast, 4/24/2026

\*B6. Construction History: (Construction date, alteration, and date of alterations) This property was constructed in 1940. Alterations observed in the field are listed in P3a. Description.

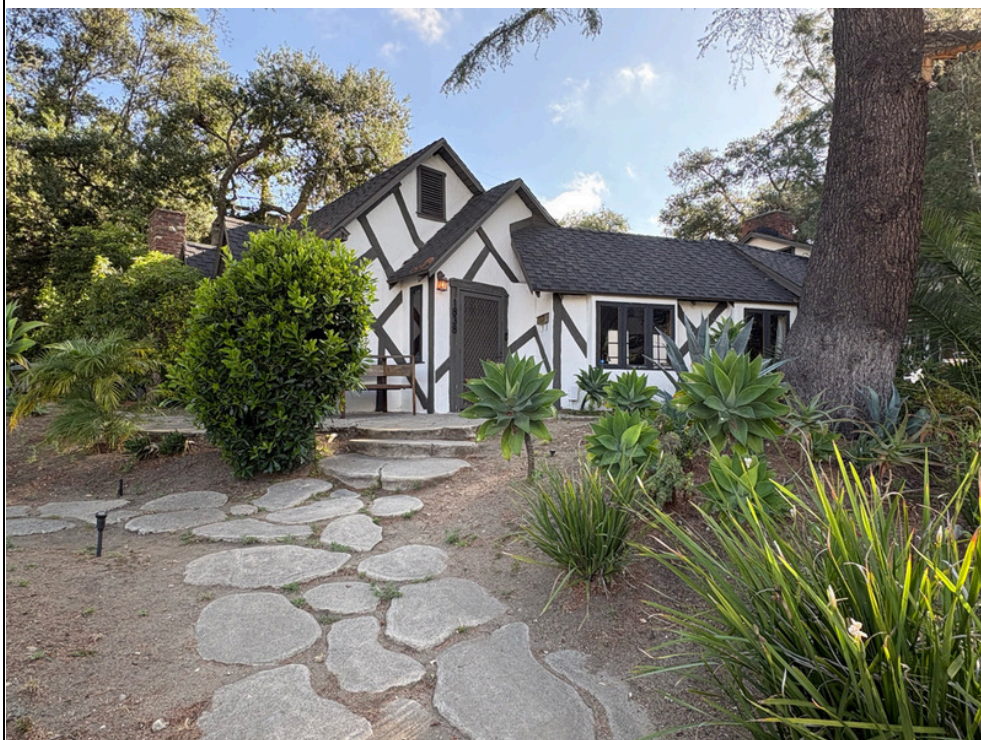
P5a. Photograph or Drawing (Photograph required for buildings, structures, or objects)

P5b. Description of Photo: (view, date, accession #) View northeast, 4/24/2026

\*B6. Construction History: (Construction date, alteration, and date of alterations) This property was constructed in 1922. Alterations observed in the field are listed in P3a. Description.

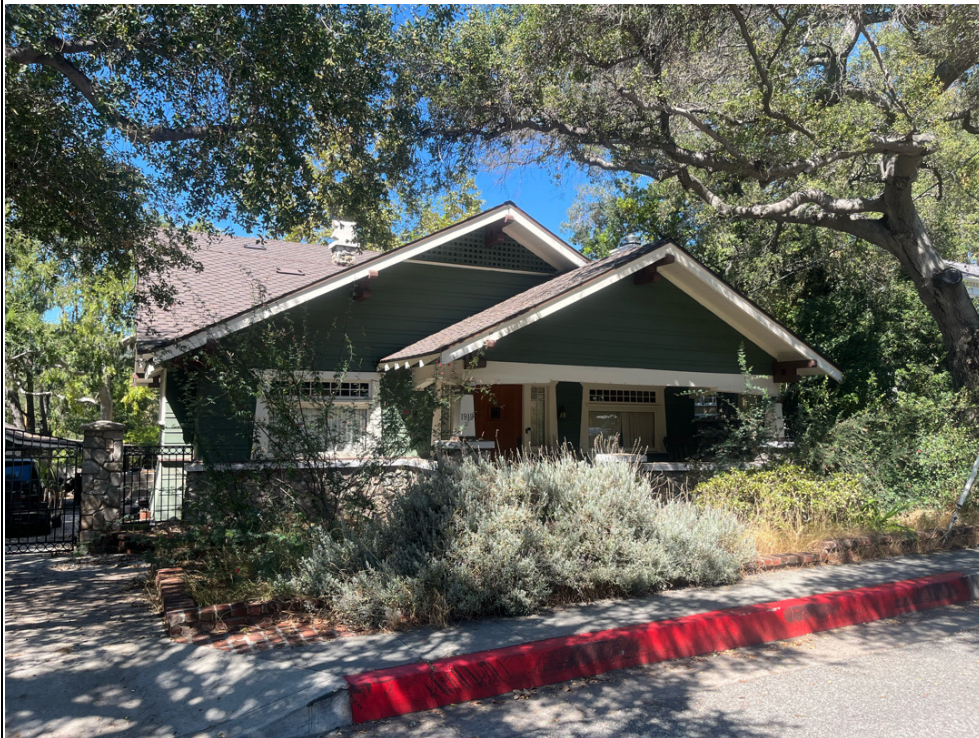
P5a. Photograph or Drawing (Photograph required for buildings, structures, or objects)

Alterations: windows replaced, some, secondary; visible solar panels

P5b. Description of Photo: (view, date, accession #) View west, 8/31/2026

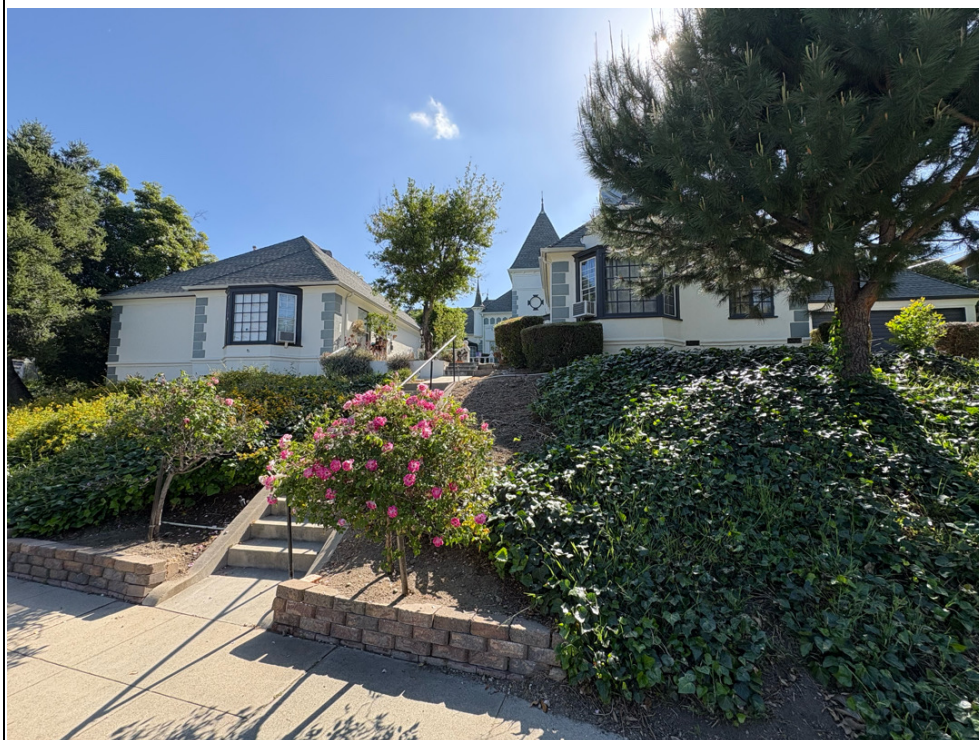
P5a. Photograph or Drawing (Photograph required for buildings, structures, or objects)

P5b. Description of Photo: (view, date, accession #) View northeast, 4/24/2026

\*B6. Construction History: (Construction date, alteration, and date of alterations) This property was constructed in 1938. Alterations observed in the field are listed in P3a. Description.

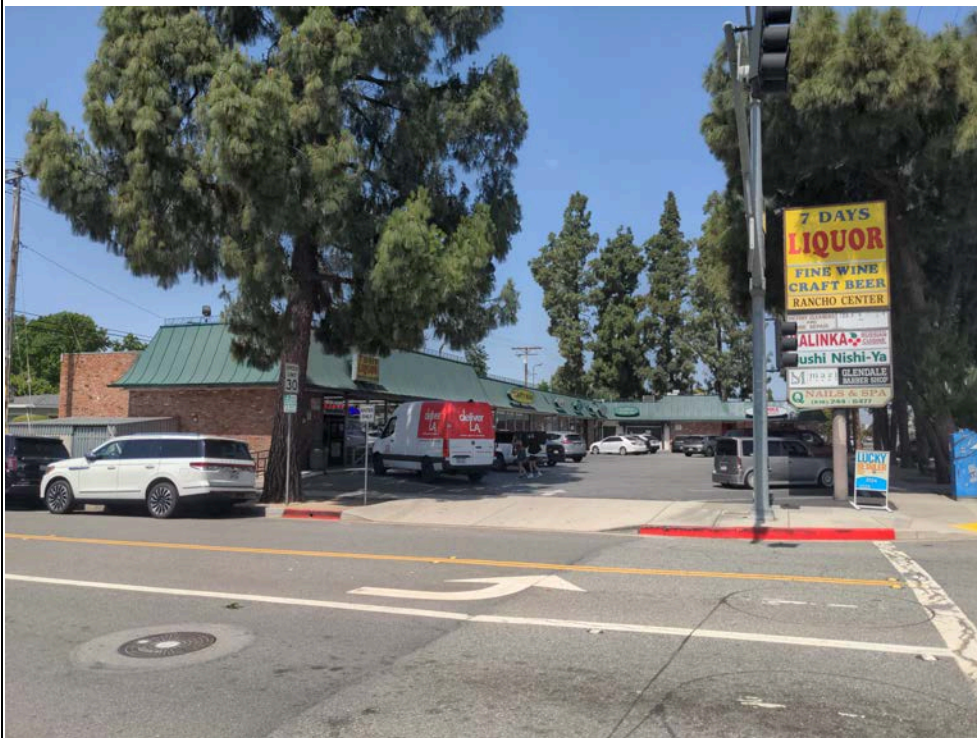
P5a. Photograph or Drawing (Photograph required for buildings, structures, or objects)

Alterations: windows replaced, some, primary; windows replaced, some, secondary

P5b. Description of Photo: (view, date, accession #) View south, 4/17/2026

\*B6. Construction History: (Construction date, alteration, and date of alterations) This property was constructed in 1969. Alterations observed in the field are listed in P3a. Description.

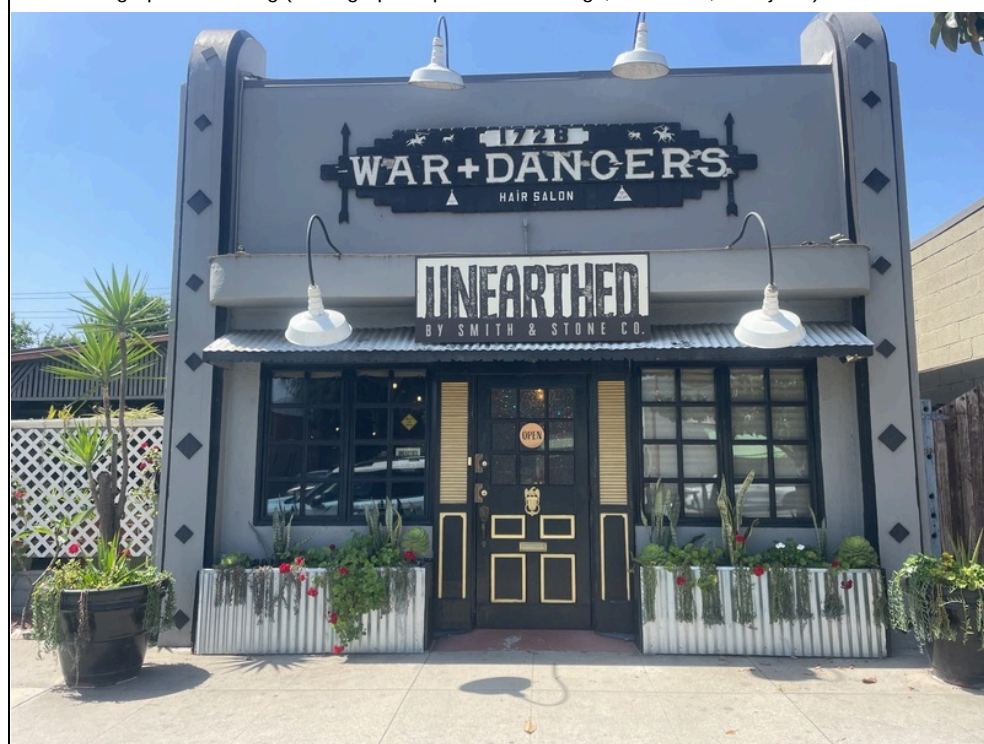
P5a. Photograph or Drawing (Photograph required for buildings, structures, or objects)

Alterations: windows replaced, some, primary; signage added/replaced;  
door(s) replaced, some; one storefront altered (1712, board and batten  
with wood "gate" detail fronting window)

P5b. Description of Photo: (view, date, accession #) View south, 4/17/2026

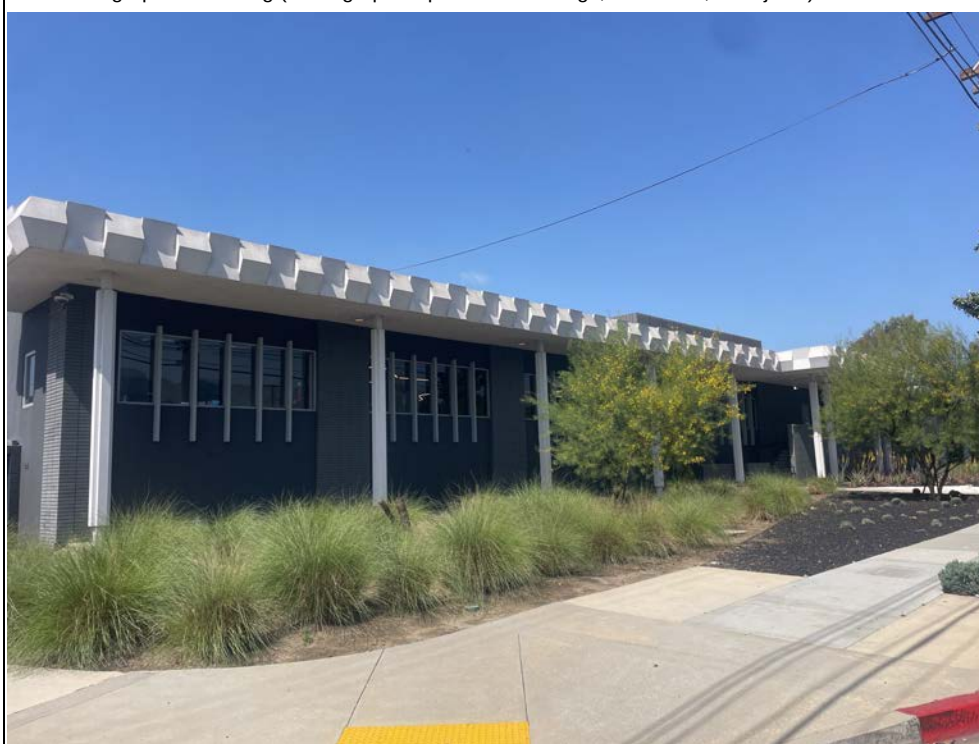
P5a. Photograph or Drawing (Photograph required for buildings, structures, or objects)

Alterations: windows replaced, some, primary; awning(s) added;  
decorative elements added; light fixture added/replaced; signage  
added/replaced

P5b. Description of Photo: (view, date, accession #) View south, 4/17/2026

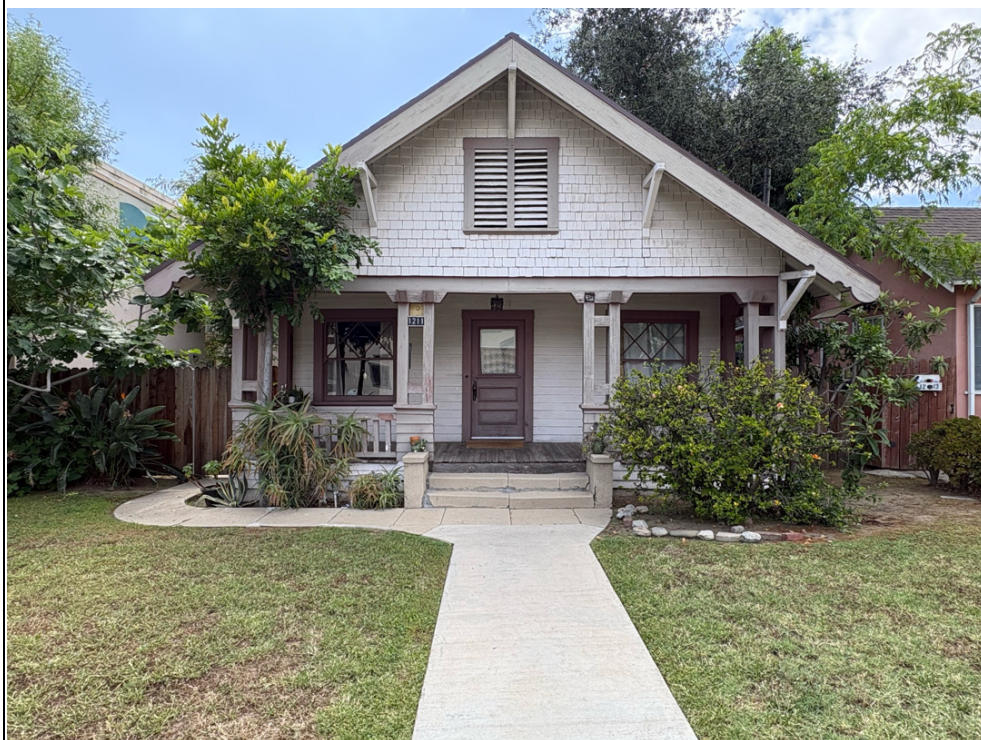
P5a. Photograph or Drawing (Photograph required for buildings, structures, or objects)

Alterations: windows replaced, some, secondary; rooftop mechanical equipment added; signage added/replaced; interlocking geometric detail added to canopy eave; secondary (side) entrance reconfigured with multiple new door openings, windows, and L-shaped metal entry roof added

P5b. Description of Photo: (view, date, accession #) View west, 4/27/2026

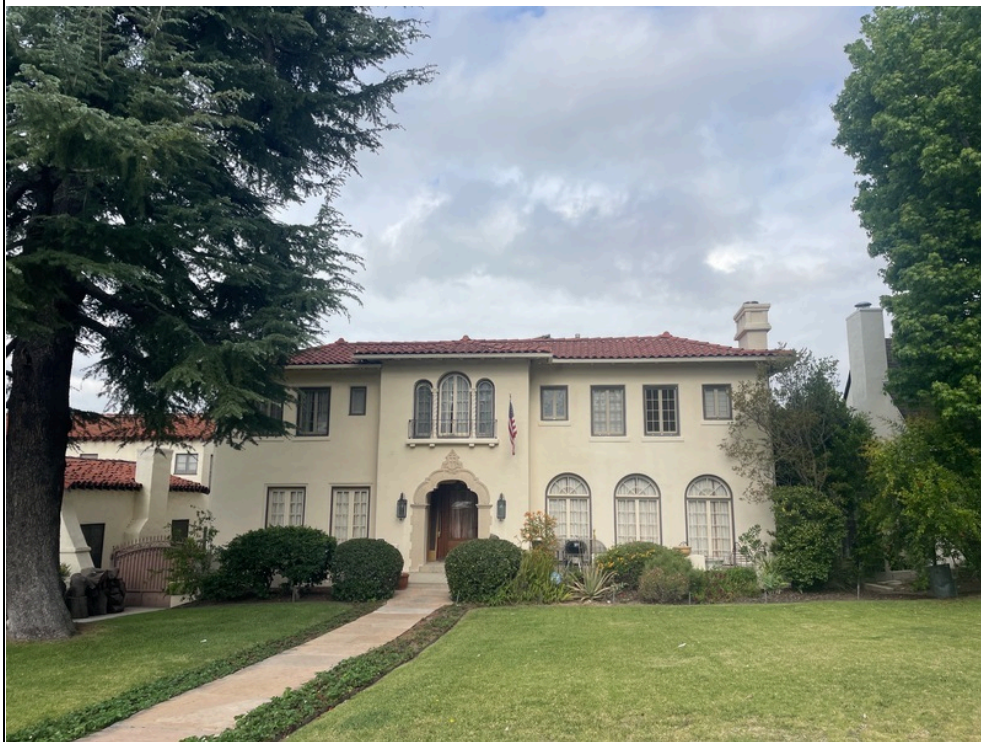
P5a. Photograph or Drawing (Photograph required for buildings, structures, or objects)

P5b. Description of Photo: (view, date, accession #) View west, 4/20/2026

\*B6. Construction History: (Construction date, alteration, and date of alterations) This property was constructed in 1926 for Henry J. and Helen Friesen. Minor alterations observed in the field are listed in P3a. Description.

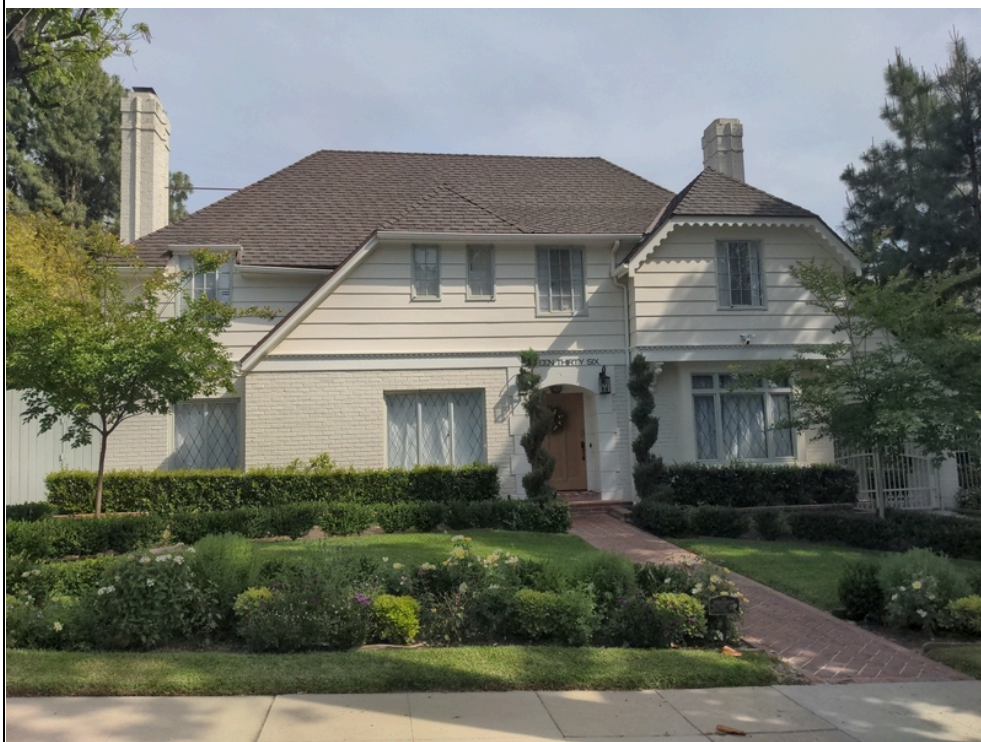
P5a. Photograph or Drawing (Photograph required for buildings, structures, or objects)

P5b. Description of Photo: (view, date, accession #) View east, 4/16/2026

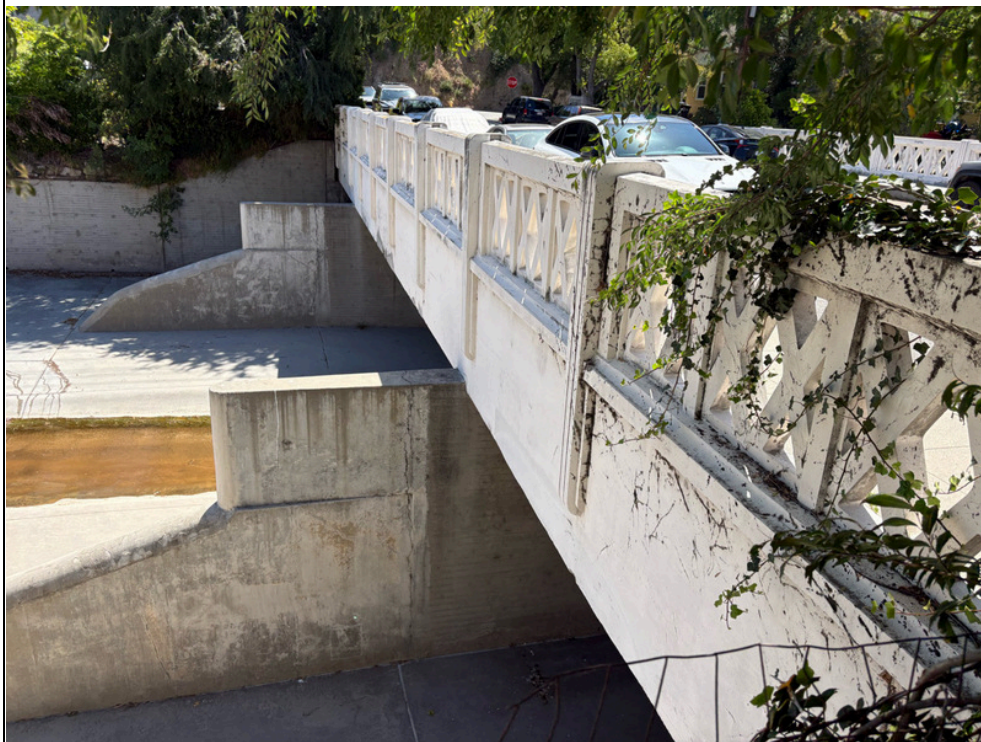
P5a. Photograph or Drawing (Photograph required for buildings, structures, or objects)

P5b. Description of Photo: (view, date, accession #) View southwest, 4/24/2026

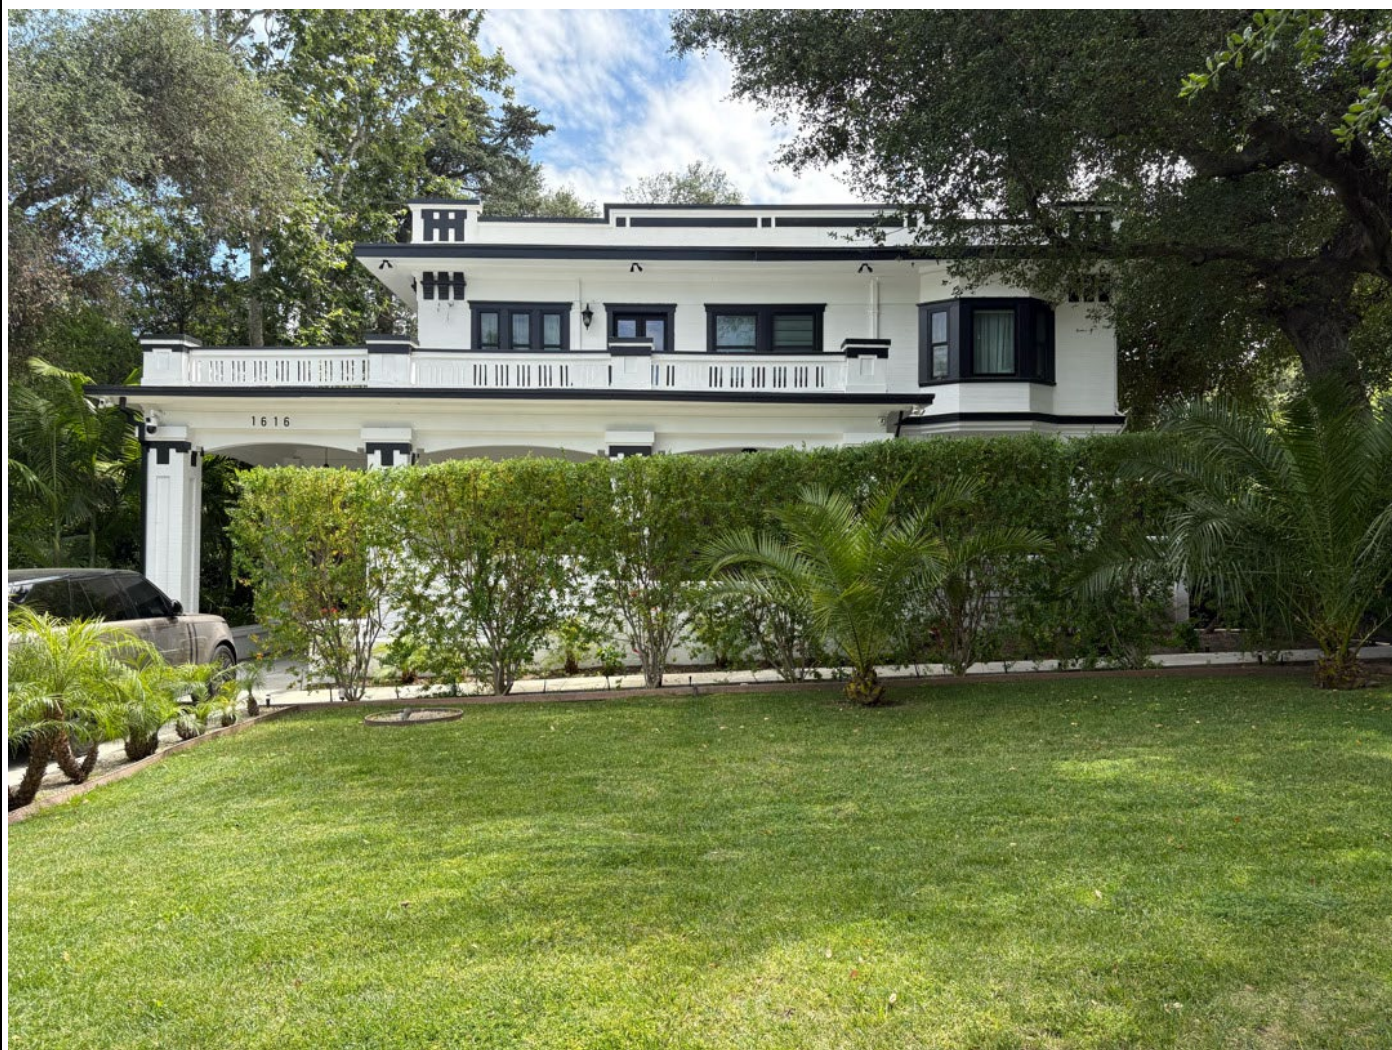
The property's character-defining features remain unchanged from those identified in 2014. No new alterations were noted in the 2026 survey update of this property, and it continues to retain a high degree of integrity. Photo below is view south, taken April 24, 2026.

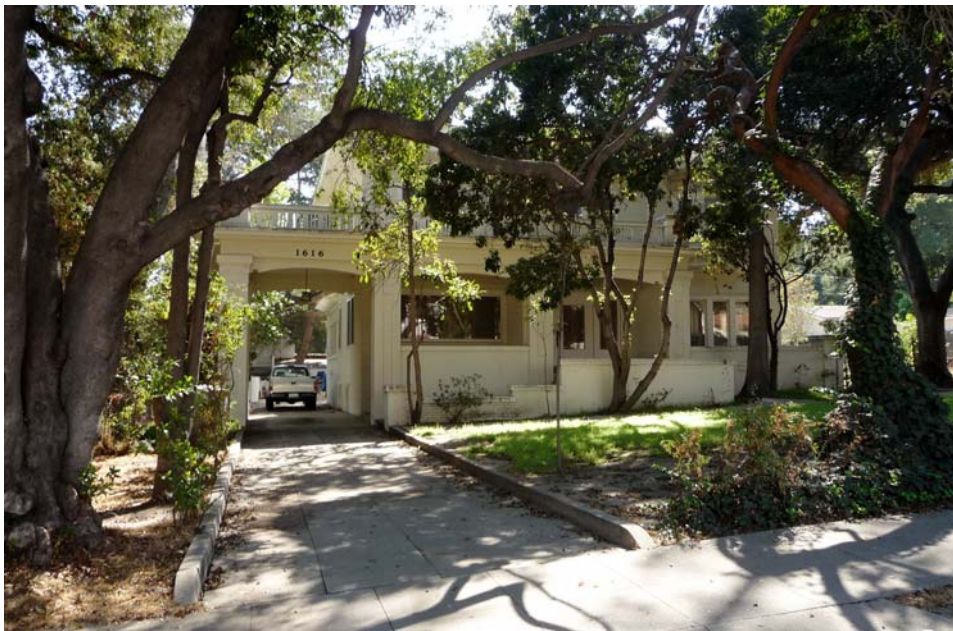
\*P5a. Photograph or Drawing (Photograph required for buildings, structures or objects)

- Setting: moderate setback
- Style: American Foursquare (with Prairie elements)
- Stories: 2
- Plan: L-shaped
- Facade: symmetrical
- Foundation: concrete
- Construction: wood frame
- Wall Cladding: wood lap, brick
- Porch (type, details): partial width, squared brick pier supports with decorative inset panels, low brick wall with concrete coping, segmental arch openings with carved wood detail, balustrade above porch roof
- Door (type, material, details):
  - Type 1 (primary): single, wood, fully glazed, sidelights, wood surround
  - Type 2: double, wood, screen

P5b. Description of Photo: (view, date, accession #) Primary facade, view southwest. ARG, October 2014.

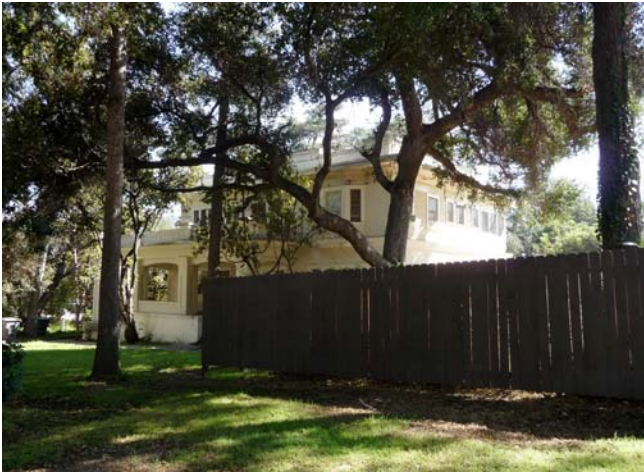
Image 2. Primary elevation, view southeast. ARG, October 2014.

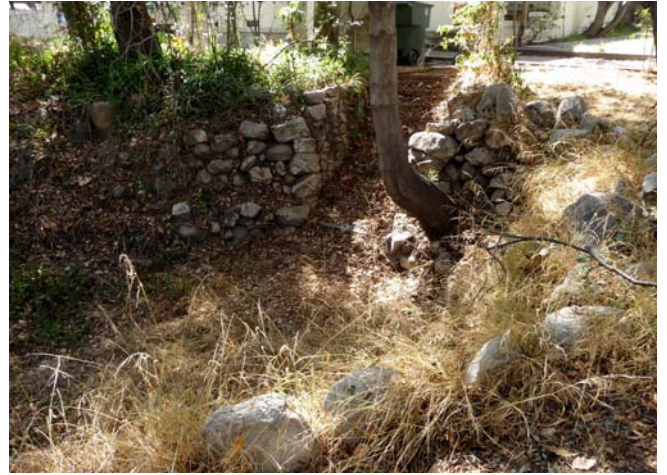
Image 3. Stone hardscape features, view southwest. ARG, October 2014.

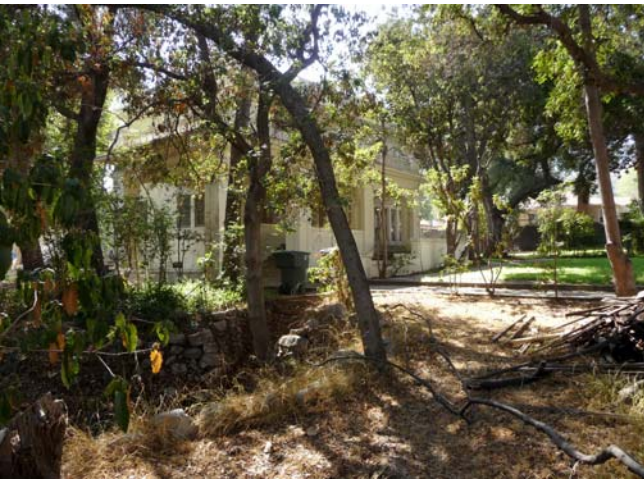
Image 4. House and landscape features, view southwest. ARG, October 2014.

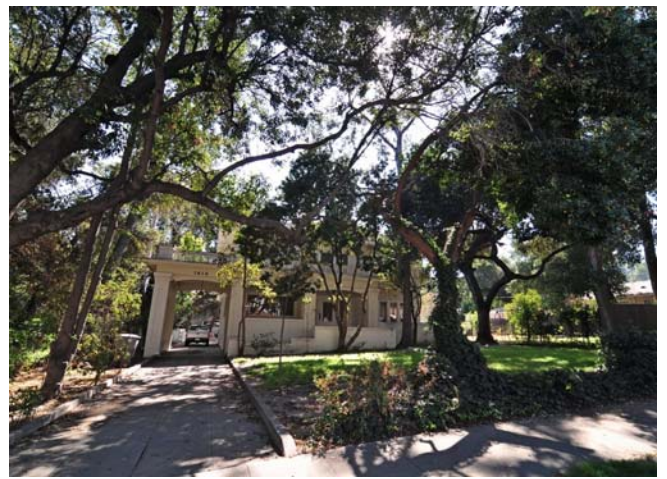
Image 5. Landscape features, view south. Carlberg Associates, October 2014.

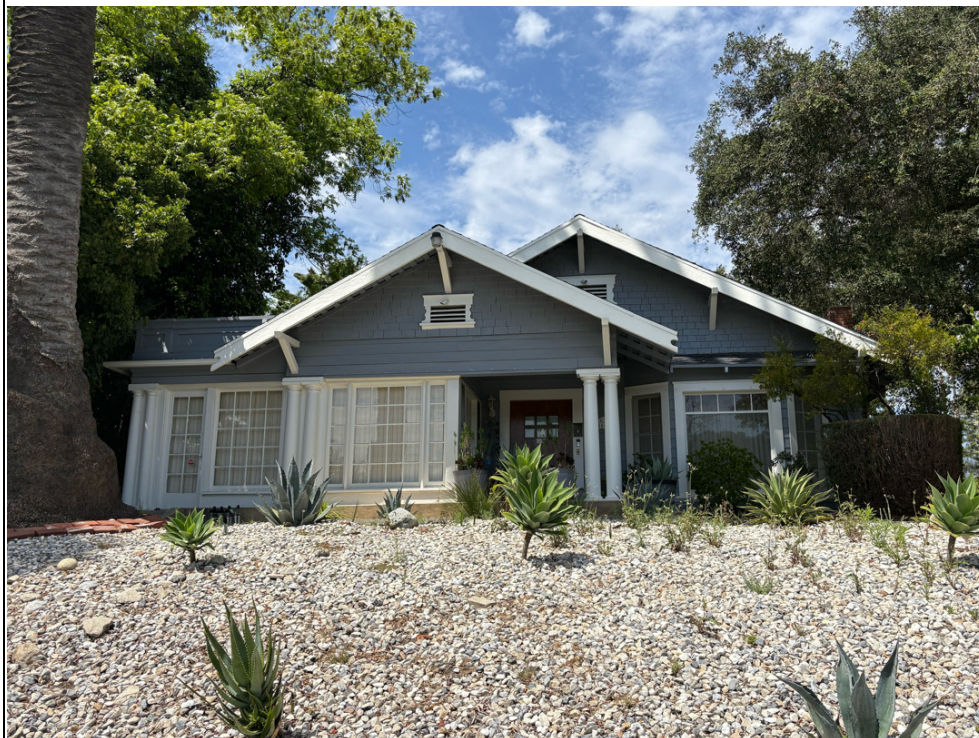
P5a. Photograph or Drawing (Photograph required for buildings, structures, or objects)

P5b. Description of Photo: (view, date, accession #) View north, 4/24/2026

\*B6. Construction History: (Construction date, alteration, and date of alterations) This property was constructed in 1912. A portion of the front porch was enclosed with glazing (original configuration still legible) at an early date. Alterations observed in the field are listed in P3a. Description.

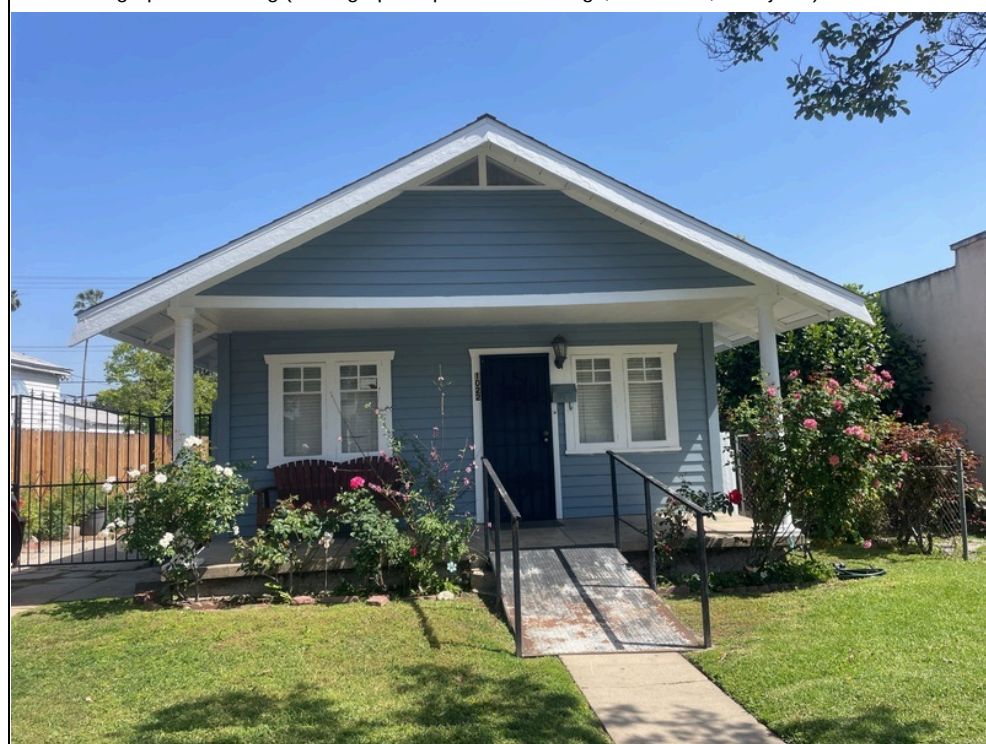
P5a. Photograph or Drawing (Photograph required for buildings, structures, or objects)

P5b. Description of Photo: (view, date, accession #) View east, 4/17/2026

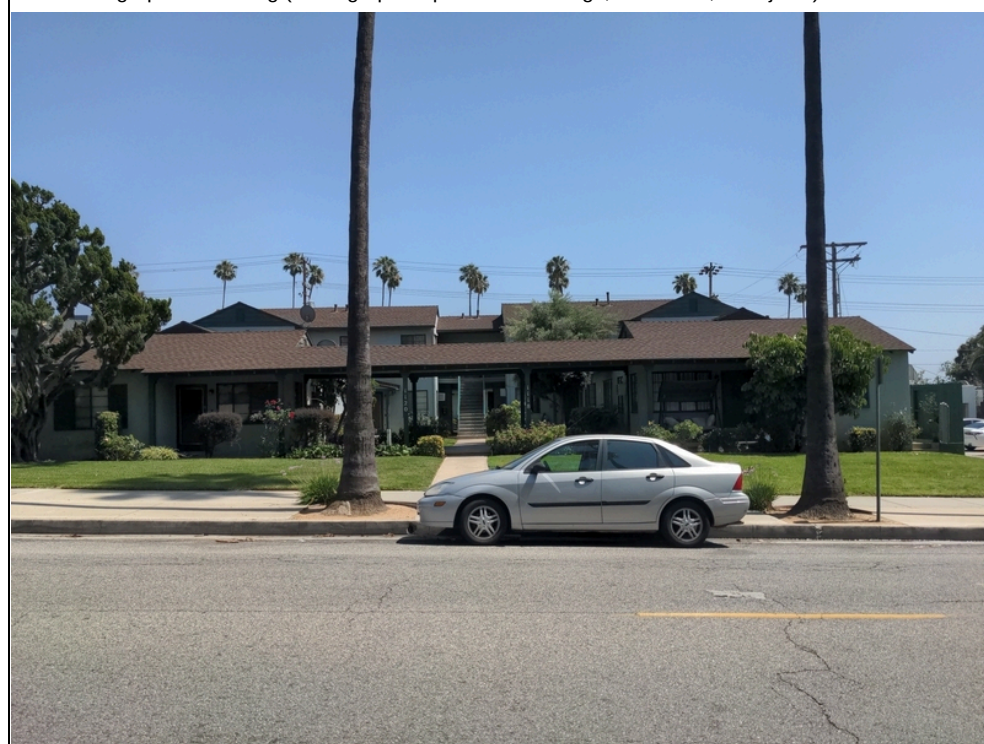
P5a. Photograph or Drawing (Photograph required for buildings, structures, or objects)

Alterations: addition, rear; windows replaced, some, secondary; security door added; window(s) boarded up

P5b. Description of Photo: (view, date, accession #) View east, 4/17/2026

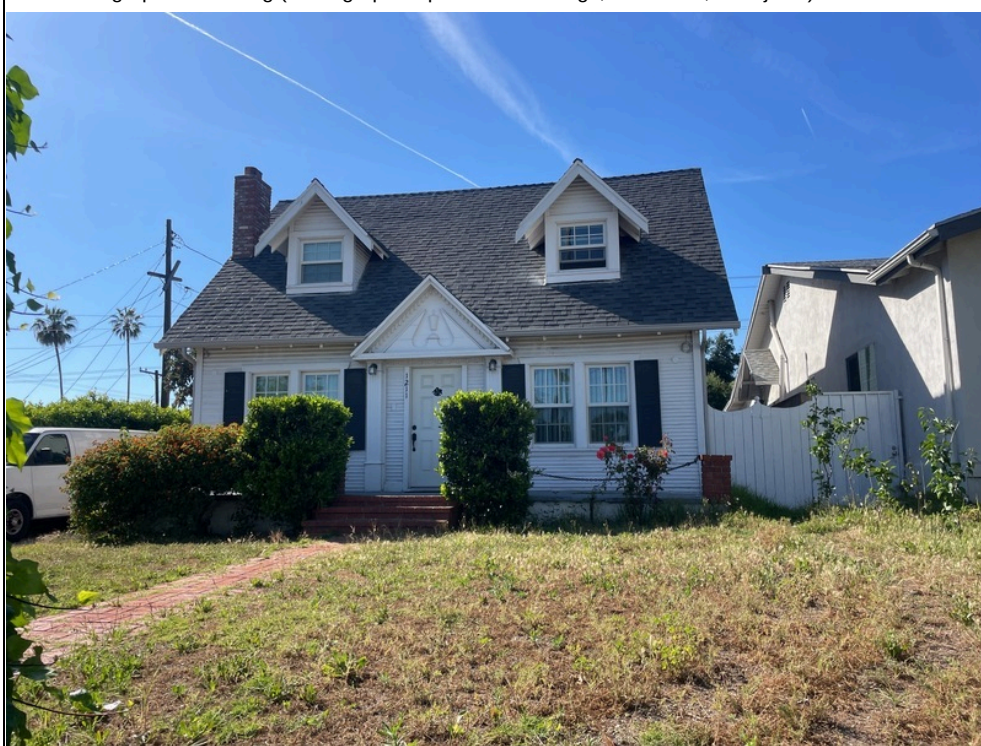
P5a. Photograph or Drawing (Photograph required for buildings, structures, or objects)

P5b. Description of Photo: (view, date, accession #) View west, 4/15/2026

\*B6. Construction History: (Construction date, alteration, and date of alterations) This property was constructed in 1915. Alterations observed in the field are listed in P3a. Description.
