## PRIMARY RECORD

\*Resource Name or # (Assigned by recorder) 1804 Tamerlane Dr

Historic Property Type: Multi-family residential  
Current Property Type: Multi-family residential  
Property Sub-Type: Multi-Family Residential: Garden apartment  
Primary Architectural Style: Mid-Century Modern

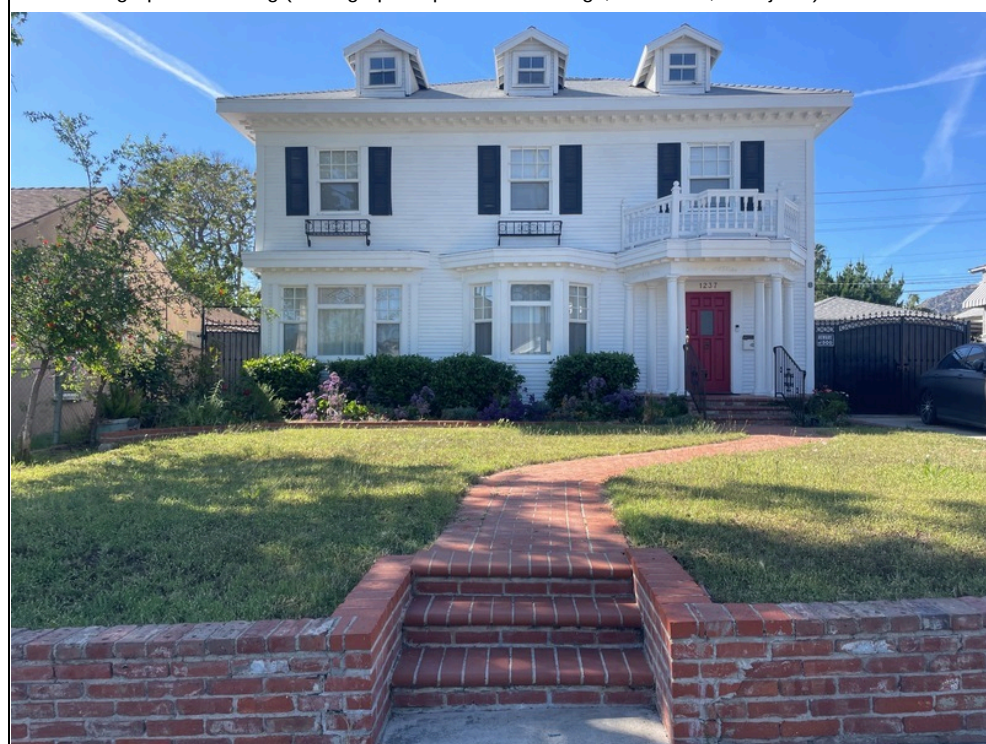
P5a. Photograph or Drawing (Photograph required for buildings, structures, or objects)

Alterations: windows replaced, all

P5b. Description of Photo: (view, date, accession #) View west, 4/15/2026

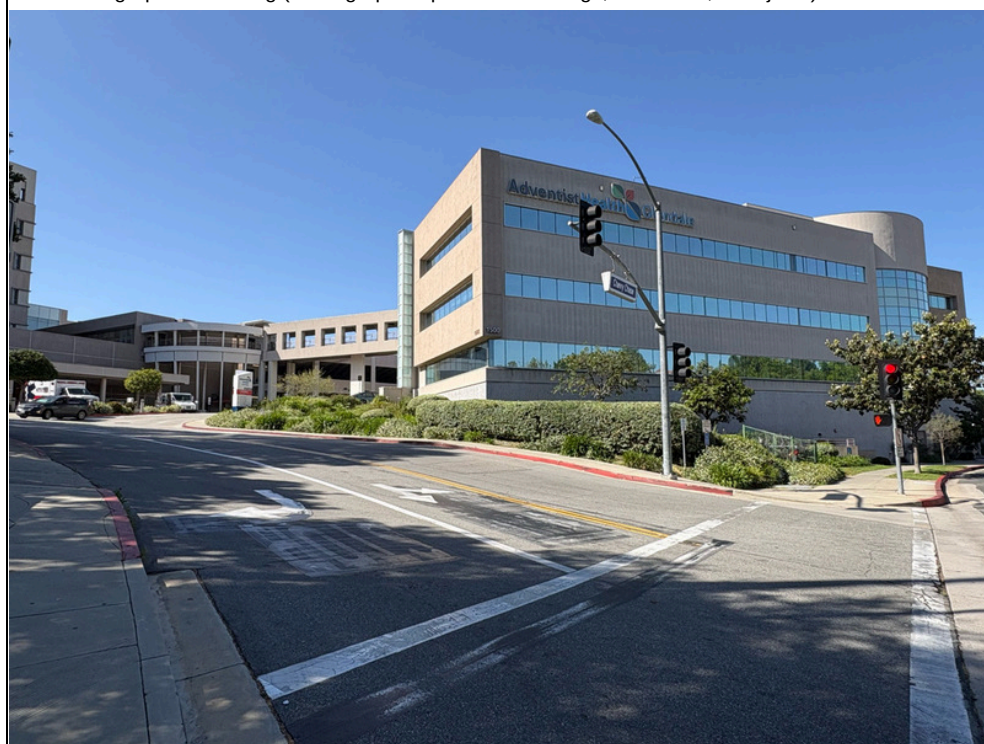
P5a. Photograph or Drawing (Photograph required for buildings, structures, or objects)

P5b. Description of Photo: (view, date, accession #) View southeast, 4/29/2026

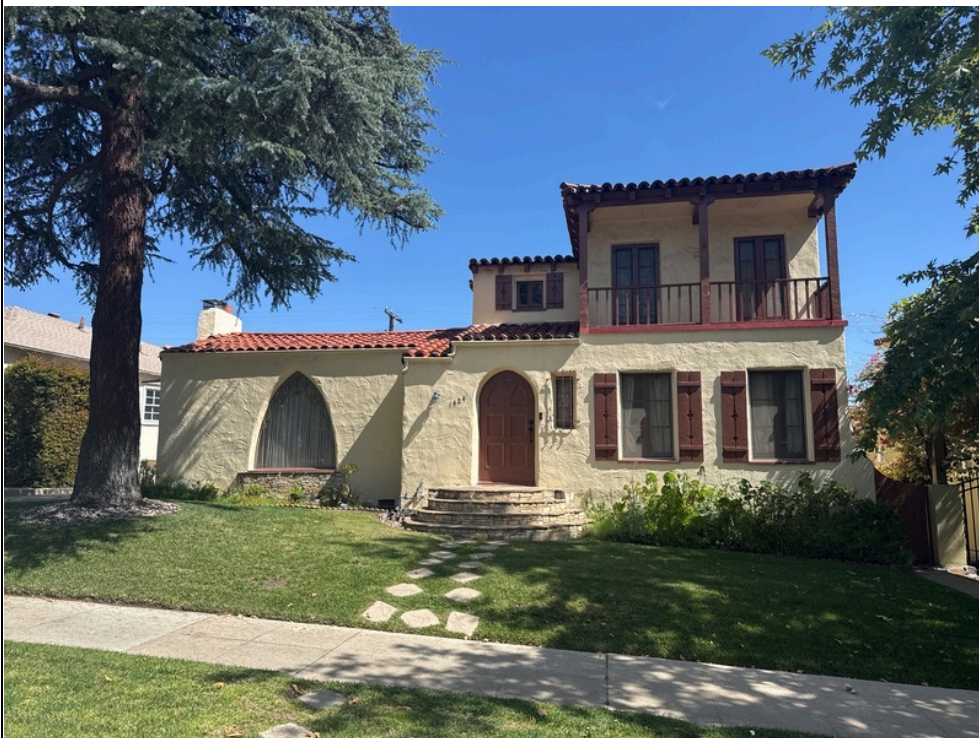
P5a. Photograph or Drawing (Photograph required for buildings, structures, or objects)

P5b. Description of Photo: (view, date, accession #) View east, 4/15/2026

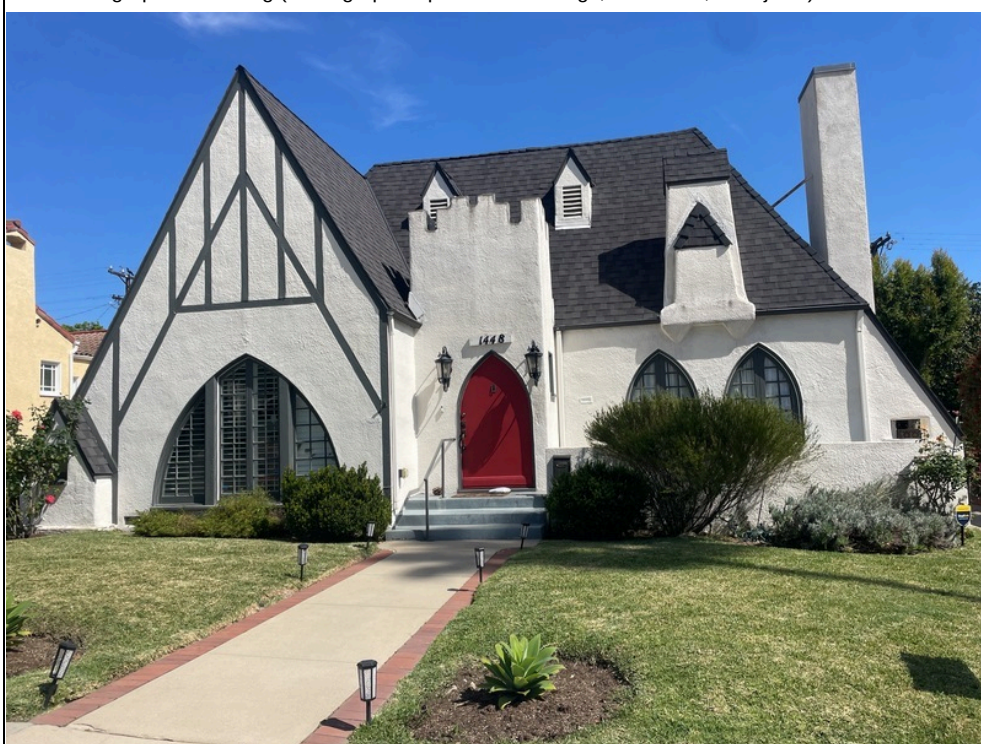
P5a. Photograph or Drawing (Photograph required for buildings, structures, or objects)

P5b. Description of Photo: (view, date, accession #) View east, 4/15/2026

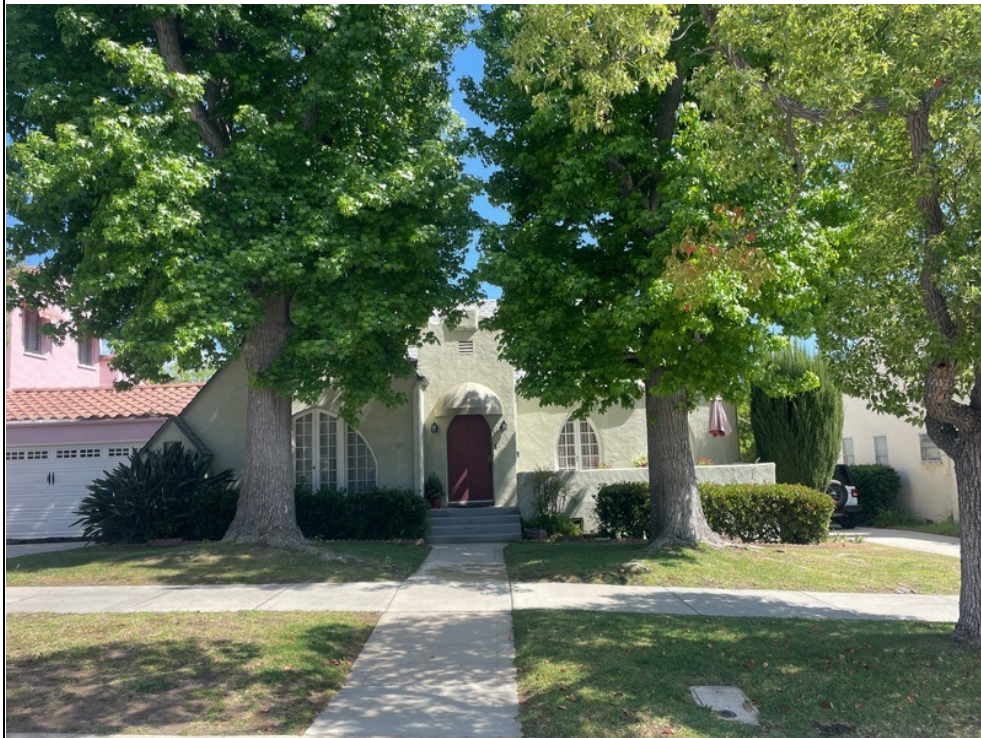
P5a. Photograph or Drawing (Photograph required for buildings, structures, or objects)

P5b. Description of Photo: (view, date, accession #) View east, 4/15/2026
